EVALUATION OF BRISCO SCOUR MONITORS

**FINAL REPORT FOR
IOWA DEPARTMENT OF TRANSPORTATION
PROJECT HR-551**

Final Report
for
Research Project HR-551

Vernon J. Marks
Research Engineer
515-239-1447

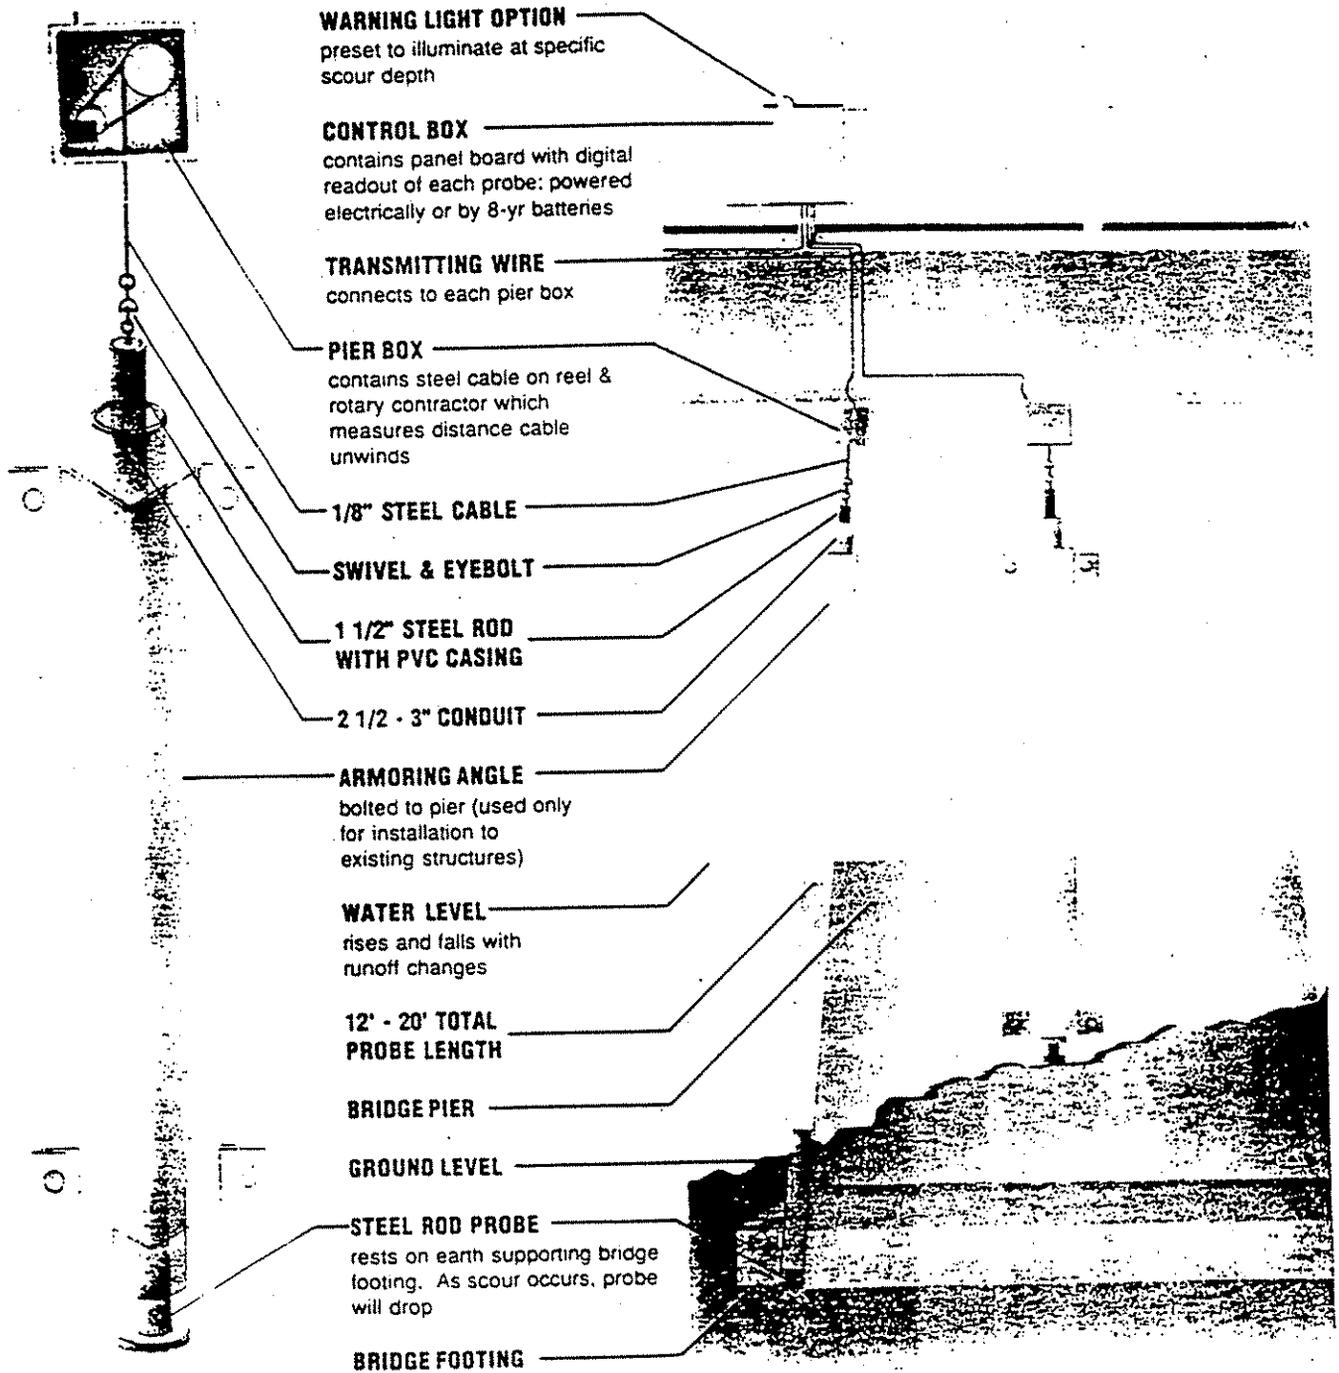
FIGURE 1
Schematic of the Brisco Scour Monitor

The Brisco Scour Monitors were developed and manufactured by Cayuga Industries Inc. of Schenectady, New York and are currently being marketed by Construction Techniques, Incorporated of Cleveland, Ohio. The system (Figure 1), very simply stated, consists of a probe resting on the river bottom connected by a cable to a reel. There is an electrical monitor of the movement of this reel which transmits to a digital readout. All mechanical underwater parts except the protection angles are galvanized to prevent corrosion. The digital readout was placed on pier 3 of the old bridge, and was later to be attached to pier MS2 of the new bridge. The attachment details are shown in Figure 2.

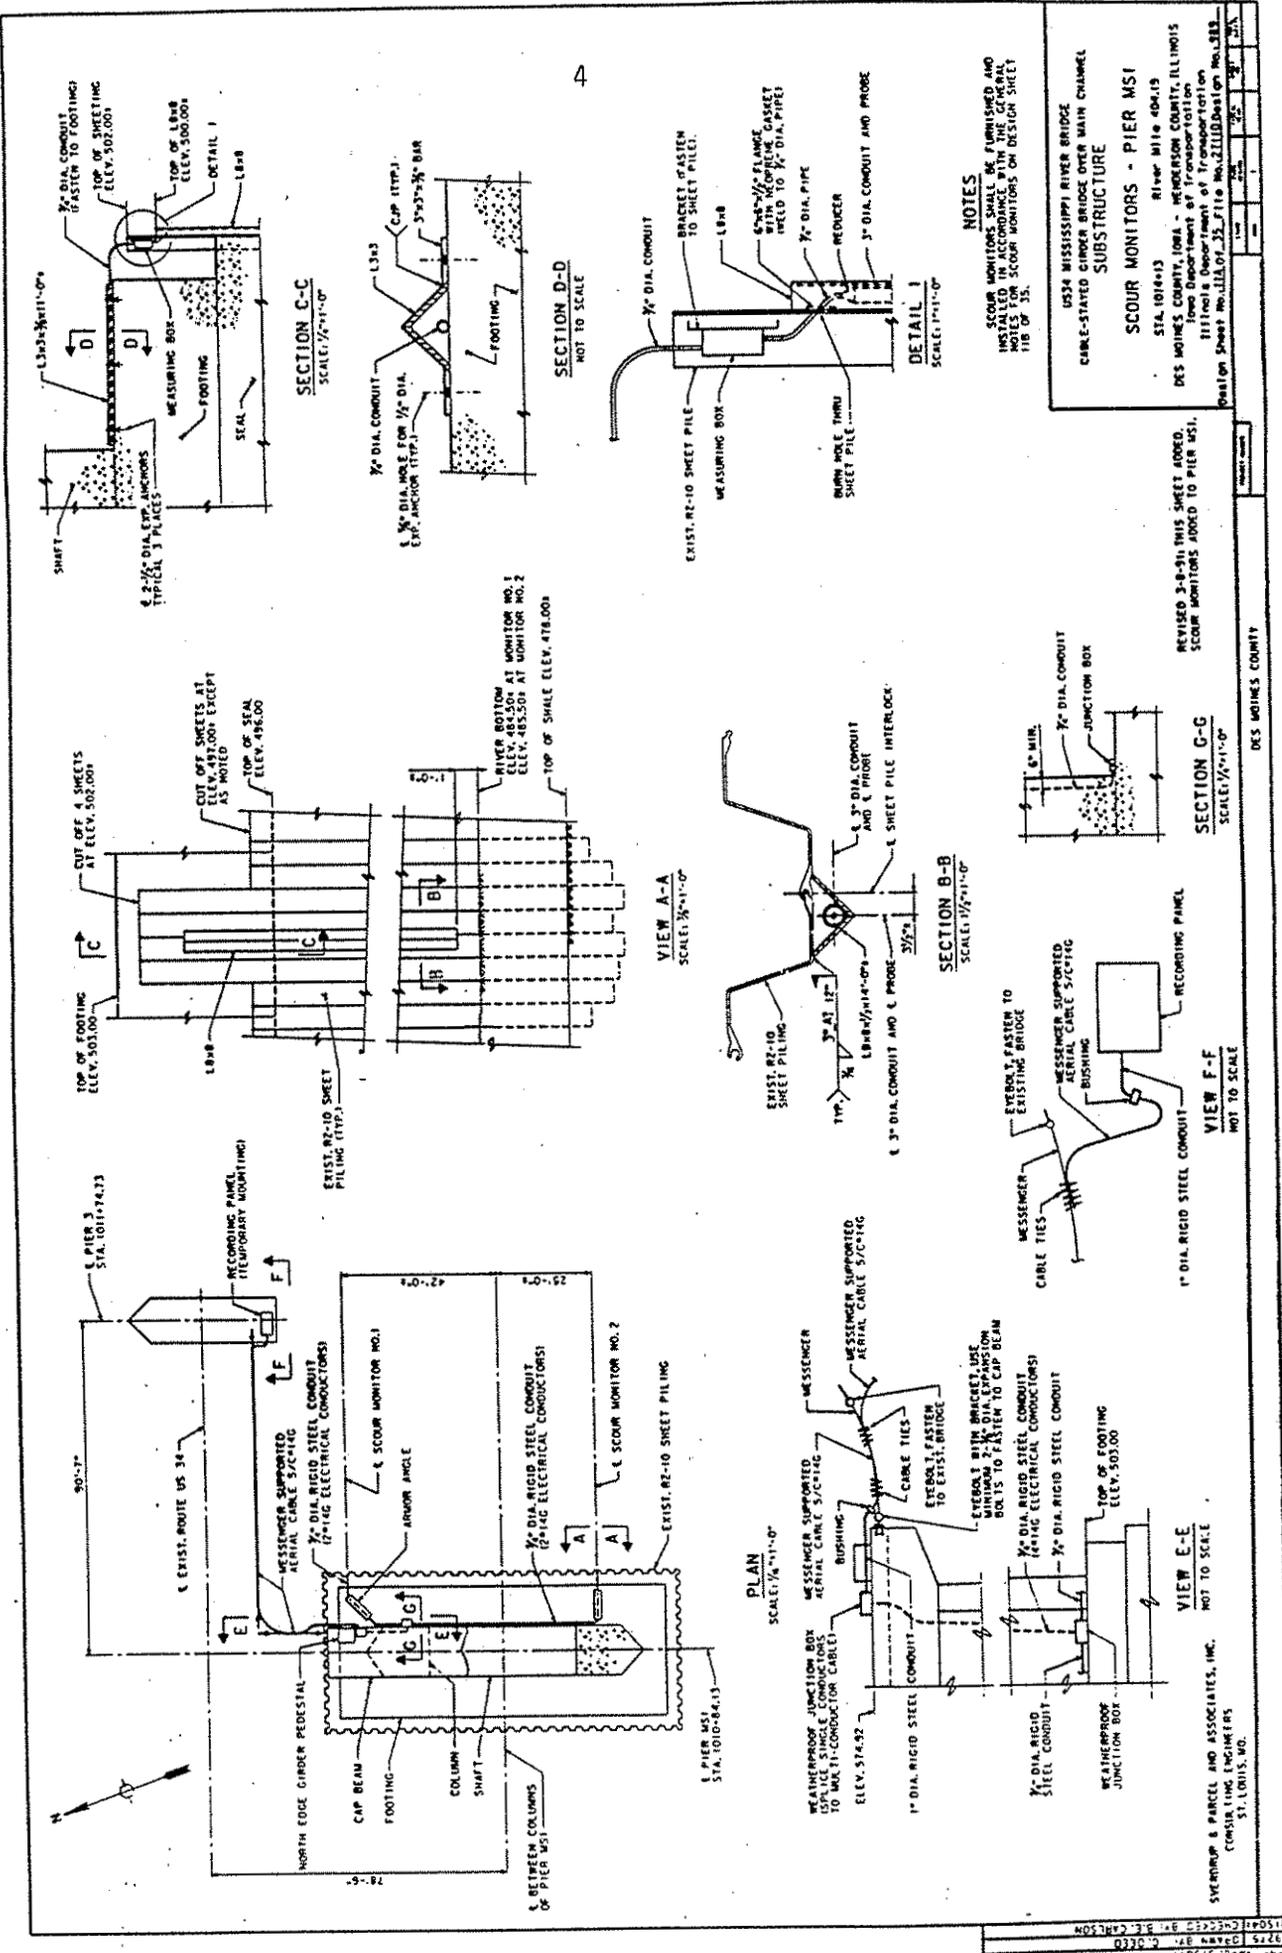
FIGURE 2
 Design Details for Installation
 of the Bridge Scour Monitors

As you know, the installation on the Burlington Bridge was different from the other installations. The probe was attached to the pier foundation and then the wires ran up the pier and a messenger cable carried the wires to the recording panel attached to the existing steel structure.

I believe that the messenger cable and the location of the recording panel were the cause of the problems with the digital counters.

Whenever there was a severe electrical storm in the area the measuring cable acted as a conduit for power surges which burned out the digital counters. The location of the recording panel on the steel bridge without grounding compounded the problem.
