**HIGHWAY DIVISION
OFFICE OF CONSTRUCTION
FIELD CONSTRUCTION REVIEW**

Project No.: NHSX-063-7(58 & 59)—3H-09	Date: 4/14/11
County: Bremer	
Contractor: CJ Moyna & Sons	
Type of Work: Grading	
Inspection Personnel: Bob Beckman, Zach Jolma	
Others Present: Ron Loecher, Bob Stanley, Steve Megivern	
Reviewed By: Melissa Serio

The project includes grading of US 63 SBL from US 63/IA. 3 north to Co. Rd. C-38 and US 63 from Co. Rd. C-38 north to 1 km north of Crane Creek.

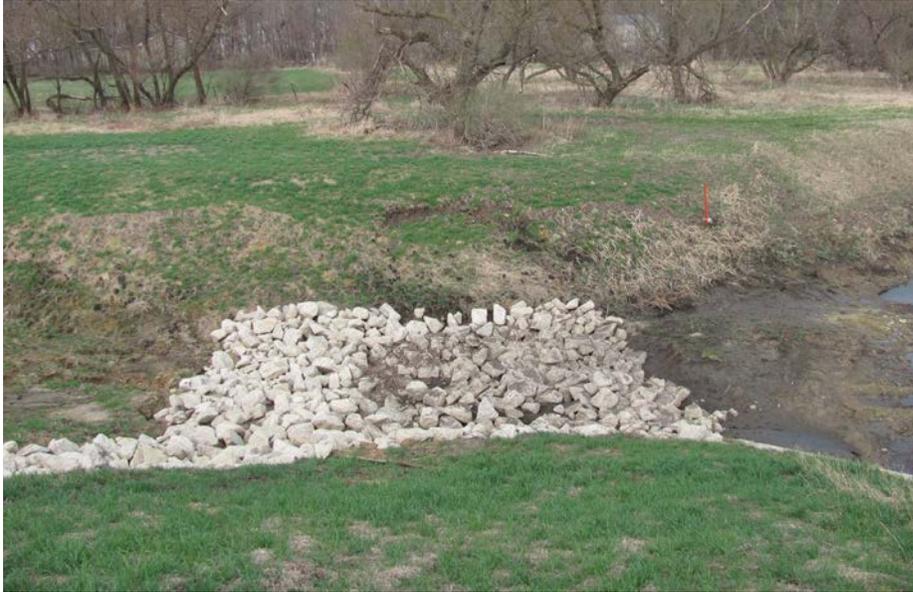
Photo from 4/14/11

Ramp A:

Recommend installing additional rip-rap in area of slide.

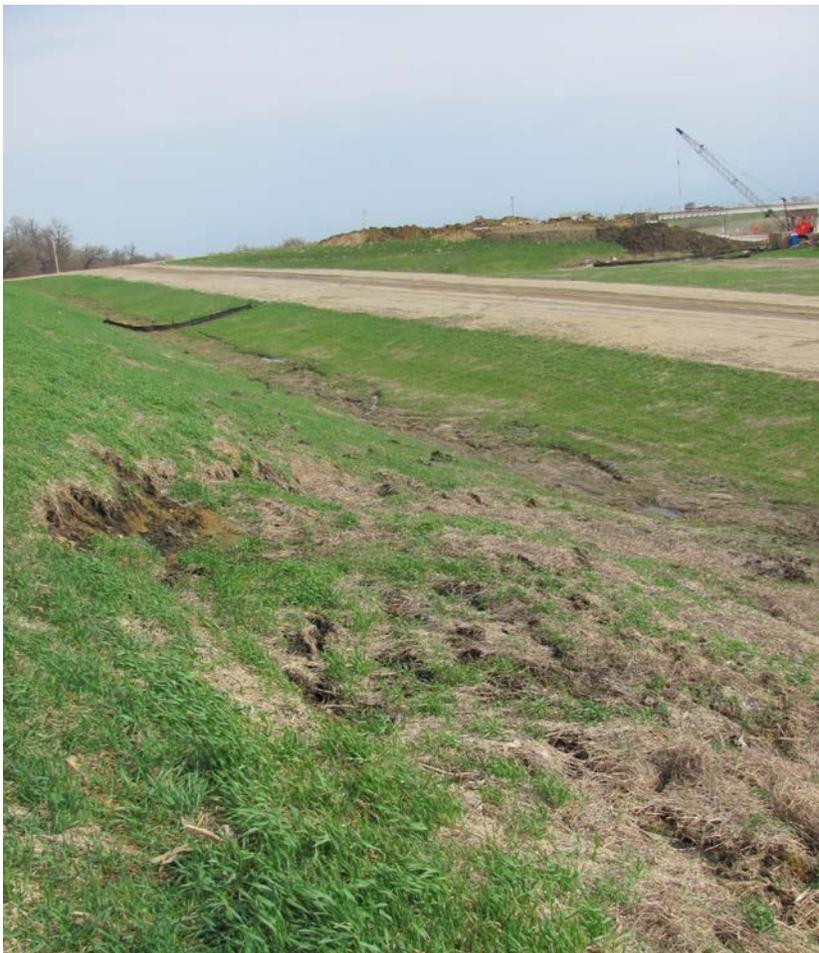
Photo from 4/14/11

Ramp C:

Backslope slide area is wet, and water from previously installed backslope drain was observing flowing. Recommend taking a wait and see approach and check area later this season during the paving project. It is anticipated the area will likely require installation of approx. 100 feet of backslope subdrain at an elevation higher than current subdrain.

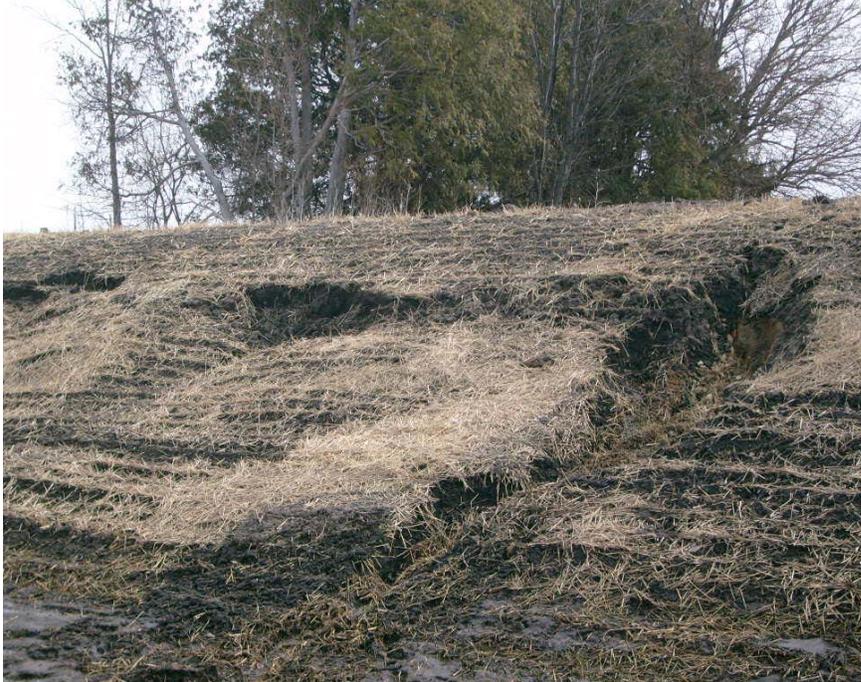
Photo from Bob Beckman.

(59) Project: Mainline Slides, approx. Sta. 124 to 130

While onsite, observed field tile and evidence of another tile that were not tied in. Appears water from tiles has been working its way out of the backslope and is likely the cause of the slide.

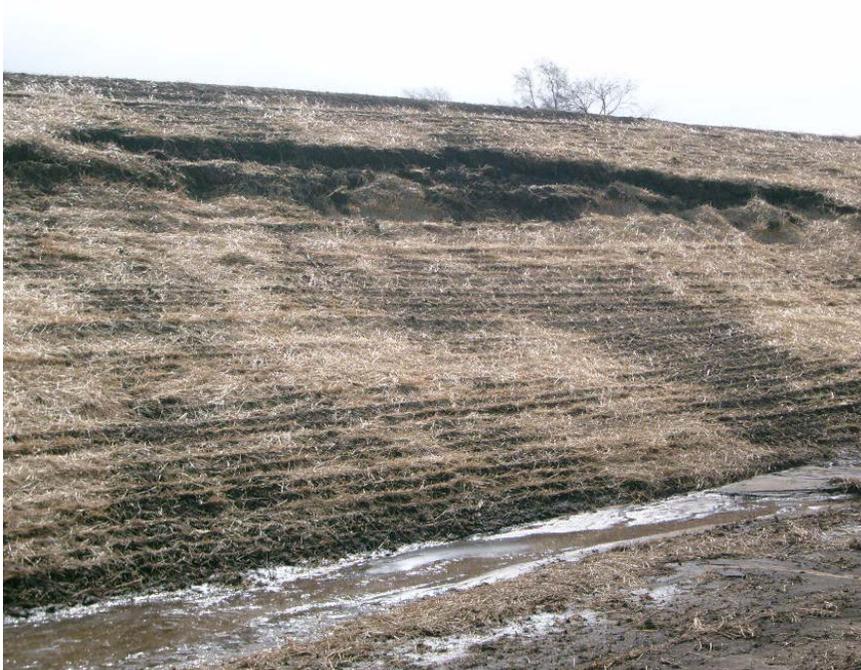
Photo from Bob Beckman.

On the remaining mainline backslope slides (north of slide with tiles) - recommend taking a wait and see approach. Slide areas were not wet. Area above the slide was also not wet and appeared to be draining.
