**LABORATORY STUDY OF THE
LEACHATE FROM CRUSHED
PORTLAND CEMENT
CONCRETE
BASE MATERIAL**

**Final Report
For
MLR-96-4**

Project Development Division

**Iowa Department
of Transportation**

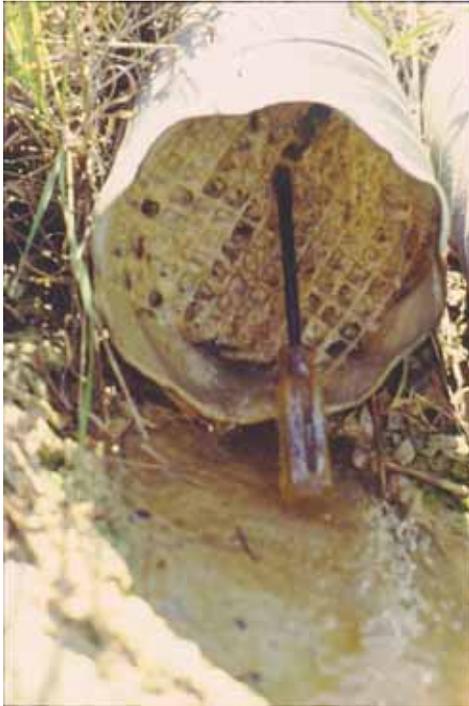
Fig B-1
Drain outlet with wire mesh rodent guard completely plugged by calcium deposits.

Problems of soil erosion were being noted at drain outlets, specifically in western Iowa, in the area of loess soils. Of course, the erosion is detrimental to efficient and safe grass mowing operations. Field trip observations tied the erosion to lack of vegetation growth as a result of high pH water from drain outlets. Field trip observations also turned up several cases where the wire mesh rodent guards had been clogged with calcium carbonate precipitation. See Appendix B, photos 1, 2, 3, and 4 showing drain rodent guard blockage and soil erosion.

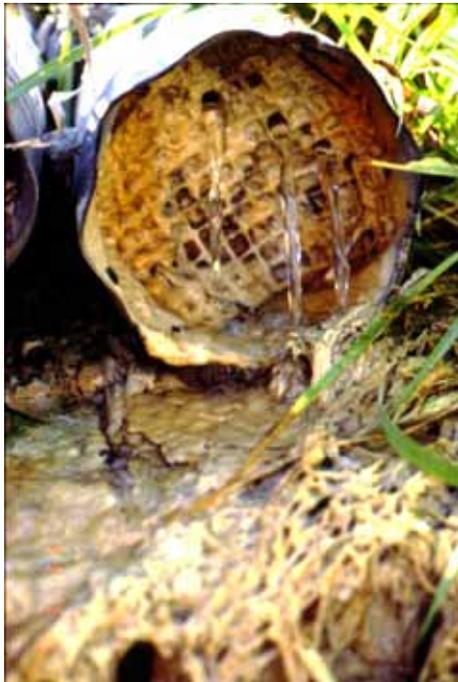
Fig B-2
Plugged drain outlet discharging backed-up water after being punctured with a screwdriver.

1. High pH levels of drainage water will continue high for many years following construction.
2. The high pH drainage water will leave precipitates at the edge drain outlets. The precipitate growth can completely block the wire mesh rodent guards at the end of a drain outlet and cause drainage water to be backed up inside the drain. This is not a problem with the 'finger' type rodent guards.
3. The high pH of the drainage water can kill or impede grass growth at the drain outlet.
4. Soil erosion may occur from a loss of vegetation growth at drain outlets which have high pH water discharge. The erosion can become a hazard for the maintenance mowing equipment and personnel. It can also cause the headwall slabs to fall away.

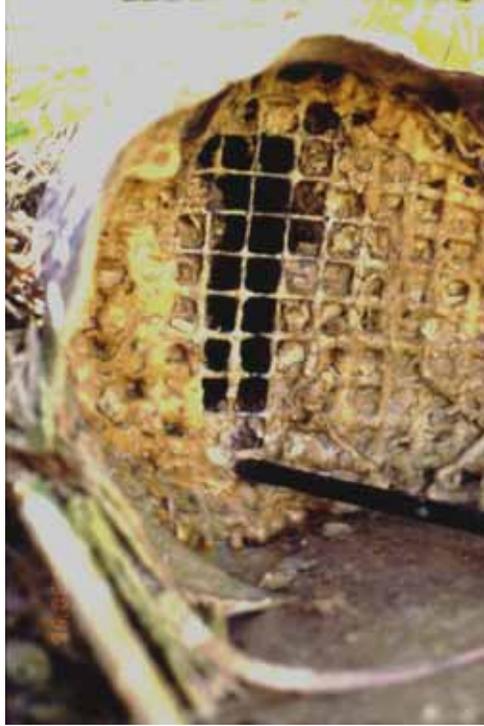
Fig B-3
Wire mesh rodent guard plugged by deposits.

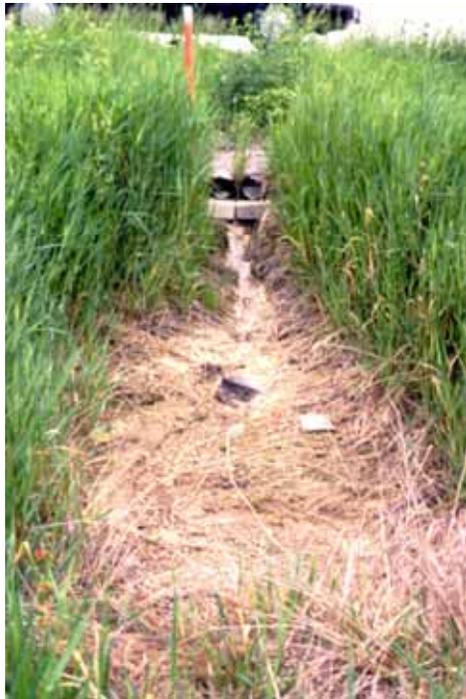
Fig B-4
High pH drainage water impedes vegetation growth and contributes to soil erosion and loss of drain outlet headwalls.

The high pH water can be detrimental to growth of grass or other vegetation near the drain outlets. The lack of the grass root structure, in turn, allows soil erosion to occur below and beyond the drain outlet. Severe erosion may cause the drain outlet headwall to be displaced. This erosion is also hazardous for right-of-way mowing operations.

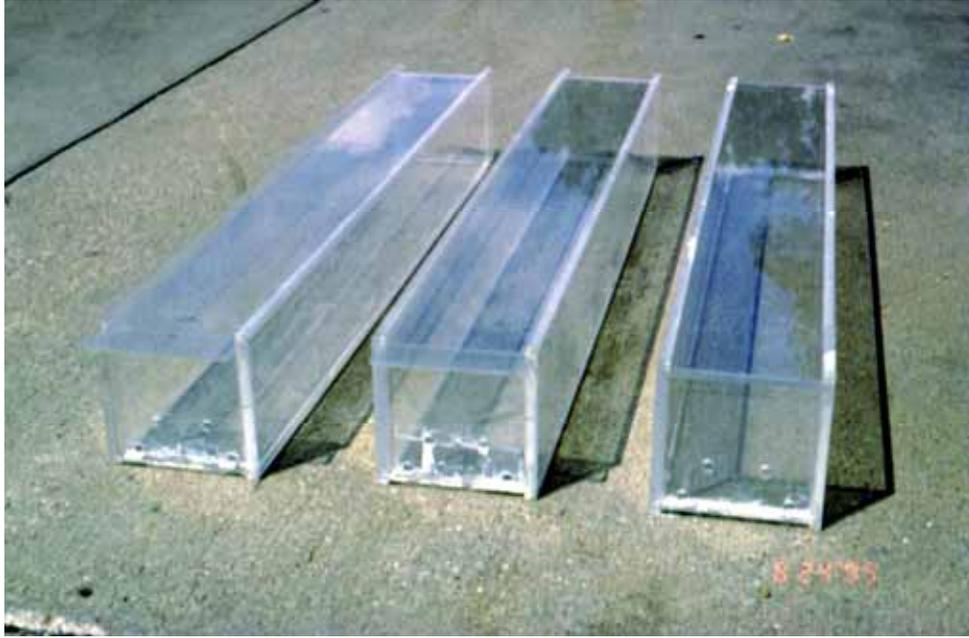
Fig C-1
Three boxes built to hold recycled PCC drainable base samples for leachate evaluation.

Three narrow and long boxes were constructed to contain the aggregate and water for the test (see Appendix C). The boxes were made of Plexiglas to allow visibility through the walls. Box dimensions were 6 inches wide, by 6 inches high, by 48 inches long. The top was a sliding removable cover. A compartment to pour water into the box was at the top of one end and a cork-plugged outlet was at the bottom of the opposite end. The compartment regulated the actual water flow into the box to a low level. The boxes were set at a slight angle so that any water that was poured in at the top end would flow toward the lower corked outlet. The boxes were kept in the Cement and Concrete laboratory wet room during the test period.

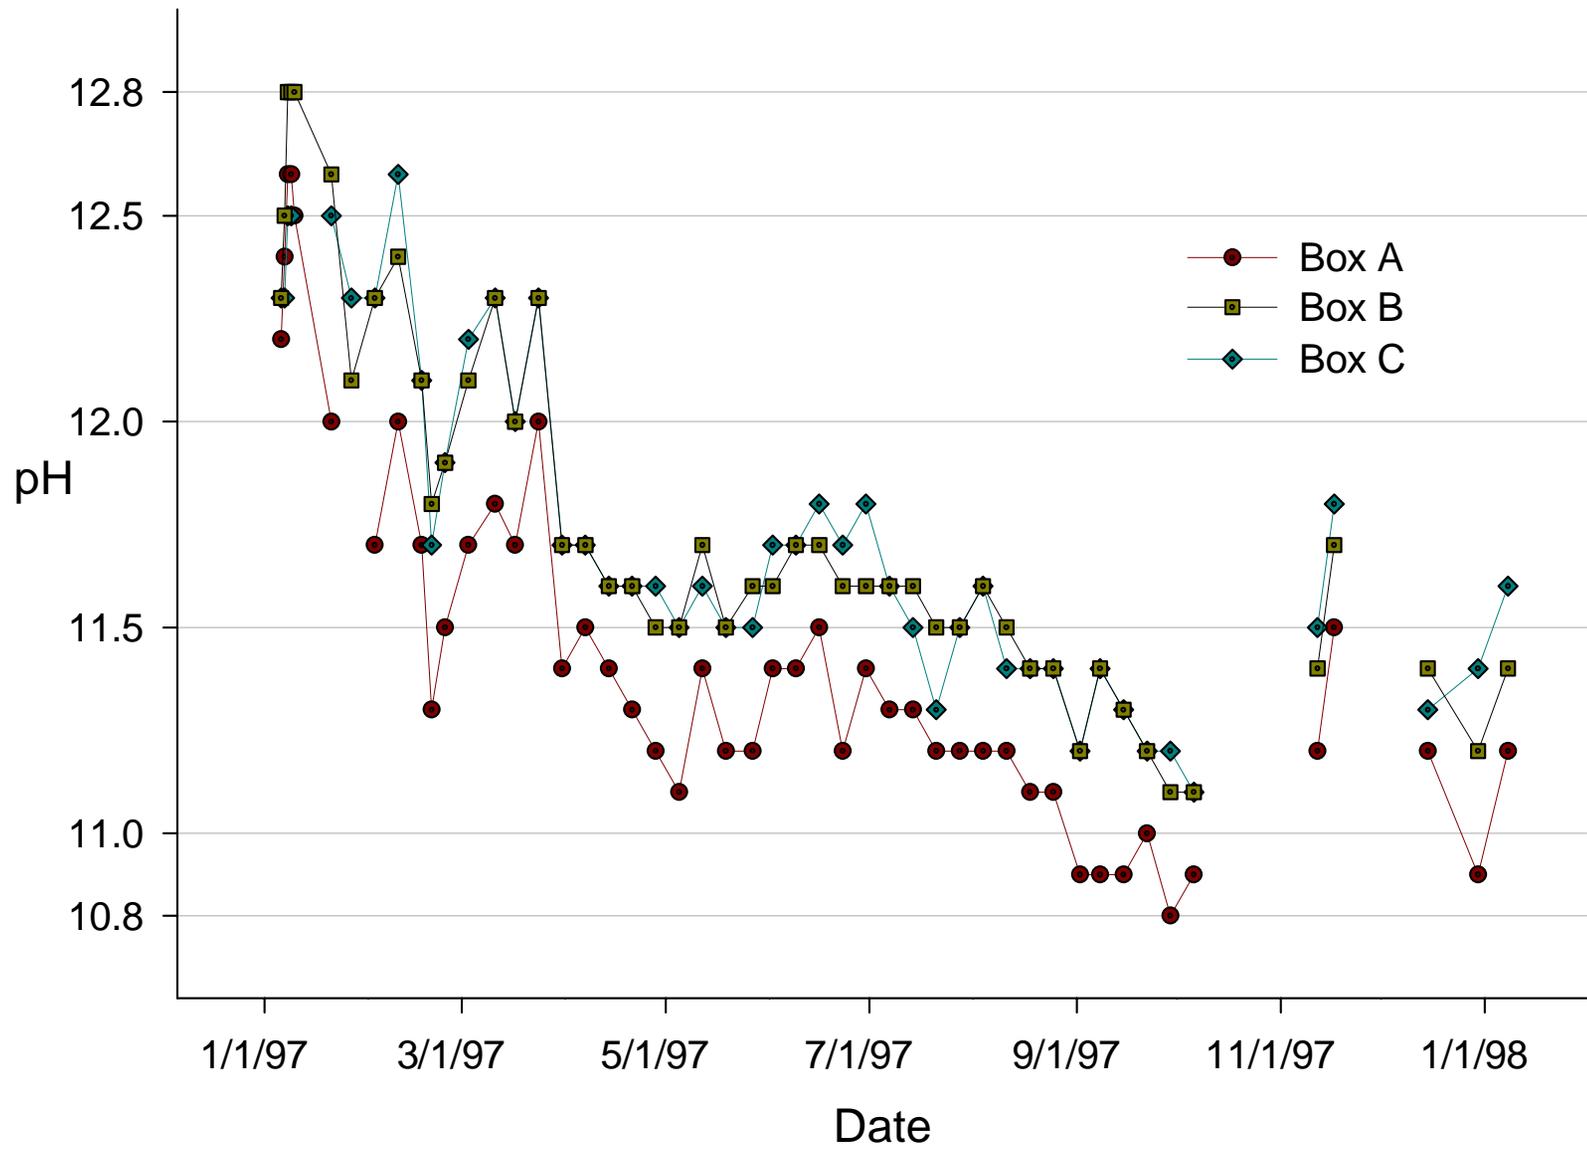
pH Test Results

pH TEST RESULTS VERSUS TIME

Upon the initial combining of distilled water with the recycled crushed PCC drainable base material, the water pH soon rose to the range of 12.5. Over the first 10 weeks of testing the pH gradually came down to around 11.5. It leveled off and stayed around that value for the next 20 weeks. Within the last 20 weeks of testing there was a dip in the pH down to around 11.0. However, this dip is believed to be due to problems with the pH meter. After the meter was repaired, the pH readings were again around 11.5.

From comparison of pH values between the 3 boxes, it was clearly evident that Box A consistently had a pH value of about 0.3 lower than Box B or Box C (see Appendix D for a graph of the results). As testing progressed, considerable amounts of calcium carbonate precipitated around the outlet holes.
