TR-521
FIELD INVESTIGATION OF HYDRAULIC STRUCTURES
FACILITATING FISH ABUNDANCE & PASSAGE THROUGH
BRIDGES IN WESTERN IOWA STREAMS

FINAL REPORT

March 2006

16. ABSTRACT The overarching goal of the proposed research was to evaluate the hydraulic performance of twenty two (22) fish-passage structures located in close proximity to bridges in western Iowa and within the HCA (Hungry Canyon Alliance) territory. Such structures include riprap weirs, fish ladders and grouted ripraps. The hydraulic performance of the aforementioned structures was evaluated via detailed field tests for a range of flow conditions relevant to fish migration through bridge waterways in different streams in western Iowa.

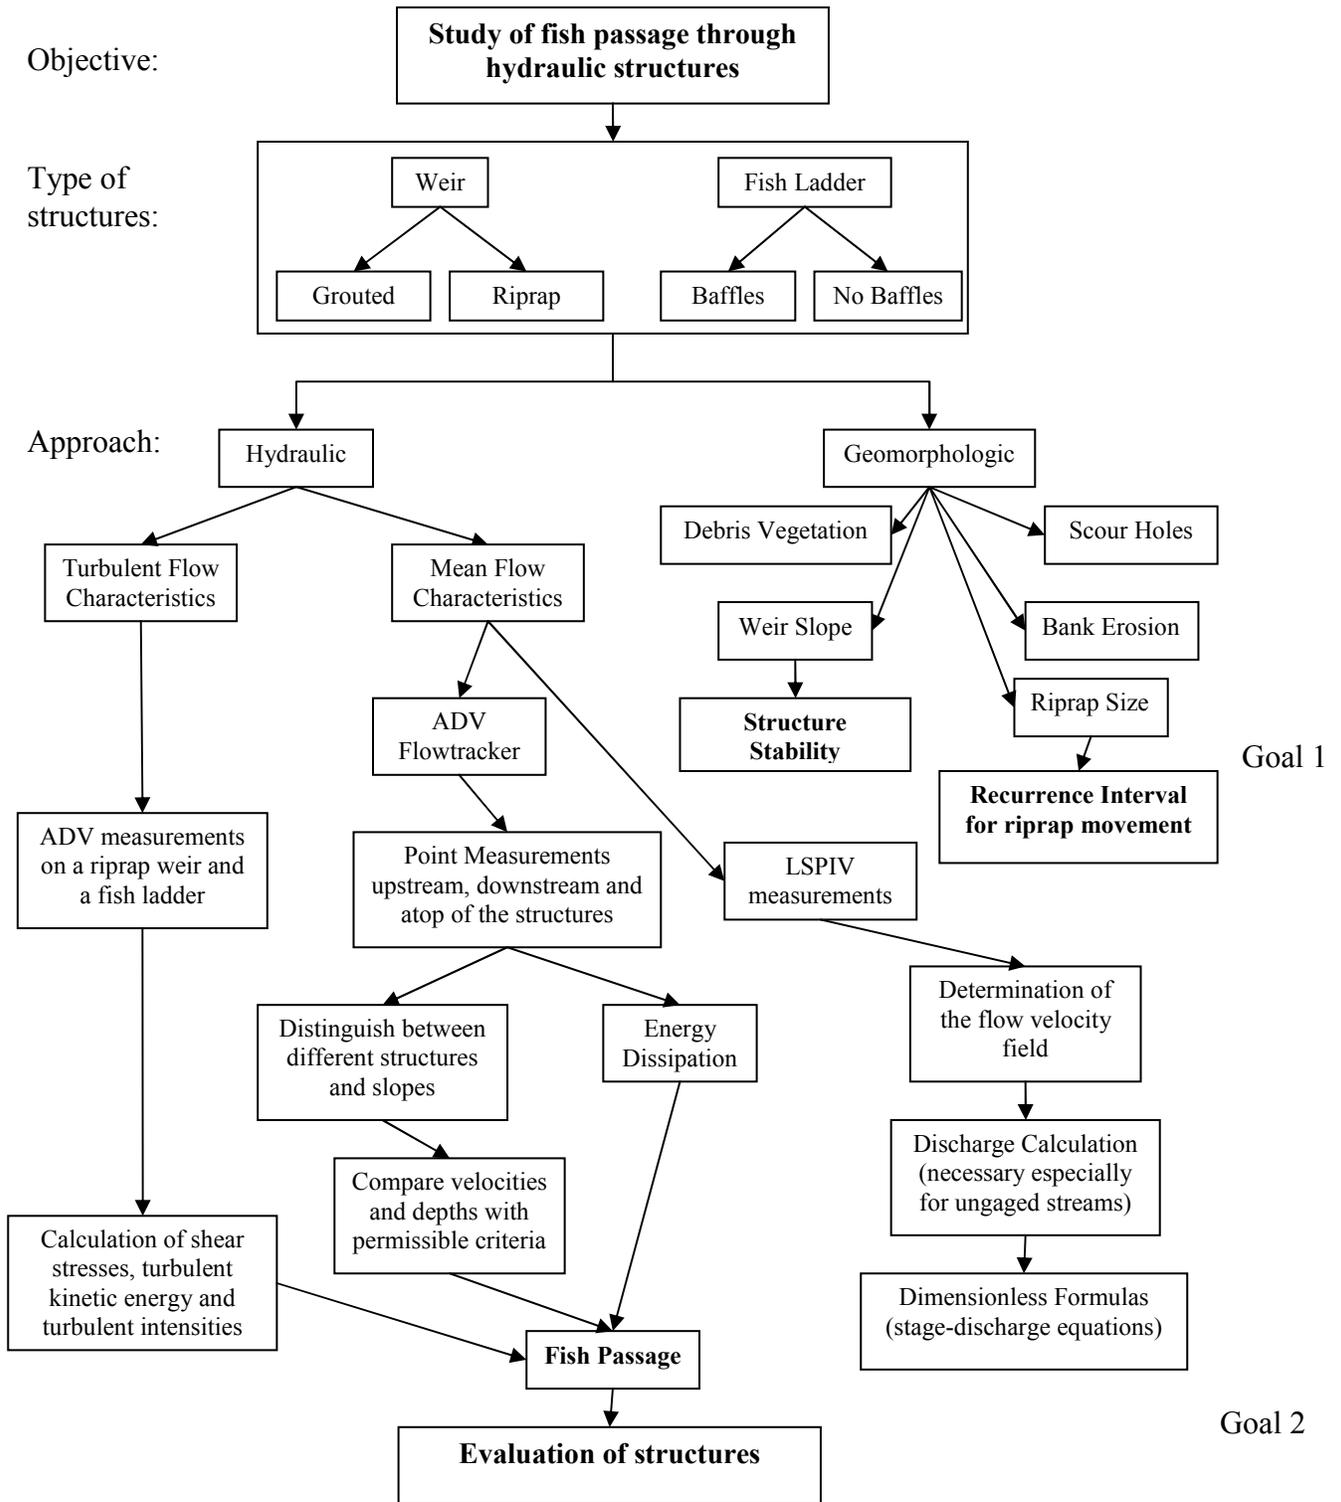
Figure 1b. An outline of this research

Figure 1b outlines the objective, approach and goals of this investigation. It illustrates the different steps considered in order to meet the goals of this study.

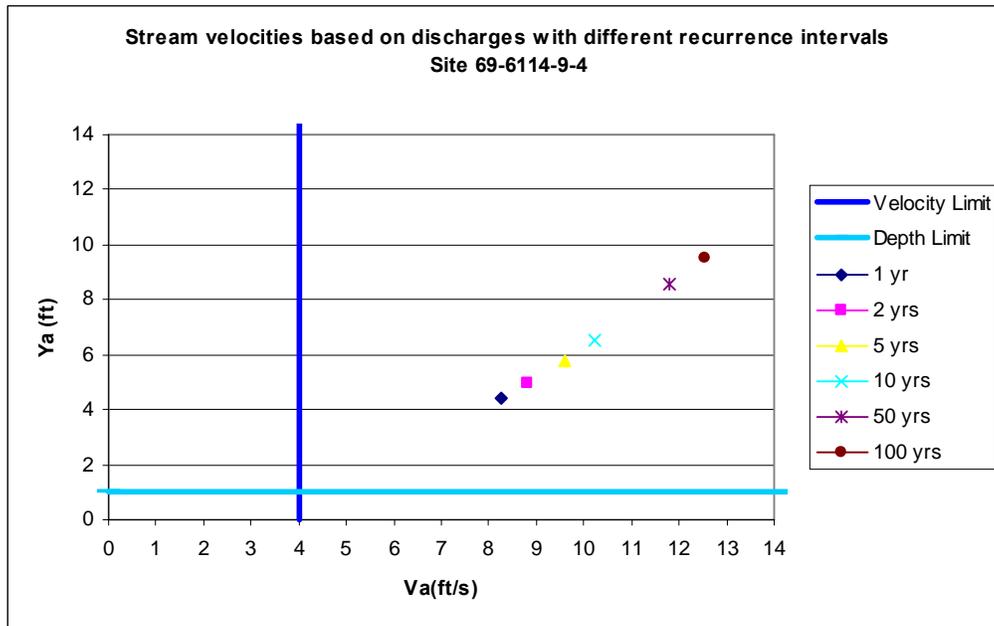
Figure 2. Velocities for discharges with different recurrence periods for Long Br. Cr.

The low recurrence period discharges (Q_1 , Q_2 , and Q_5) are useful for examining the performance of structures with respect to fish passage. The high occurrence events (Q_{10} , Q_{50}) are useful for examining the stability of structures. It was found that all structures would satisfy the minimum water depth criterion of 1ft for fish passage during low recurrence period discharges (Figures 2-23, Appendix A). The permissible velocity criterion (4 ft/s) was violated for all structures and for all recurrence periods (Figures 2-23, Appendix A).

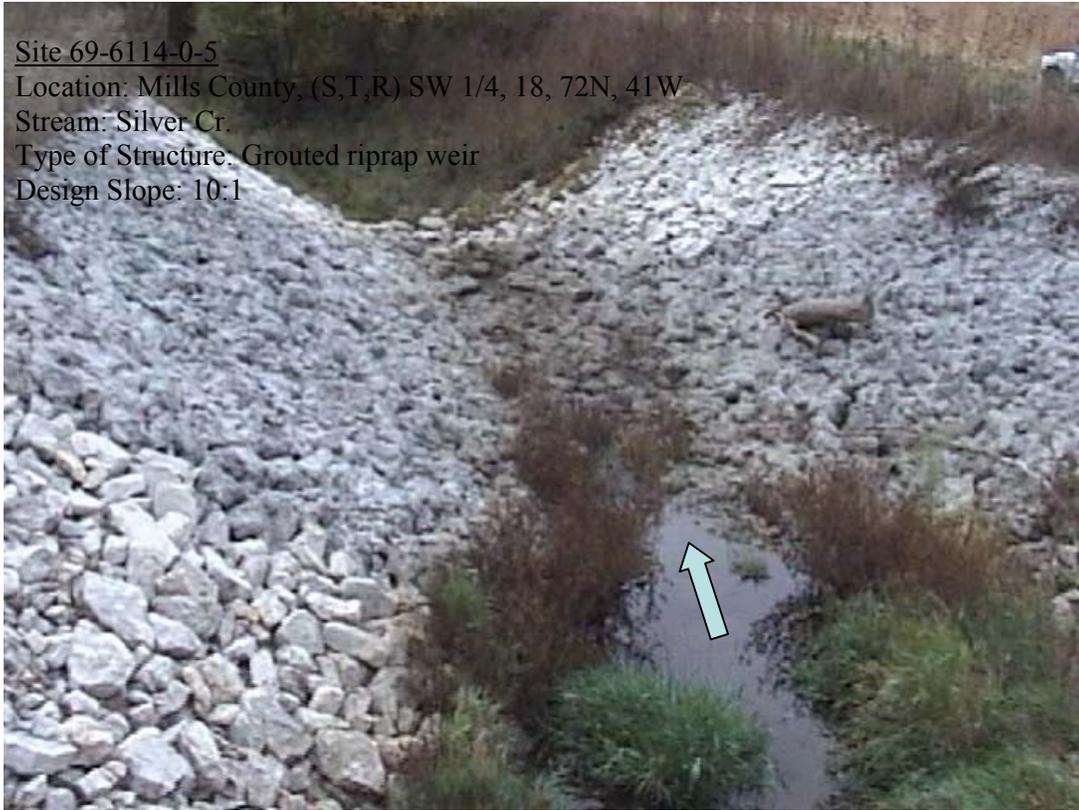
Figure 33a. Description of site 69-6114-0-5

Site 69-6114-0-5
 Location: Mills County, (S,T,R) SW 1/4, 18, 72N, 41W
 Stream: Silver Cr.
 Type of Structure: Grouted riprap weir
 Design Slope: 10:1

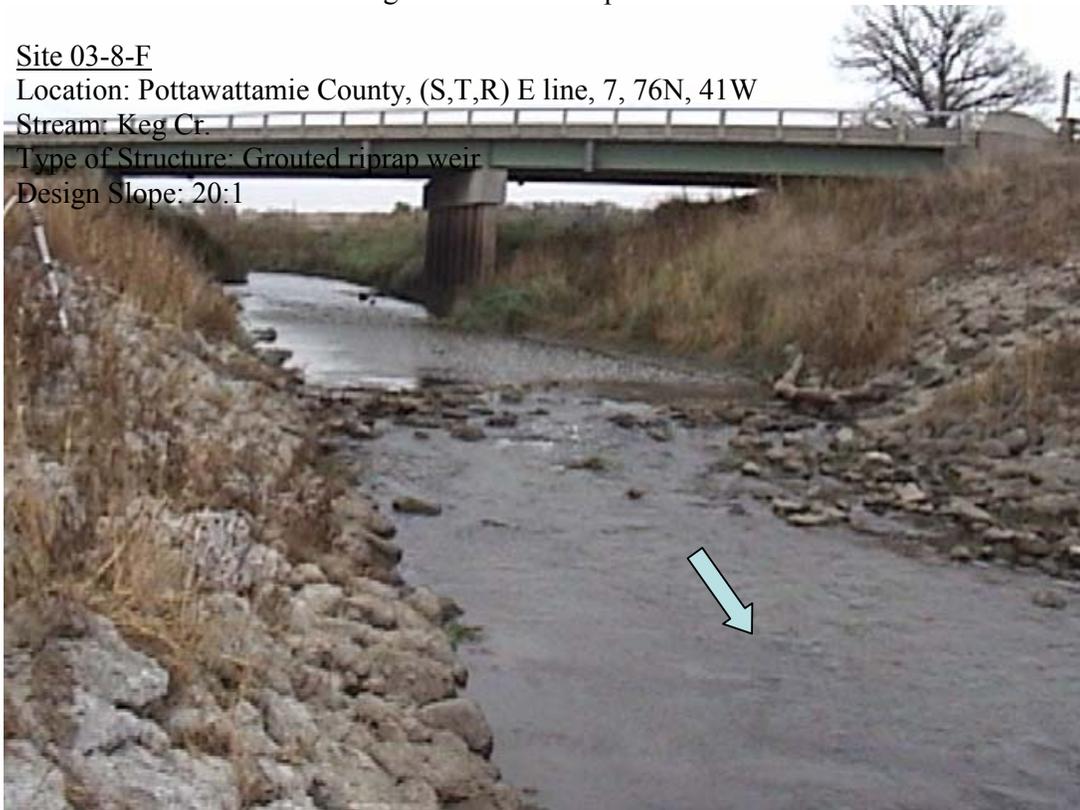
Figure 44a. Description of site 03-8-F

Type of Structure: Grouted riprap weir

Design Slope: 20:1

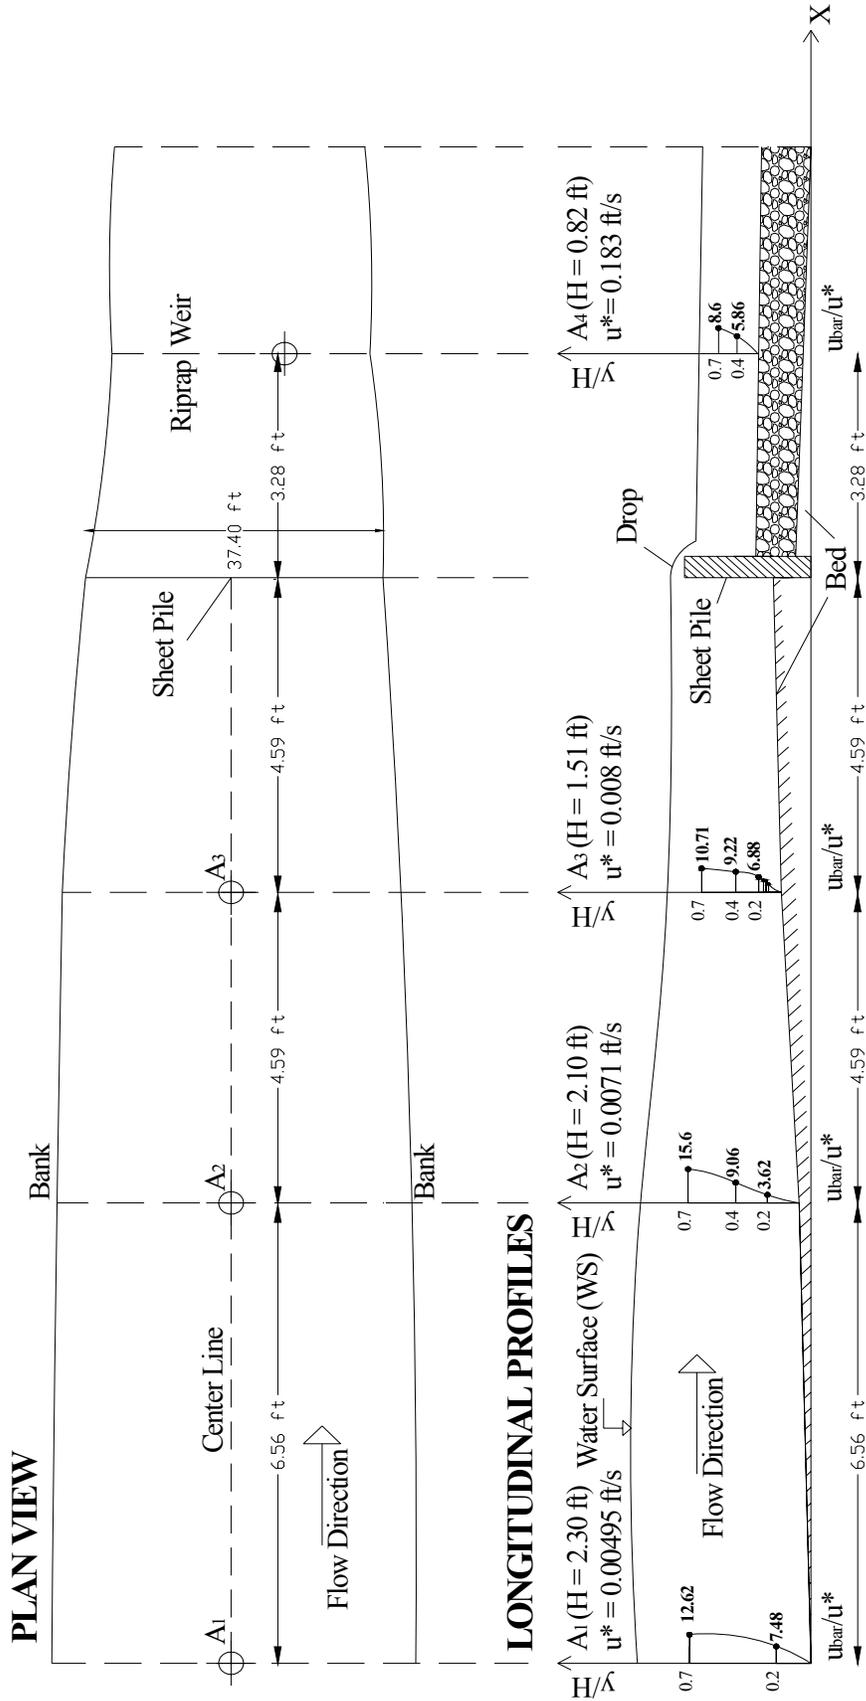
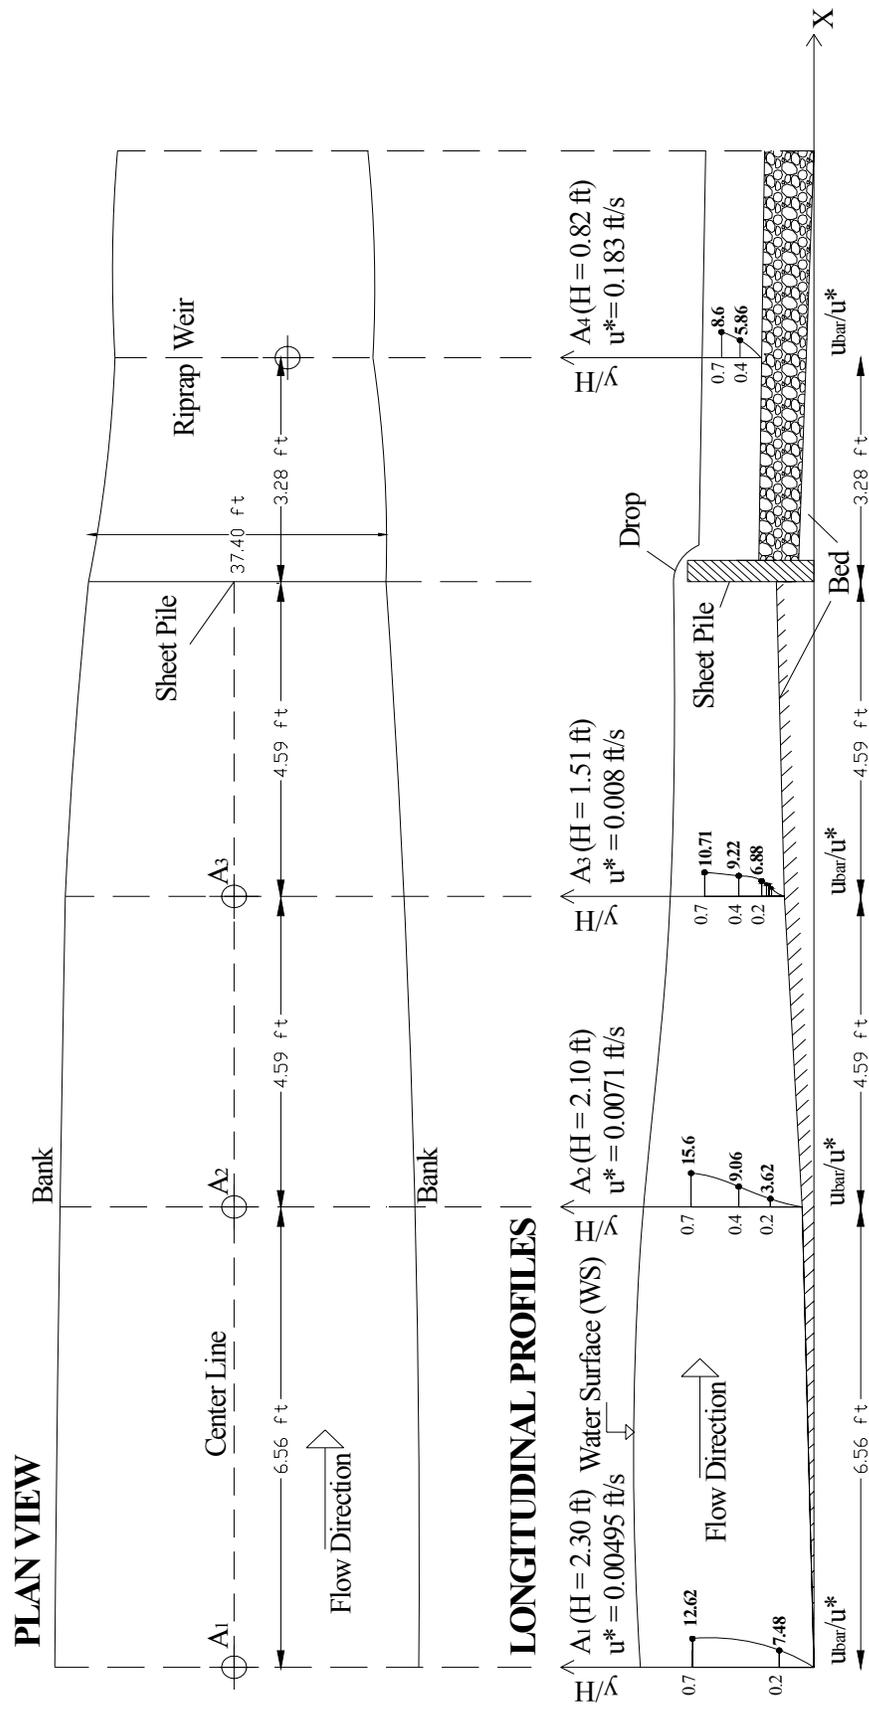
Figure 55a. u_{bar}/u^* diagram for riprap weir

In the riprap case the variation of the velocity around the zero value for the v and w profiles suggest the presence of strong secondary currents. The genesis of these currents is mostly attributed to the transitional change of the channel from the expanded cross section to the constricted cross section found atop of the structure. Figure 55d (Appendix C) shows that turbulent intensities in the vertical direction obtain significantly higher values than the other turbulent intensities (in the longitudinal and traverse directions). This implies a high level of turbulence in the vertical direction, caused by the eddy stretching of the flow in that direction, due to the presence of the sheet pile at the entrance of the structures (Figure 55d, Appendix C). The high magnitude vertical turbulent intensity leads to high magnitude shear stress values at the entrance of the structure. Stress values greater than 35 lbf/ft^2 can cause fish mortality. This criterion was not violated for both cases.

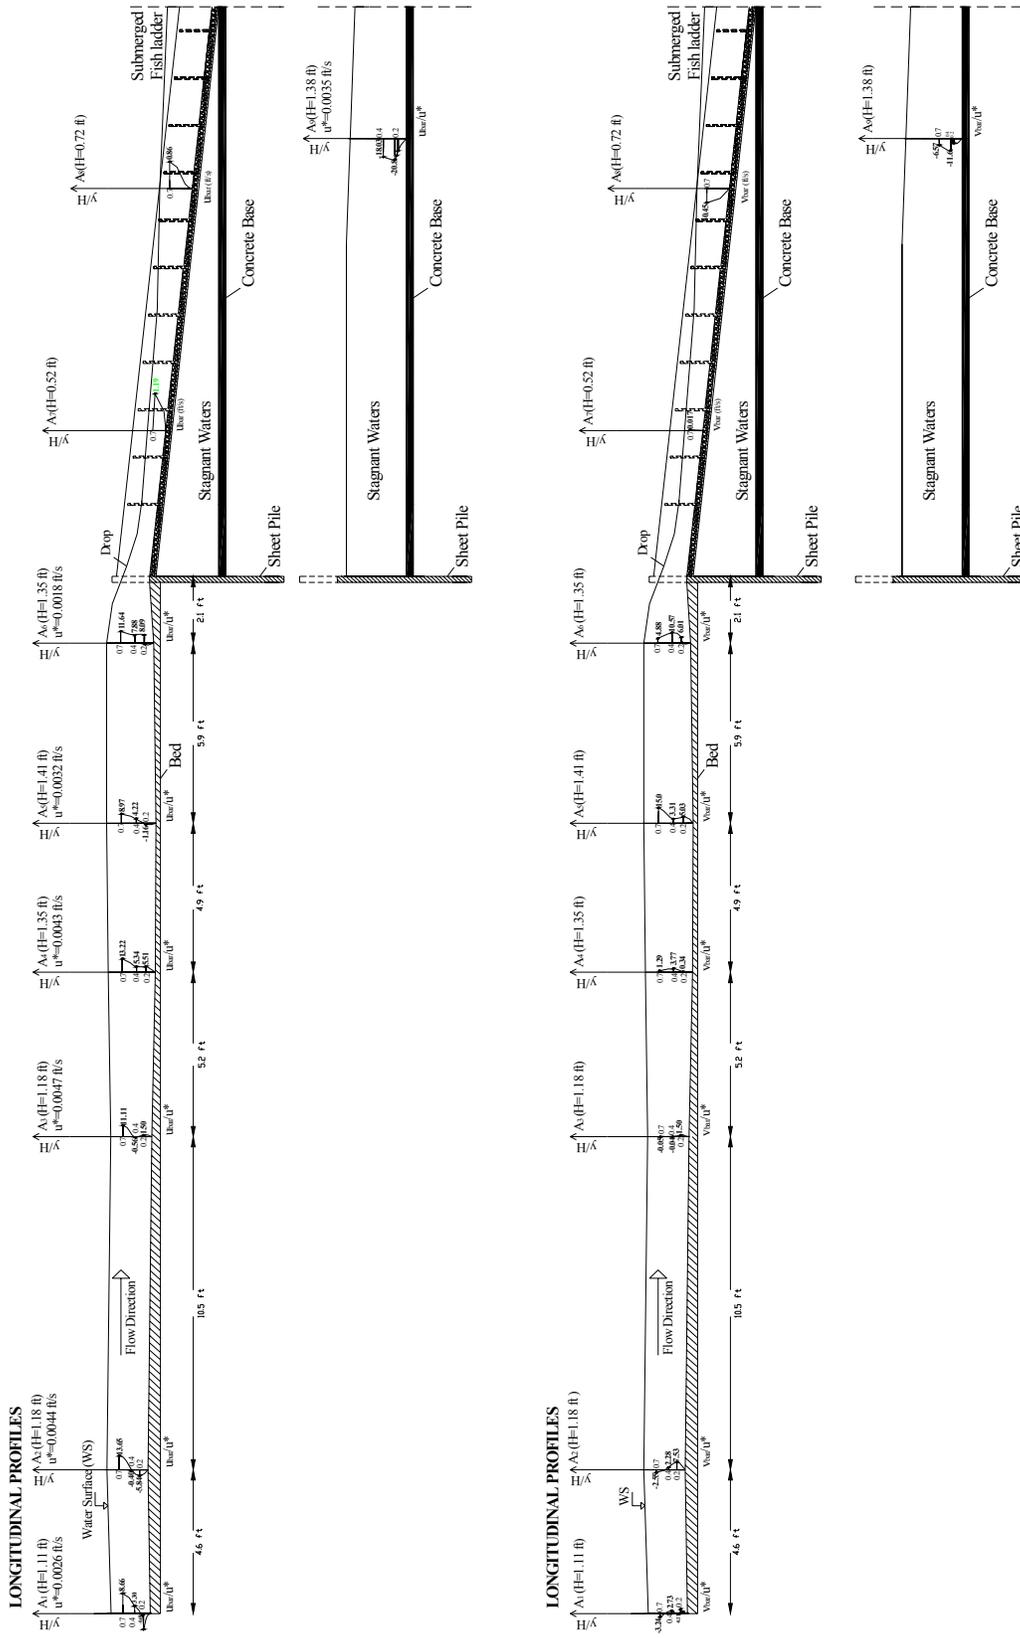
Figure 56b. u_{bar}/u^* and v_{bar}/u^* diagrams for fish ladder

Finally, in the case of the fish ladder the flow presents a similar behaviour with respect to turbulence. High magnitude vertical turbulent intensities are observed in Figure 56d (Appendix C).
