# **Evaluation of Dowel Bar Retrofits for Local Road Pavements**

**February 2008**

**IHRB Project TR-520**

## **FINAL REPORT**

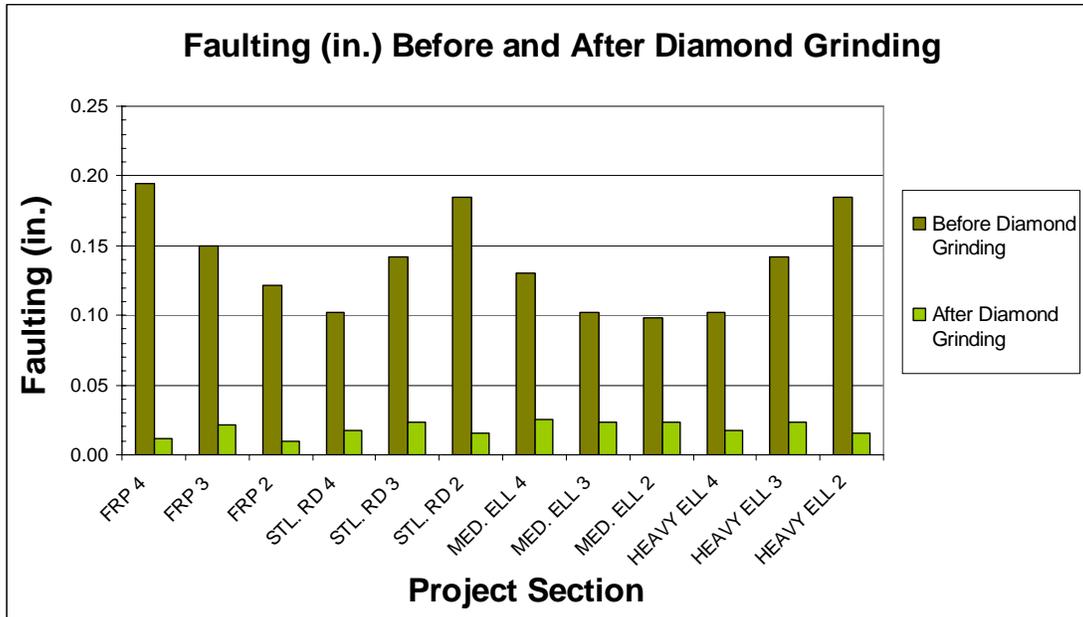
Figure 2. Faulting before and after diamond grinding

The thought originally occurred that the percentage of reduction in the initial faulting because of diamond grinding would be a good evaluation of the effectiveness of diamond grinding. However, there does not appear to be any correlation between initial faulting and the effectiveness of the diamond grinder. Figure 2 shows, if anything, diamond grinding better reduces faulting in the sections with higher initial faulting rather than the sections with lower initial faulting. For this reason, the data seems to suggest that diamond grinding reduces the faulting to a particular value rather than a percentage of the original faulting. However, diamond grinding on pavements of much higher initial faulting than this project may not yield the same values as this project. Nevertheless, the conclusion can be made that any similar concrete pavements with initial faulting less than 0.19 inches can be reduced to a value of roughly 0.019 inches. At this particular stage of the dowel bar retrofit there are no bars in the pavement. Therefore, an important note is that the dowel type and number are of no particular relevance in Figure 2 except to help label the sections for post-retrofit comparisons. Figure 3 shows the overall average before diamond grinding is about 0.138 inches and the average after is approximately 0.02 inches.

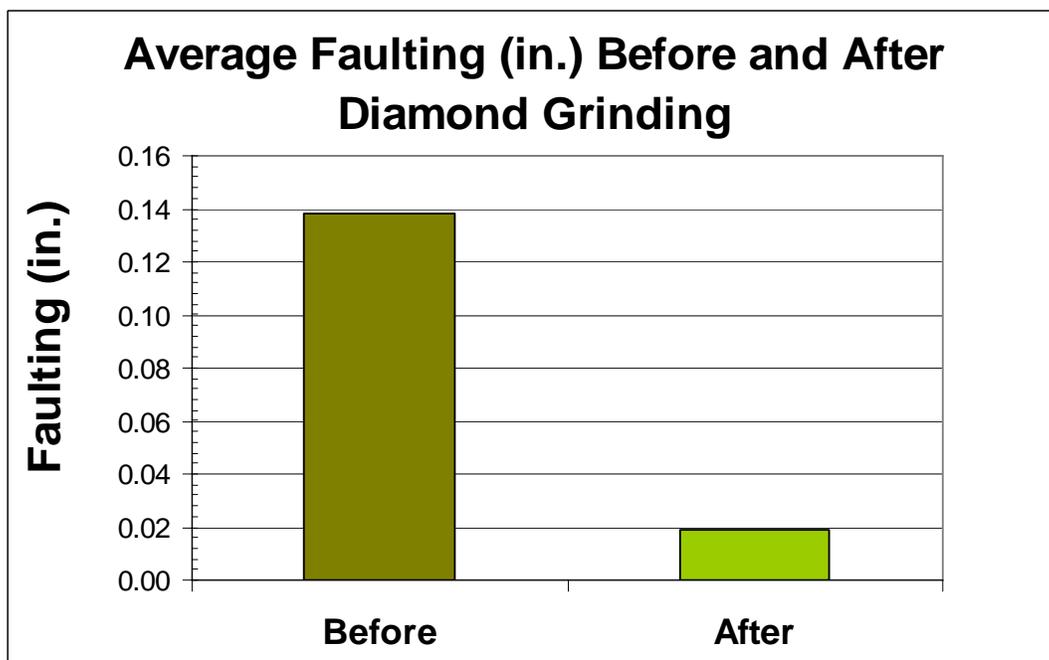
Figure 3. Average faulting before and after diamond grinding

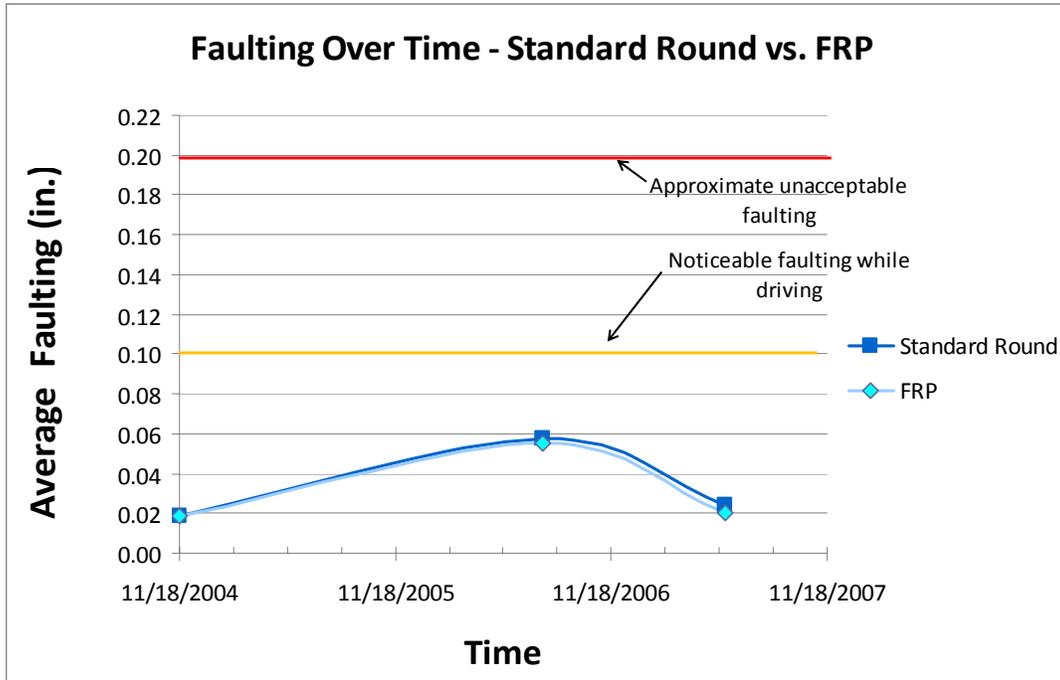
Figure 4. Faulting over time – standard round vs. FRP

To analyze dowel bar performance, the least change in faulting over the testing period was determined to indicate the most successful joints. The average faulting over the project life is found in Figures 4 and 5. Figure 4 compares standard round dowel bars with FRP dowel bars. Figure 5 compares standard round dowels with elliptical dowel bars. In the figures all dowel sections were assumed to have the same initial faulting of

0.019 inches, which was the average faulting achieved through diamond grinding. This is to show the performance of each type over time. The faulting decrease from 2006 to 2007 can be attributed to effects of weather, season, and pavement temperature differences. Regardless of the decrease in faulting from 2006 to 2007, the graphs still show there is no significant difference in faulting based on dowel material or shape. Hence the conclusion is that all four dowel bar types have equal performance in faulting. Also important to note is that the average faulting values over the study period were lower than the noticeable faulting tolerance of drivers.

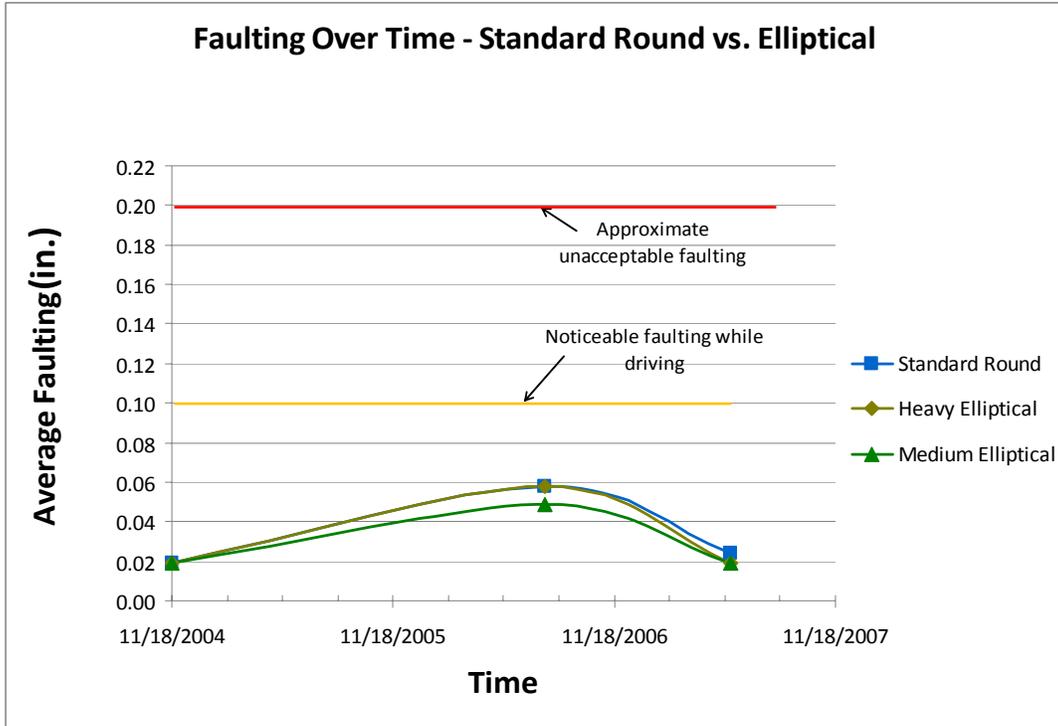
**Figure 5. Faulting over time – standard round vs. elliptical**

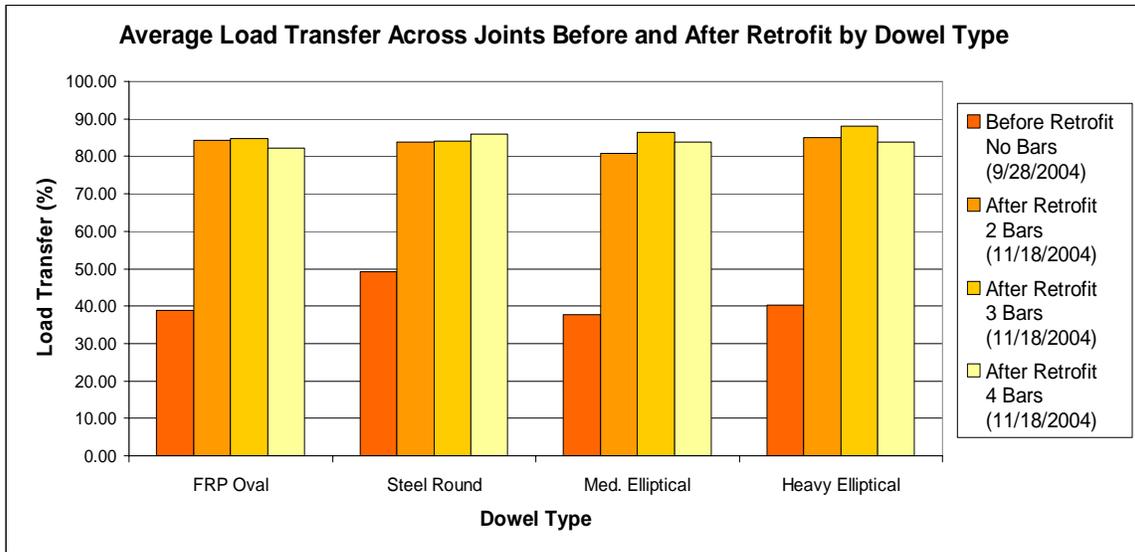
**Figure 6. Overall average joint load transfer before and after dowel retrofit**

Before construction, in September 2004, an overall average of all the joint sections showed that 41.5% of the load was being transferred across the joints. After construction, in November 2004, the overall load transfer became 85.7 percent. The load transfer from the final data set taken in July 2007 came to 92.4 percent. This data suggests that the load transfer in a pavement increases from approximately 40% to at least 80% or 85% when a dowel retrofit is introduced into an eight-inch-deep non-doweled pavement. This data also suggests that the load transfer is maintained at an acceptable level over the research period. Figure 6 shows the immediate load transfer change after the dowel retrofit.

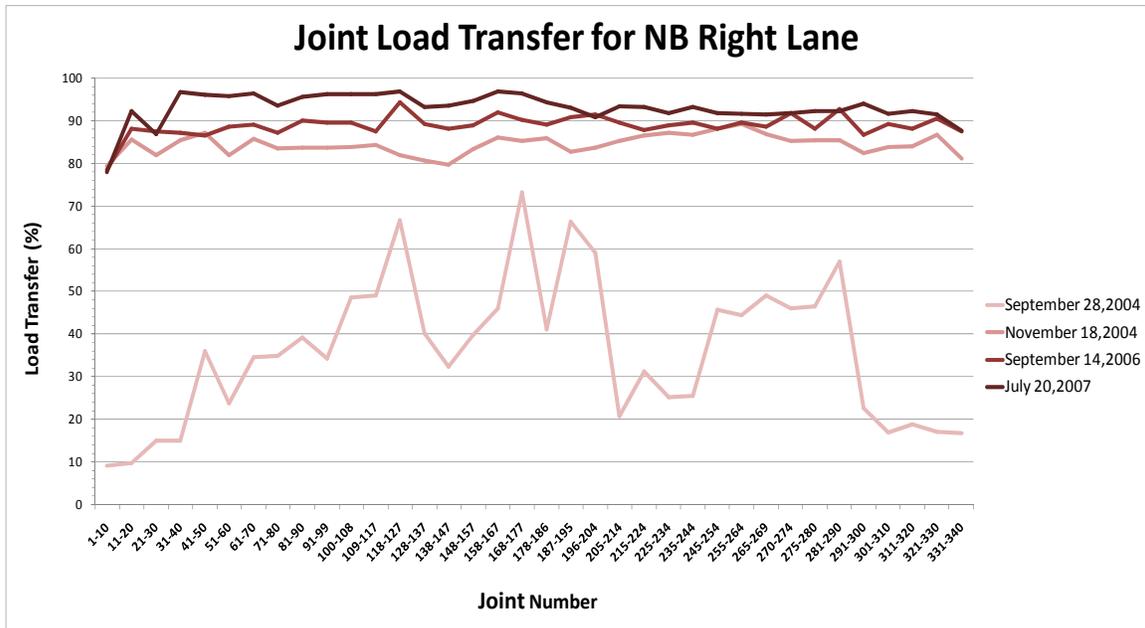
**Figure 7. Joint load transfer values, northbound right lane**

Figures 7 and 8 show the joint load transfer for the northbound and southbound lanes over the project life. The part of the graph that is substantially lower correlates to the load transfer of the pavement before any dowel bars were inserted into the pavement. The graphs of the load transfer after the dowel bars were instigated show that the load transfer remains in the 85–95% range regardless of where it is on the project.

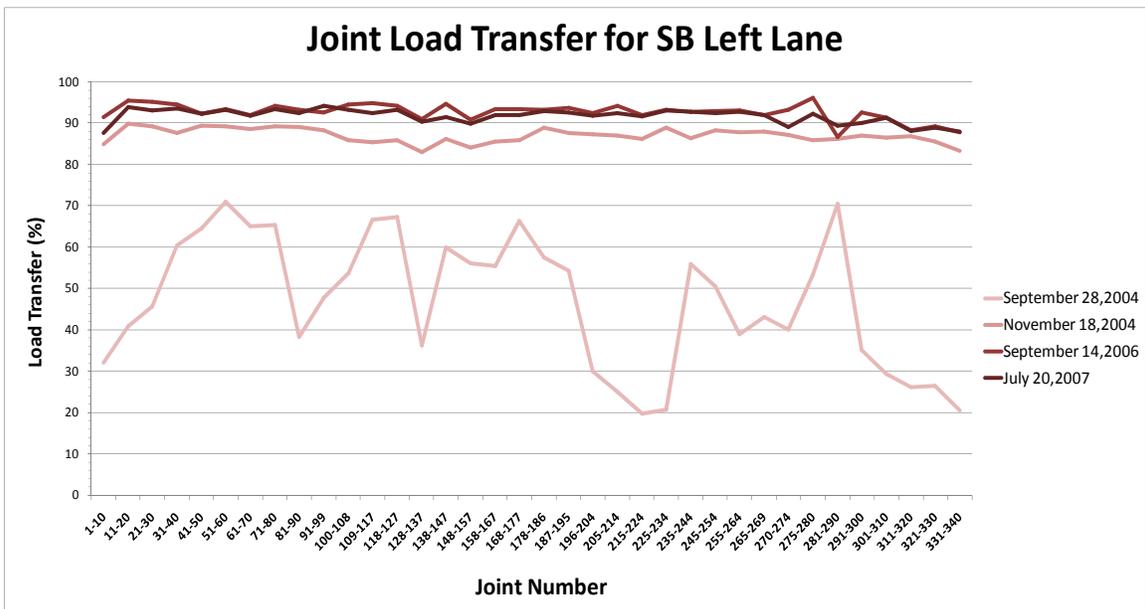
**Figure 8. Joint load transfer values, southbound left lane**

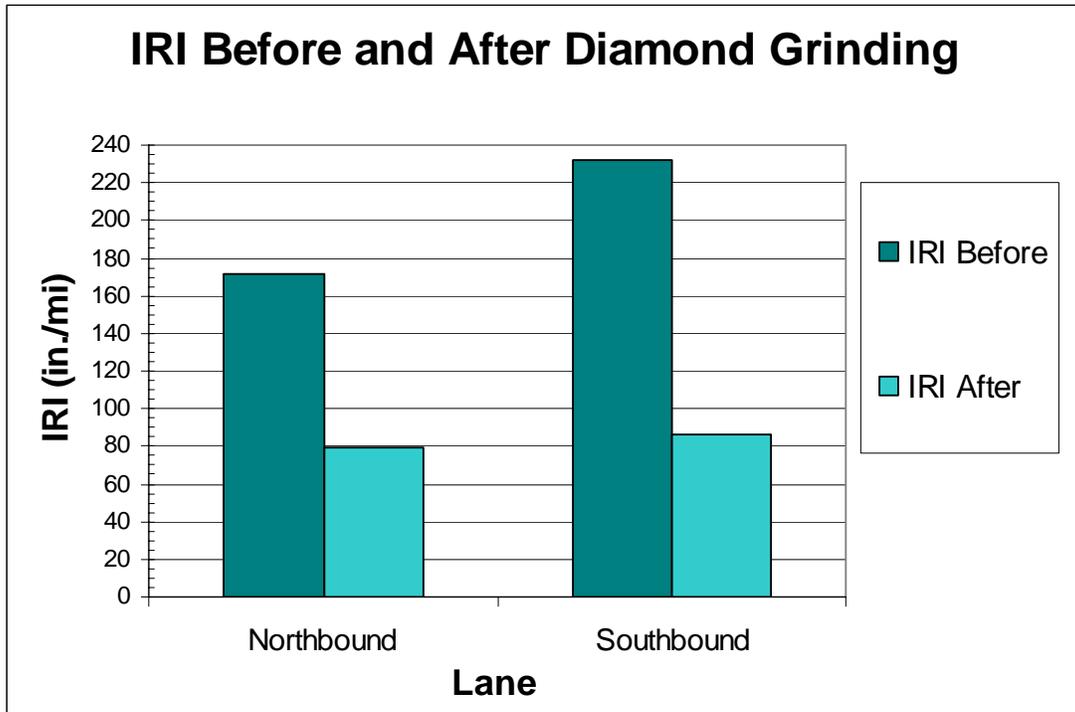
**Figure 9. IRI before and after diamond grinding**

The data collected were used to quantify the effectiveness of diamond grinding and to determine which type and quantity of dowel bar best maintains the pavement's smoothness. As with faulting, it was originally thought that the percentage of reduction in the initial IRI because of diamond grinding would be a good evaluation of the effectiveness of diamond grinding. However, there does not appear to be any correlation between initial IRI and the effectiveness of the diamond grinder, as seen in Figures A.10 and A.11. These graphs seem to suggest that diamond grinding reduces the IRI to a particular value, just as it did with faulting. Even so, Figure A.11 shows that it is possible to diamond grind a pavement with an IRI as high as 330 down to 105 in/mi (this can be seen in the first 150-foot section). Figure 9 shows that diamond grinding is effective at producing a post-grinding IRI value around 80 when the average initial IRI is between 170 and 230 in/mi.

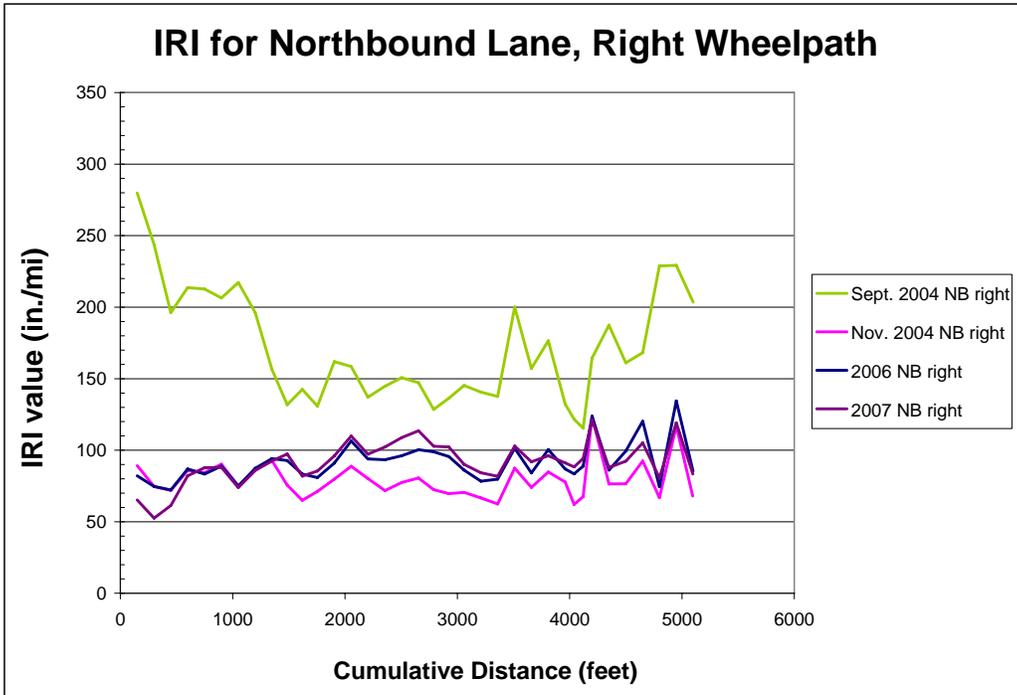
Figure 10. IRI for northbound right wheel path

Figures 10 and 11 show the IRI over time for the northbound and southbound lanes, respectively. In the figures the IRI is much higher in September 2004. This marks the IRI of the pavement before the diamond grinding had taken place. The November 2004 IRI data drops significantly, which indicates the IRI after diamond grinding. The IRI then gradually goes up, showing general wear of the pavement over time.

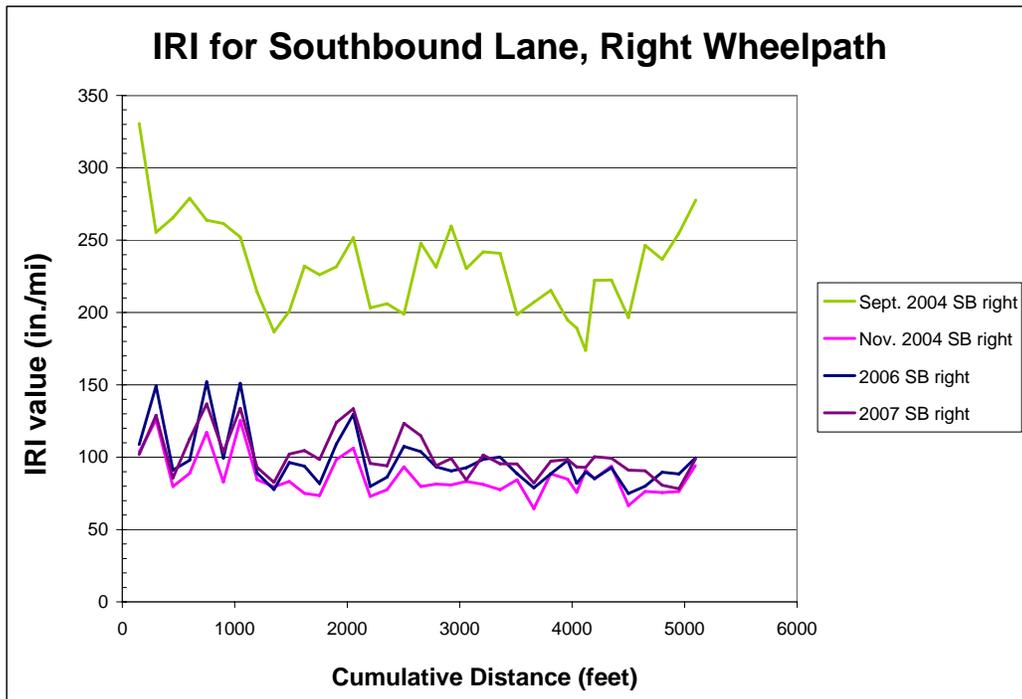
Figure 11. IRI for southbound right wheel path

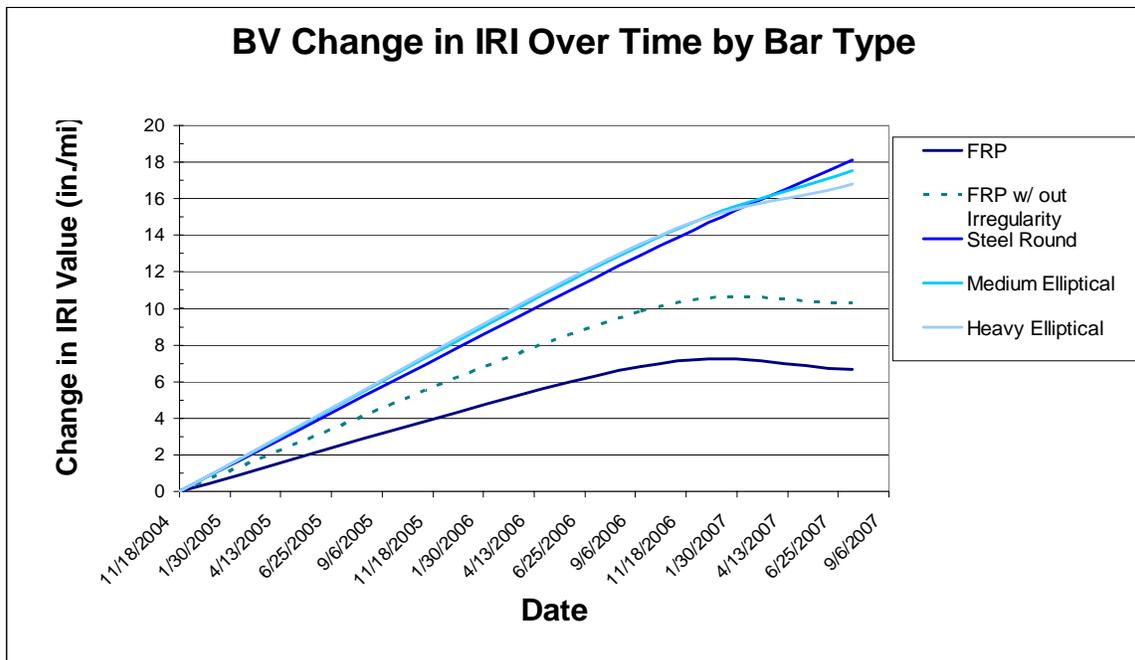
**Figure 12. Change in IRI over time by bar type**

Figure 12 shows the average change in IRI by dowel type over time. The figure is not intended to be used for quantitative measure, but to compare how the different dowels perform relative to the other dowel types. In Figure 12, FRP performs significantly better than the other bars for maintaining a lower IRI value over time. This means that using FRP dowel retrofits will maintain a smoother ride than standard round or elliptical steel dowels, according to this research data. The dashed line in the graph is a better representation of the FRP data if the irregularities are removed. This still indicates that FRP bars maintain IRI better than the other dowel bars tested.

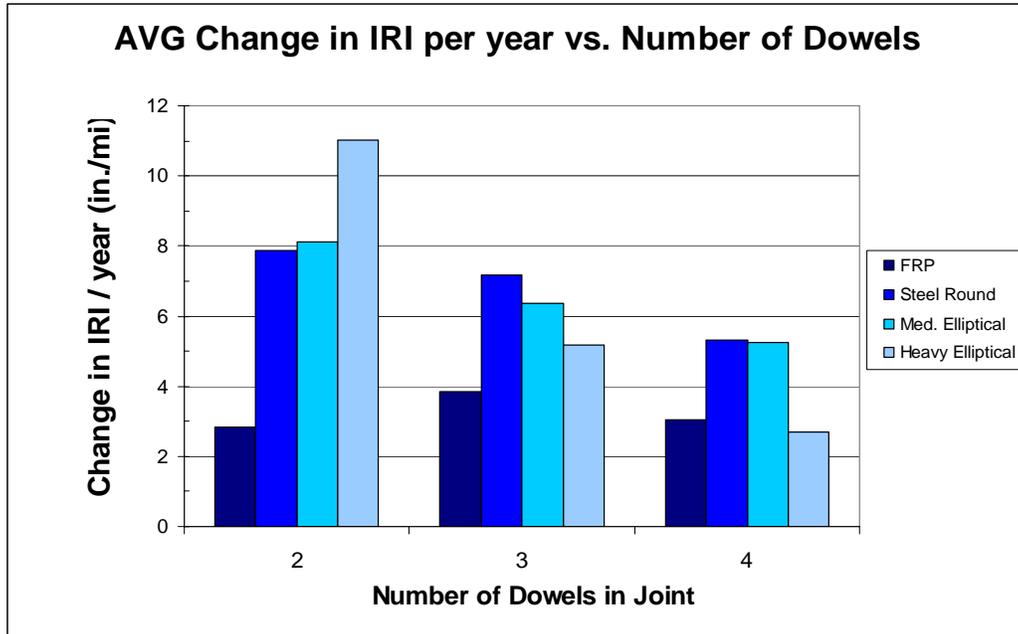
**Figure 13. Change in IRI per year vs. number of dowels used**

Figure 13 shows the average change in IRI per year by the number of dowels used in the joint. Excluding FRP bars, Figure 13 shows that using two bars will give a higher IRI value and thus a rougher pavement over time than using three and four bars. FRP bars performed in an unexpected manner. The use of two bars yielded better results than using three or four bars according to this research data.

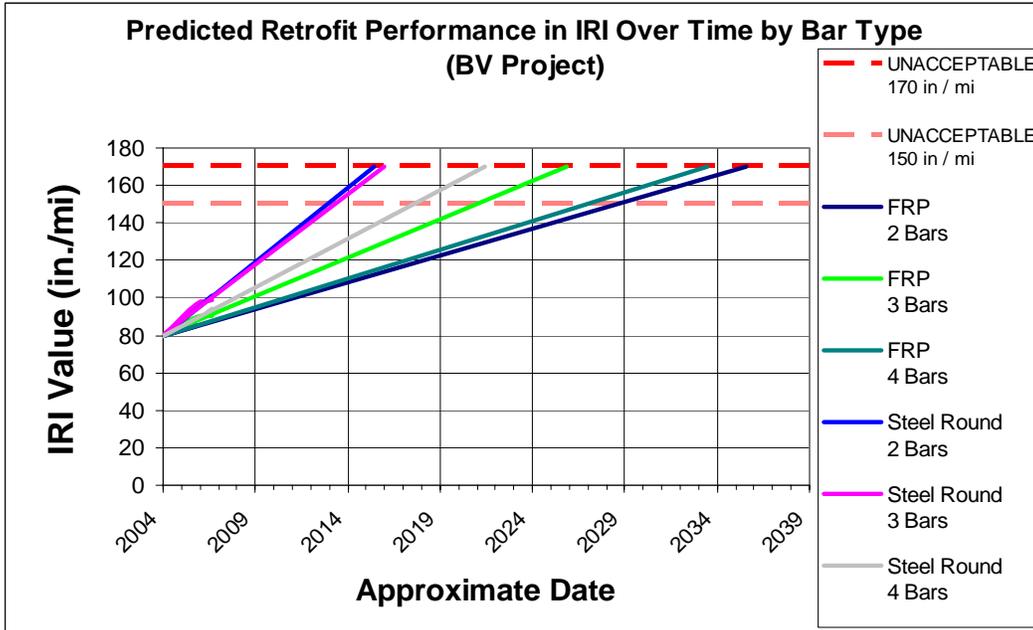
Figure 14. Predicted IRI over time (FRP & steel round)

The quantitative value used to compare the number of bars used in each joint is expressed as an average change in IRI per year. The change in IRI per year was used to determine the average pavement life extension caused by the dowel retrofit in terms of road smoothness. The change in IRI data collected during this study was graphed versus time starting at a value of 80 (approximate value attained after grinding). A linear trendline was assigned to each data set. These trendlines were then extended until they passed the maximum acceptable IRI values of 150 and 170 in./mi. These numbers were mentioned earlier as the acceptable road user tolerances for roughness. These points signify the useful life of the retrofit based on IRI. The graphical representation of the data can be found in Figures 14 and 15. These graphs are based on a linear interpolation of the data collected in this report. The linear relationship between time and change in IRI is unknown, but the IRI values from the collected data were used to predict long term IRI maintainability. Also important to note is that all interpolations were based on a linear regression of three data points except for the FRP dowels and heavy elliptical sections with four bars. Earlier, Table 9 showed that there appeared to be irregularities in the FRP data. For this reason, data from November 2004 and September 2006 were used to do a straight line regression for two and four FRP bars. The data for three FRP bars appeared to be regular, so all three data points were used for its linear regression. The heavy elliptical data with four bars per section also seemed to have a small inconsistency with the September 2006 data. For this reason, data from November 2004 and July 2007 were used to do a straight line regression for four heavy elliptical bars.

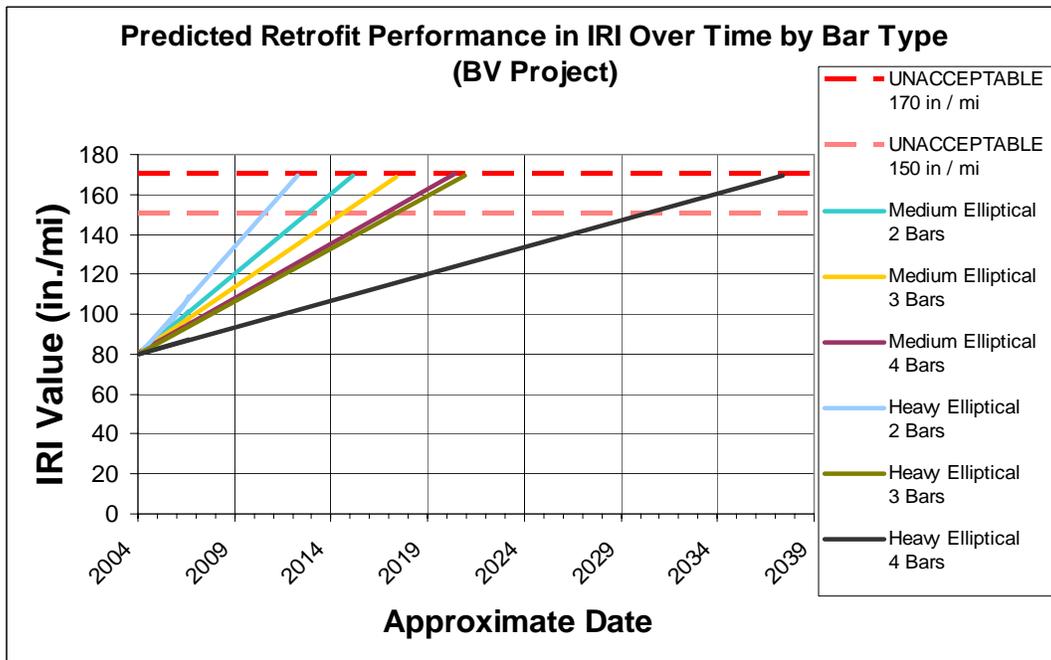
Figure 15. Predicted IRI over time (medium & heavy elliptical steel)

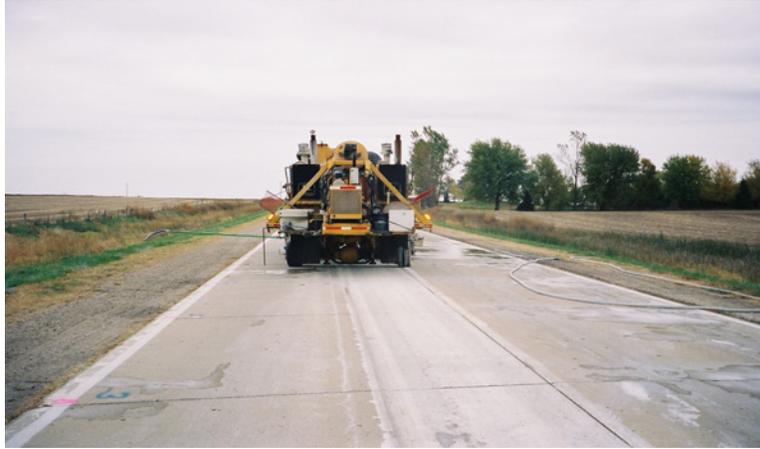
**Figure A.1. Surface grinder**

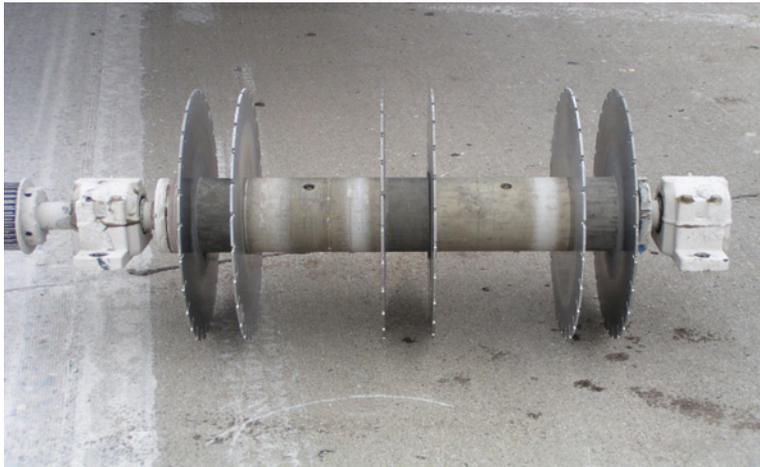
**Figure A.2. Slot cutter head**

The process started at the south end of the project at joint 31 in the northbound lane. The joints on the project were numbered from south to north as joints 1–341. The three-slot pattern was cut first (Figure A.2).

The slot sawing machine was set up to cut the slots at the prescribed width of 3.25 inches, with one side set up to cut two slots at a time and the other side set up to cut three slots at a time to accommodate the elliptical FRP bars. The contractor intended to cut the two outside slots first in all the two- and four-slot areas to accommodate the placement of the instrumented bars by the ISU research team.

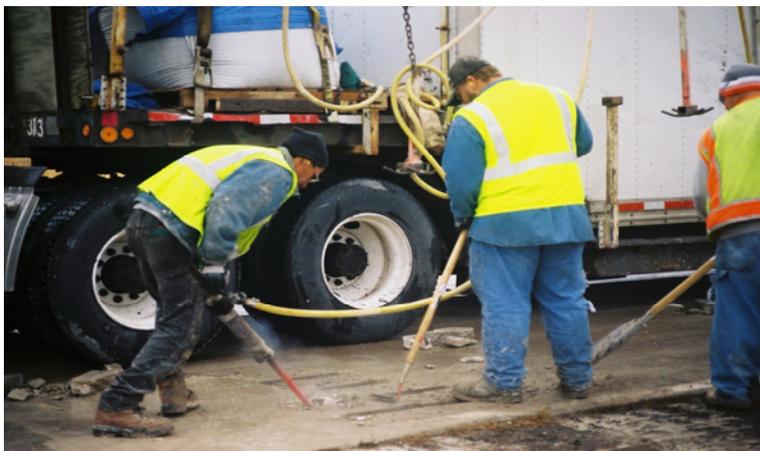
**Figure A.3. Slot material removal**

After the slots were cut, there was excess material left by the upward motion of the slot-cutting saw. This material was removed by a jackhammer with a flat hammer on the end, called bushing (Figure A.3).

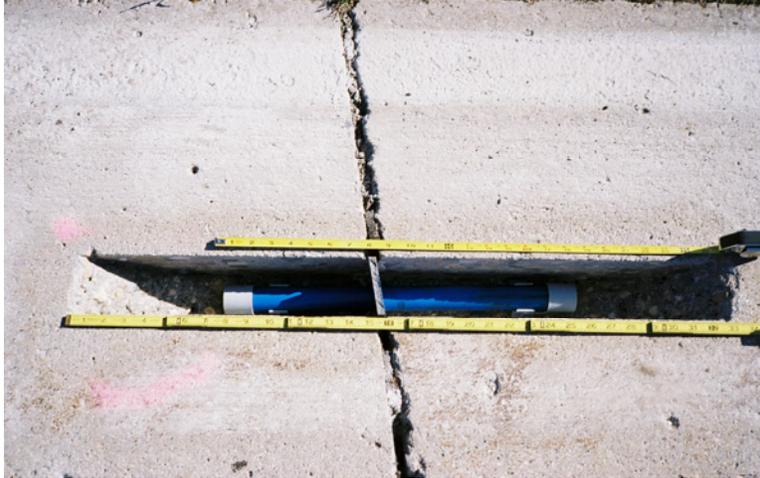
**Figure A.4. Proper slot length**

A slot length of 33–34 inches did not allow enough room to get a finger under the end of the steel bar (Figure A.4). If the slots had been cut 35–36 inches long, then no bushing would have been required.

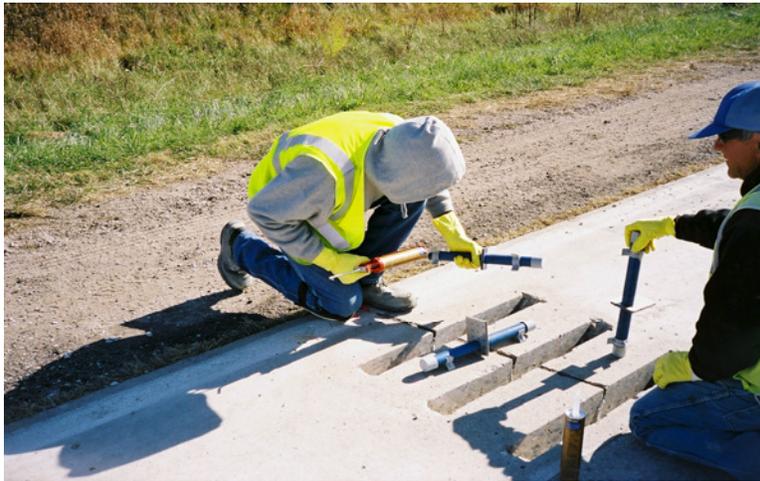
**Figure A.5. Dowel chair anchoring**

After bushing, sandblasting, and air blasting the slots, the bars were placed in the slots. All elliptical bars came with chairs that were 3.25 inches wide to lock the bars in the slot. The standard 1.5-inch steel round bars came with a standard chair that was designed to lock bars into a normal 2.5-inch slot. Liquid nail compound was used to glue the chairs, of the 1.5-inch steel round bars, to the clean concrete so that the bars could remain straight during the patching process (Figure A.5).

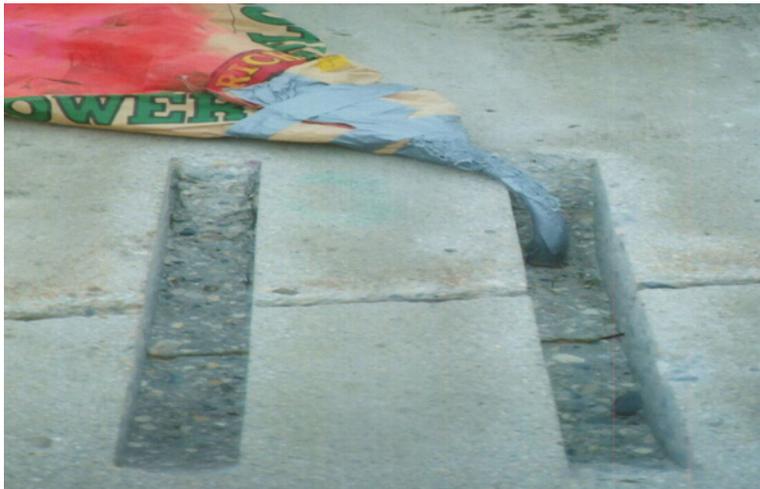
**Figure A.6. Plaster crack sealing**

Before placement of the bars, a sheetrock plaster compound was used to seal the existing crack at the bottom of the joint and on the sidewalls (Figure A.6). This material was readily available from the housing industry and did an excellent job preventing the patching mix from being vibrated into the existing joint or crack. The concrete patching material was a mix designed by the contractor using a Five Star Highway Patch Cement. During construction, the concrete mix was tested by an outside agency to ensure that the target value of 4,500 psi compressive strength was achieved in 24 hours. Preliminary tests failed, but the tests conducted during the construction of the project all exceeded the target value.

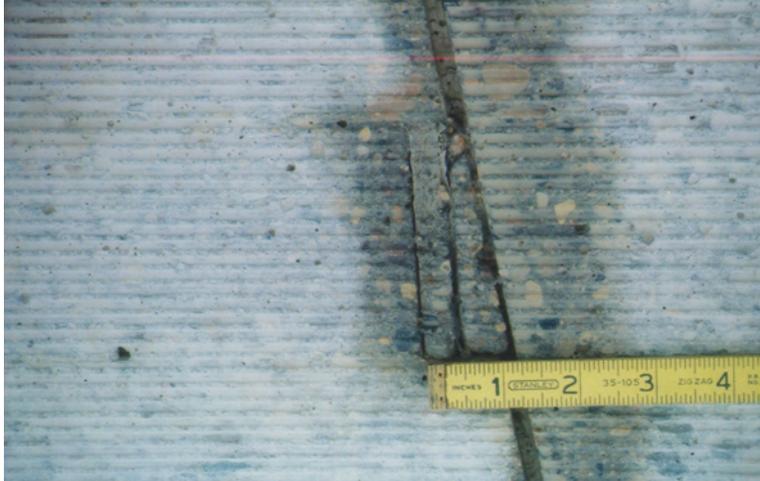
**Figure A.7. Spall protection**

After reviewing the finished product, it was noticed that the joint reformer material did not stay centered in the joint on the steel retrofit bars. Normally, the crew would chip out the concrete between the joint reformer and the joint and then fill the area with joint sealer material. This project had no sealing, so the spalls will show up after traffic and snowplows work on the roadway. There are similar spalls in other areas of the existing pavement joints (Figure A.7).

The location of these problem spalls are between joints 91 and 209 in the northbound lane. The fiber-reinforced bars had the joint reformer material designed to be at least one and one-half inches below the top of the pavement, which would reduce the chance of spalls as long as the joints were sawed as soon as possible.

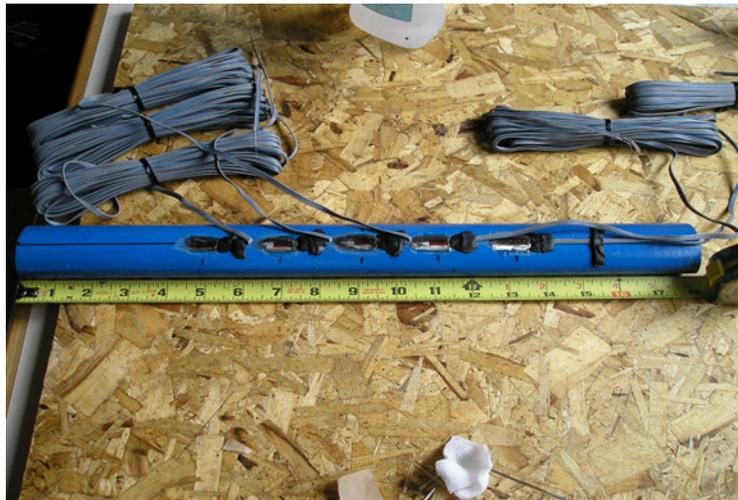
**Figure A.8. Dowel instrumentation**

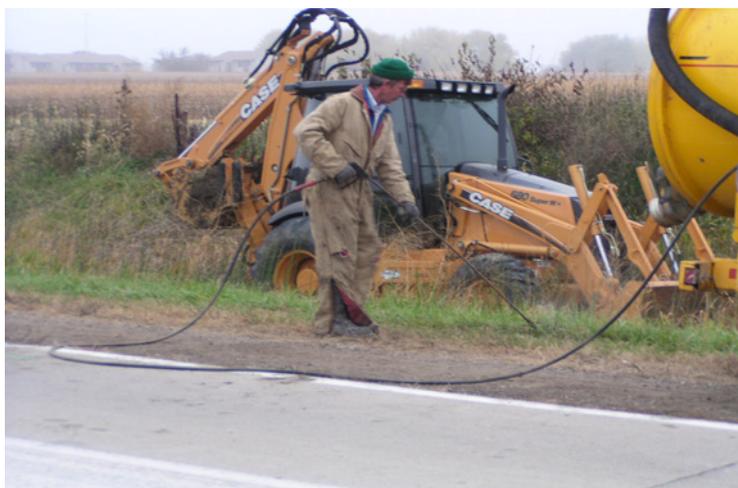
**Figure A.9. Instrumentation trench jetting**

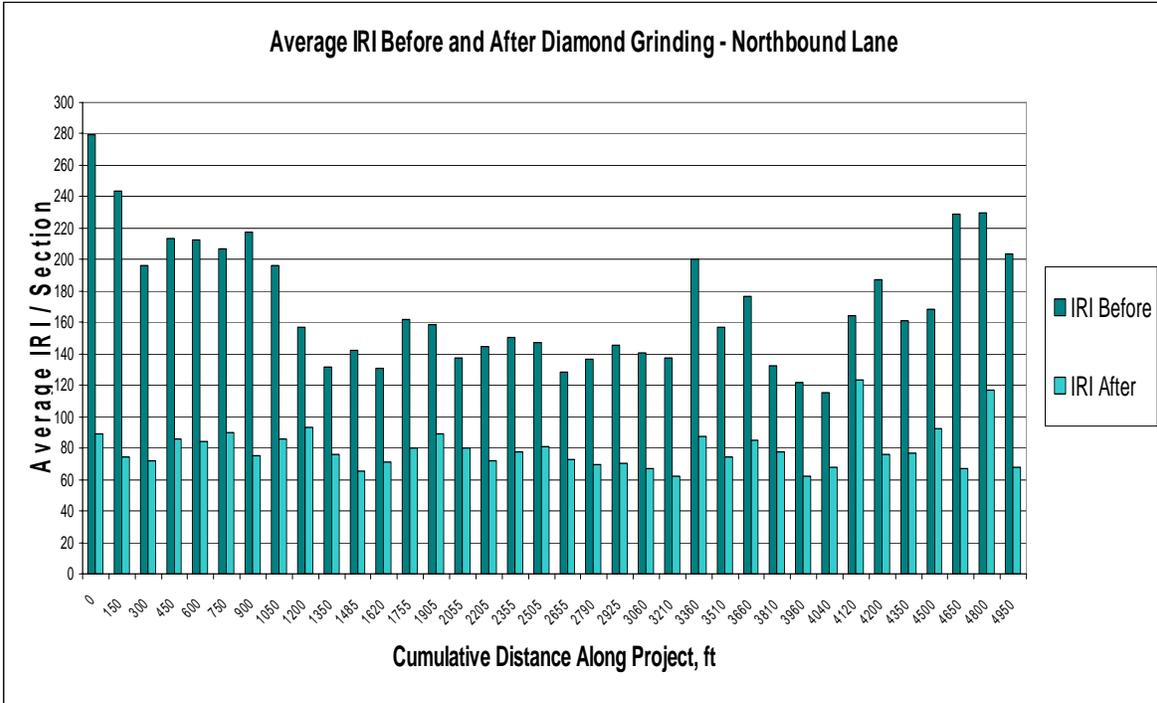
**Figure A.10. Avg. IRI before and after diamond grinding – NB lane right wheel path**

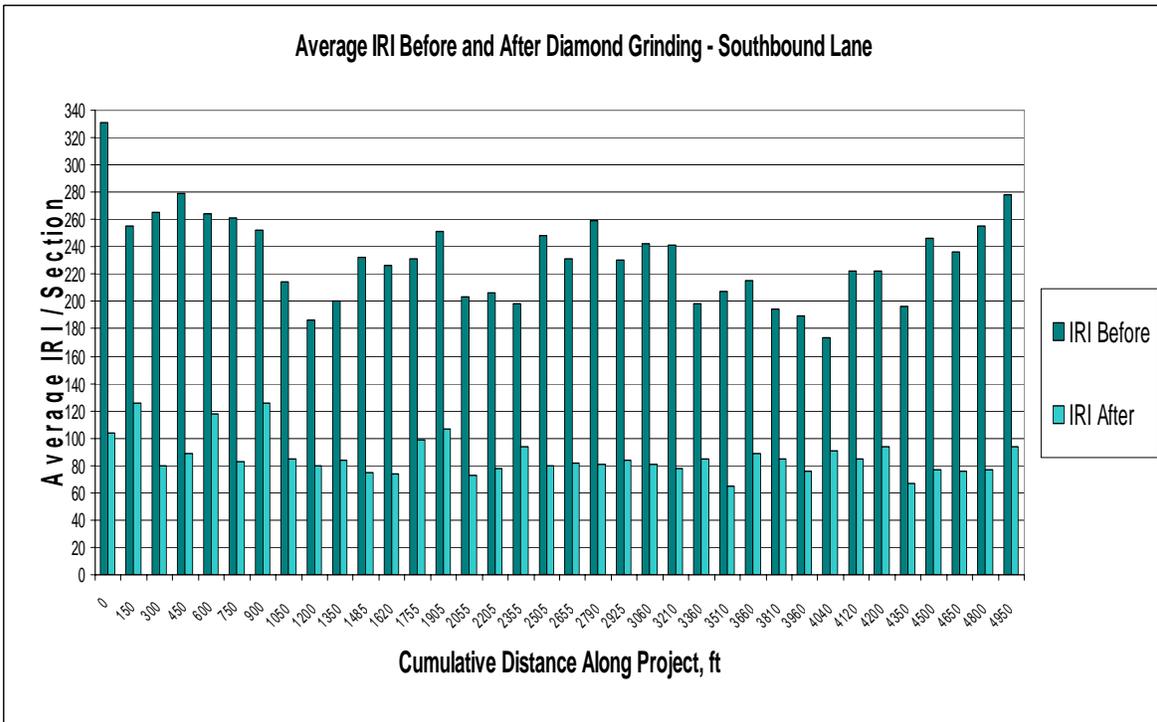
**Figure A.11. Avg. IRI before and after diamond grinding – SB lane right wheel path**

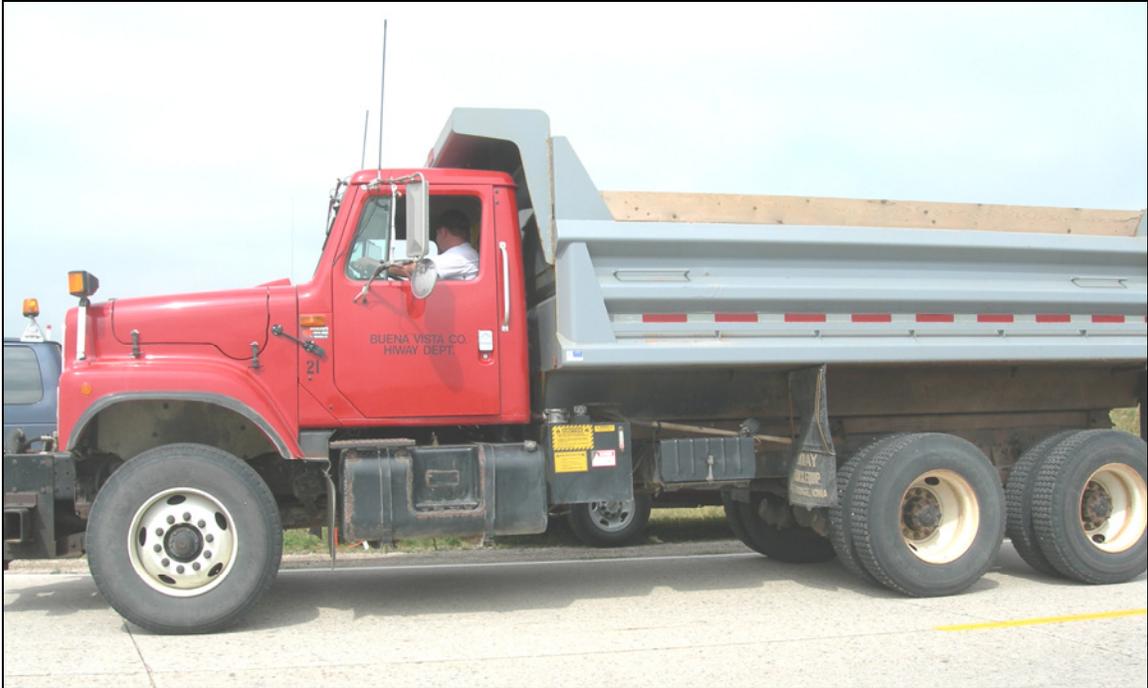
**Figure A.12. Loaded truck for strain testing**

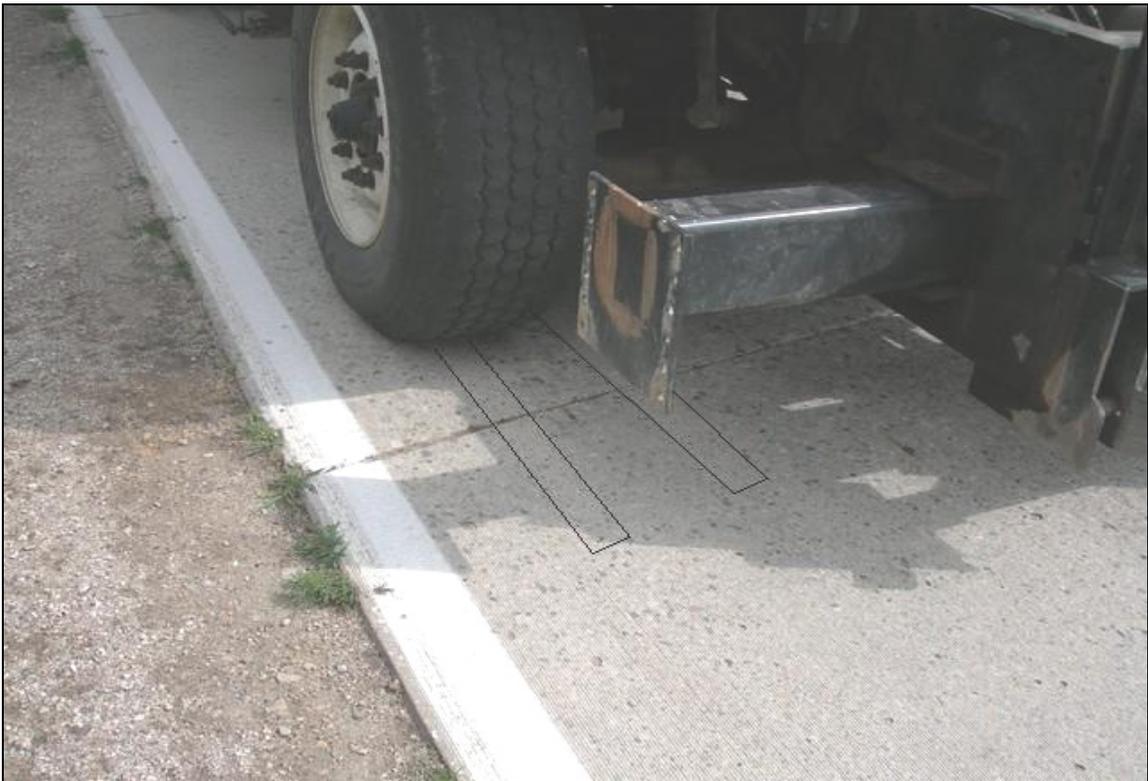
**Figure A.13. Truck driving over doweled joint (retrofit trenches outlined)**

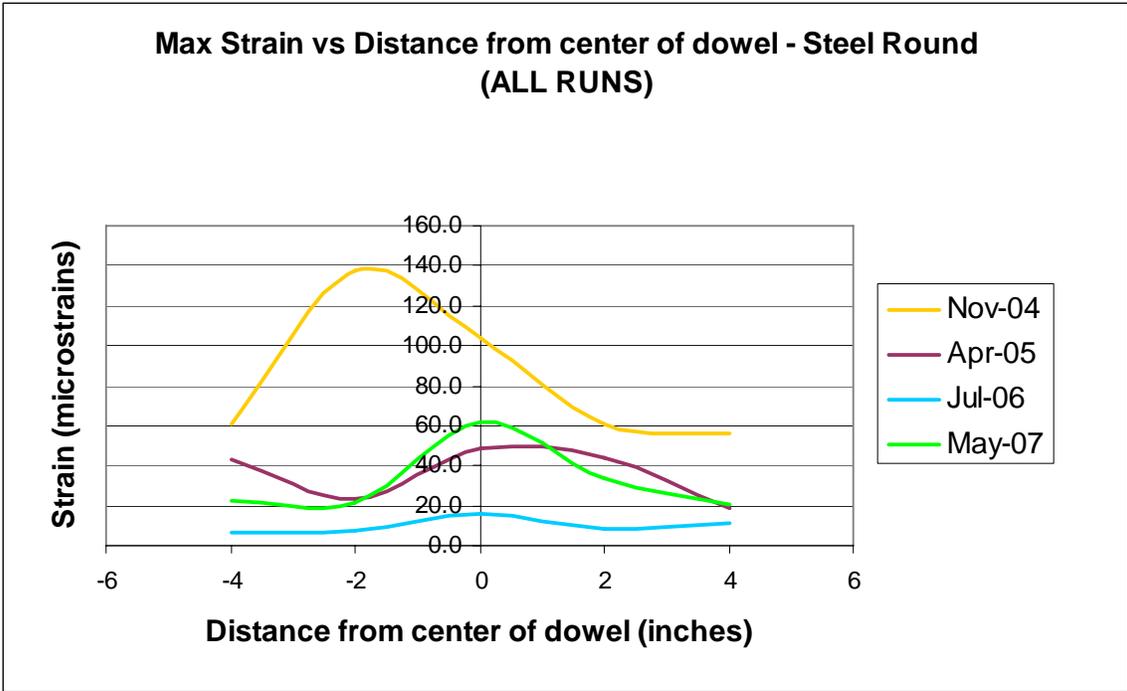
Figure A.14. Plot of max strain vs. distance from center of dowel — steel round

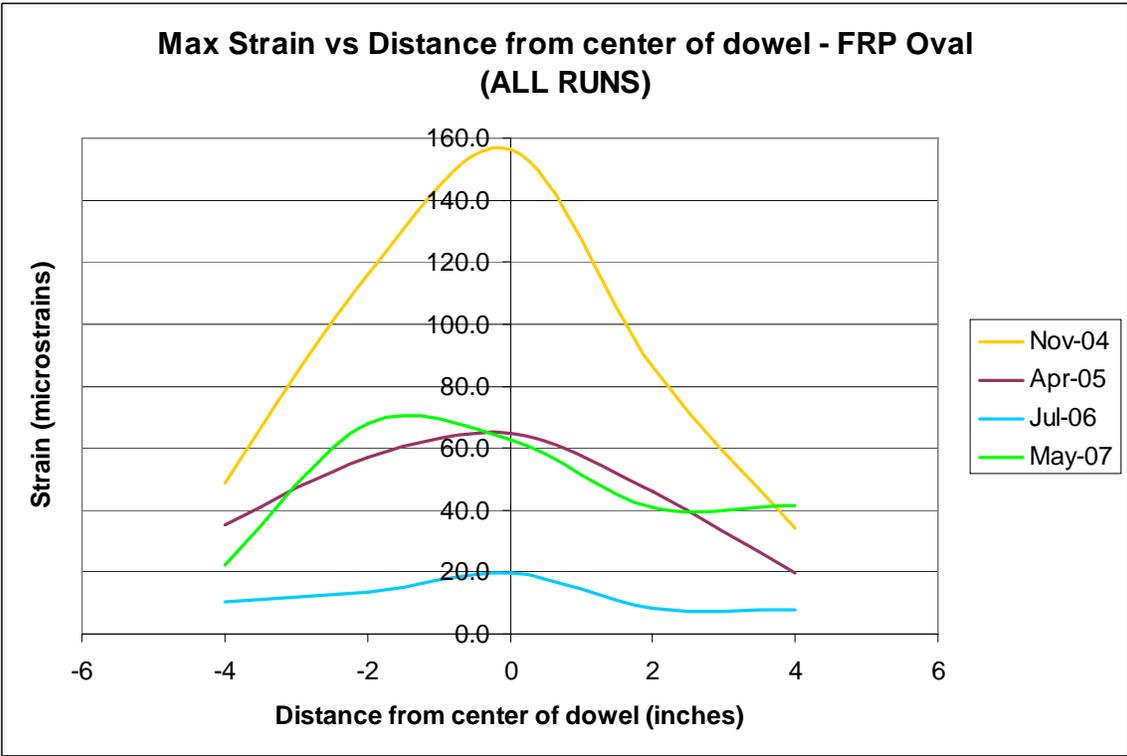
Figure A.15. Plot of max strain vs. distance from center of dowel — FRP oval

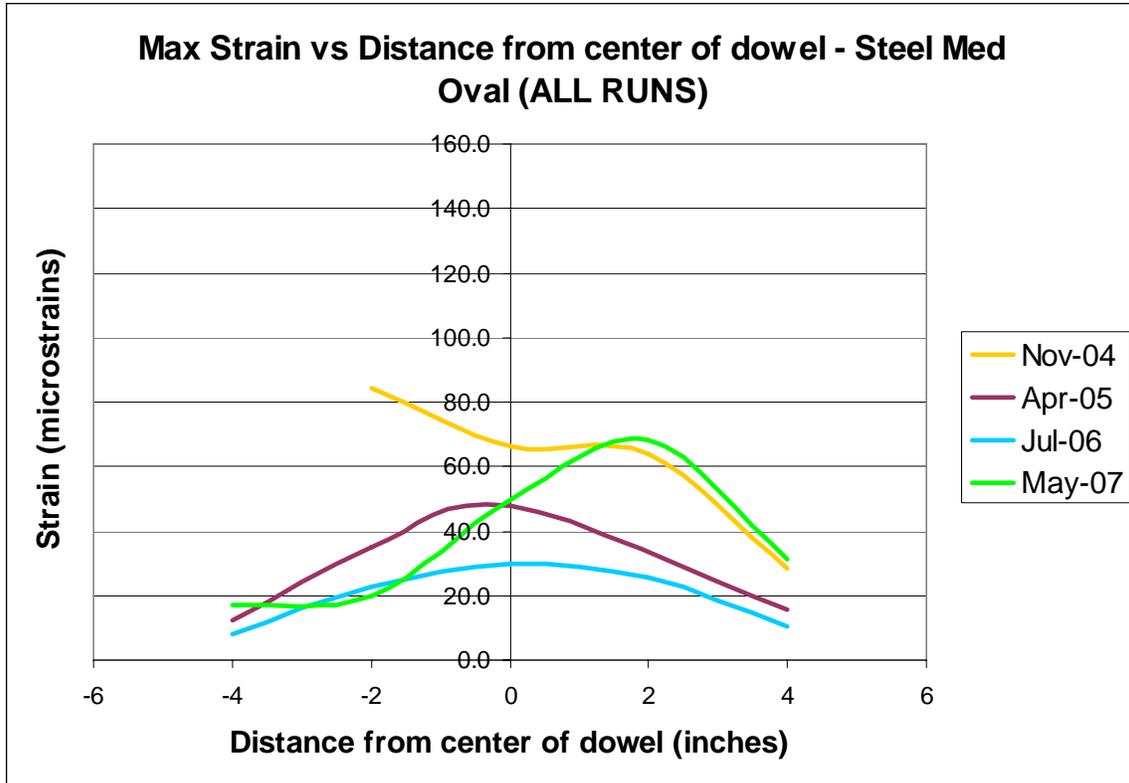
Figure A.16. Plot of max strain vs. distance from center of dowel — steel med. oval
