# Evaluation of Rumble Stripes on Low-Volume Rural Roads in Iowa—Phase I

tech transfer summary

July 2009

Evaluation of Rumble Stripes on Low-Volume Rural Road in Iowa—Phase I

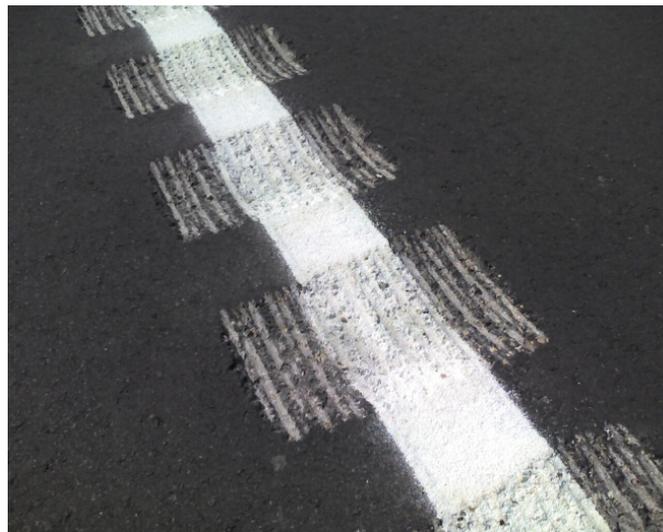
*A four-inch edge line rumble stripe placed on a rural highway in Iowa*

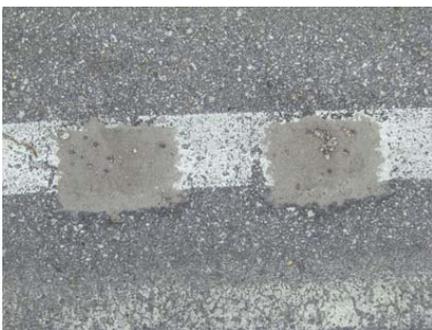
*Rumble stripe with caked material and debris in the bottom*

- In some areas, debris collected in the grooved part of the rumble strip and reduced visibility of the painted edge line.
- Preliminary results showed that the number of vehicles within 1 and 2 feet of the lane edge decreased by approximately 2% and 7%, respectively.
- The public and special user groups, including the Amish and bicyclists, had few complaints about the rumble stripes.

- Modify the design of the milling machine to allow for use on horizontal curves and to ensure predictable alignment and milling depth.
- Investigate why some milled areas fill with debris more than others.
- Continue to monitor the reaction to rumble stripes from special road users, including bicyclists, horse-drawn vehicles users, and agricultural equipment operators.

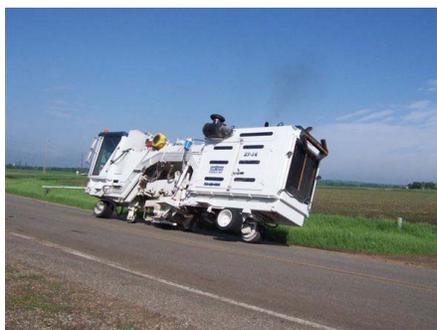
*Milling machine tipping on low side of elevated horizontal curve*

- In general, the wear of the paint markings in the rumble stripes' grooves was similar to the wear on regular surfaces. The rumble stripes did not appear to improve the longevity of the painted edge line.
- The milling machine became unstable and tipped on the low side of elevated horizontal curves because of its high center of gravity. Milling on curves was suspended until the machine was modified.
- Millings had to be blown out with an air compressor before edge lines could be applied.
- There was not enough downward pressure on the milling head, so it was difficult to mill portland cement concrete to the desired depth of 5/8 inch.
- Milling had to be omitted in areas near mailboxes to avoid damage.
- Aligning the painted edge line with the rumble strip was difficult but necessary for maximum effectiveness.

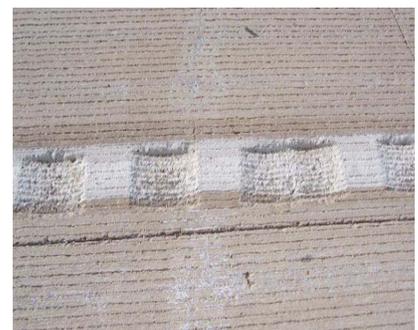
*Similar wear for edge line in rumble stripe and flat section*
