Improving Concrete Overlay Construction

Final Report
March 2010

Sponsored by
the Iowa Highway Research Board
(IHRB Project TR-600)
Federal Highway Administration
(DTFH61-06-H-00011, Work Plan 17)

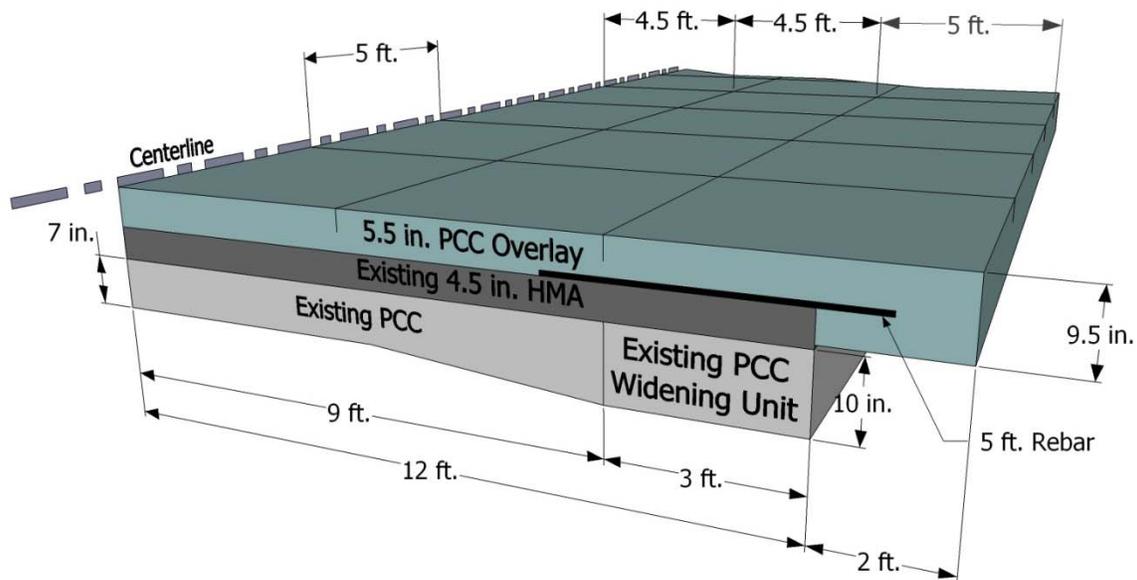
Figure 1. Osceola County typical construction cross-section and overlay

the first 3-foot widening. The project was let in February 2009. The road was built under closed road conditions, with through traffic using a detour. The typical construction cross-section and overlay jointing notes for the Osceola County project are shown in Figure 1.

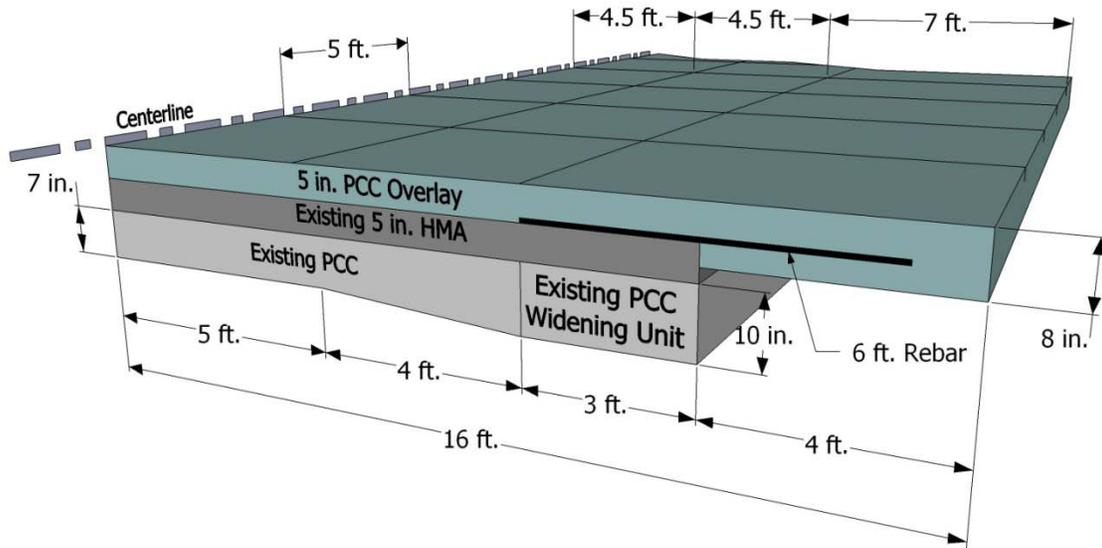
Figure 2. Worth County typical construction overlay cross-section

The existing pavement consisted of a composite section that had 5 inches of HMA over 7.5 inches PCC equivalent (10-7-10 section) with a 3-foot by 10-inch-deep PCC widening unit. The Iowa DOT designed a 5.0 inch PCC overlay of the existing 24-foot-wide pavement and the addition of an 8-inch deep by 4-foot widening unit on each side of the existing pavement. The jointing of the overlay consisted of longitudinal joints at 4.5 and 9.0 feet from the centerline, transverse joints at 5.0 foot intervals in the mainline, and 10 foot intervals in the turn lane areas. Reinforcement was to be placed over both widening joints. The project was let in January 2009. The road was to be built under closed road conditions with a detour for through traffic. The typical overlay construction cross-section and overlay jointing pattern for the Worth County project are shown in Figures 2 and 3. The length of tie-bar shown in Figure 1 was field-modified from 60 to 72 inches in length to allow for 18 inches of embedment into the new widening unit and onto the existing 18-foot pavement section.

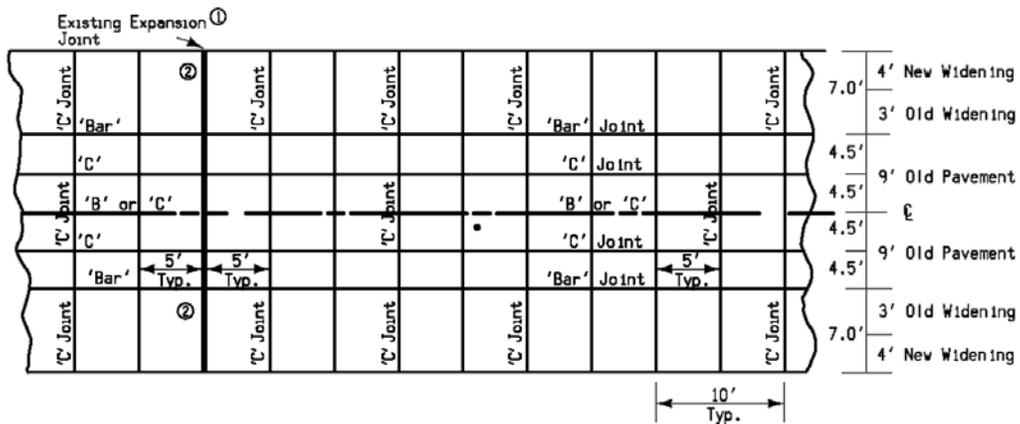
Figure 3. Worth County overlay jointing pattern

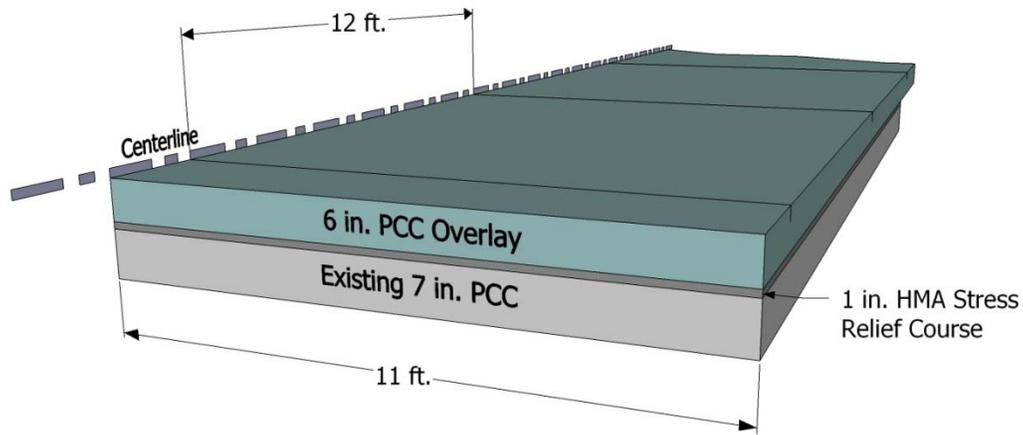
Figure 4. Poweshiek County typical overlay construction cross-section

The existing pavement was a 7-inch by 22-foot PCC pavement, built 30–35 years ago and was experiencing some joint deterioration. A 6-inch PCC unbonded overlay was planned for this project. Transverse joints were designed for 12-foot joint spacings. The project was let in November 2008. It was built with detour and full-width paving. The existing road was closed to through traffic, and a detour was used for through traffic. The typical overlay construction cross-section for the Poweshiek County project is shown in Figure 4.

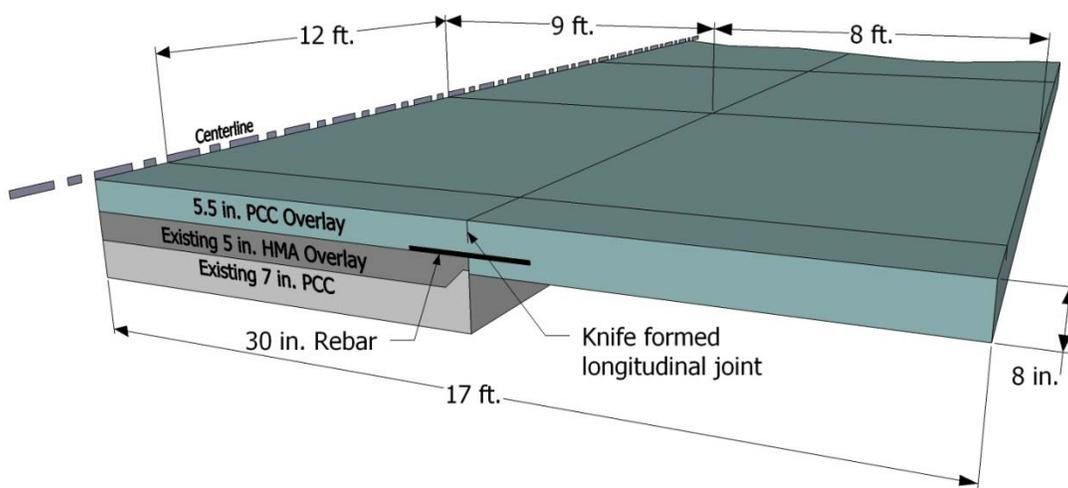
Figure 5. Johnson County typical overlay construction cross-section

The existing pavement consisted of an 18-foot-wide, 1929 PCC pavement with lip curbs. The pavement was resurfaced with HMA to fill the height of the curbs and extend a 3-inch depth of HMA to a width of 24 feet. The county designed a 5.5-inch PCC overlay of the existing 18-foot pavement and an 8-inch by 8-foot PCC widening unit. The new pavement contained longitudinal joints 9 feet from the centerline and transverse joints at 12 foot intervals. All this construction was contained in an existing 66-foot right of way. The project was let in June of 2009. The roadway was closed to through traffic, and local traffic was allowed to use the second lane in only one direction. The typical overlay construction cross-section for the Johnson County project is shown in Figure 5.

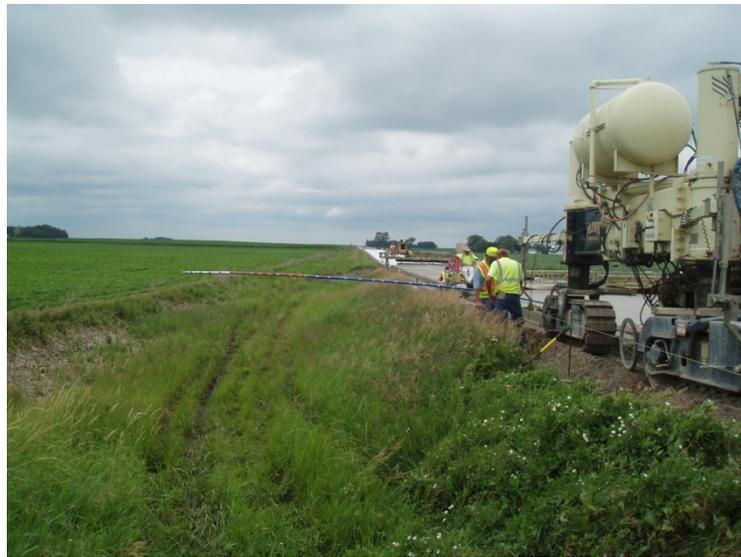
Figure 6. Osceola County paving train

Mainline paving for Iowa Highway 9 in Osceola County began on July 2, 2009 and ended August 4, 2009. Handpours for the turn lanes, bridge approaches, and gaps at US 59 were completed August 22, 2009. Mainline paving was accomplished with use of a Guntert & Zimmerman slipform paver and burlap drag, work-bridge with burlap drag, and a Gomaco cure/texture machine, shown in Figure 6. Hand-floating and mopping of the surface was accomplished between the slipform and the work-bridge.

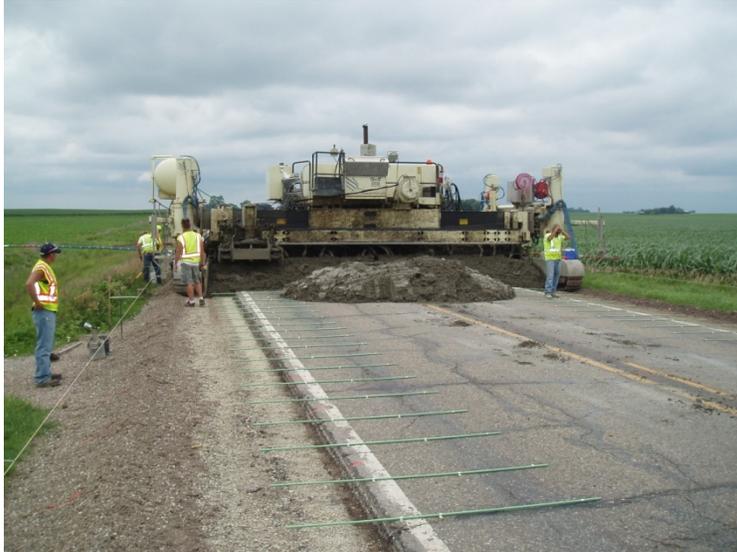
Figure 7. Osceola County tie bars

Workers also installed deformed, epoxy-coated Number 4 rebars on 30-inch centers across the old and new widening joints. These bars were 60 inches in length and were nailed to the existing asphalt surface with no less than three nails for each bar. It was important to know that the orientation of the bar nails must be such to resist movement of the roll of concrete in front of the slipform paver, as shown in Figure 7. The finished overlay product for the Osceola County project can be seen in Figure 8.

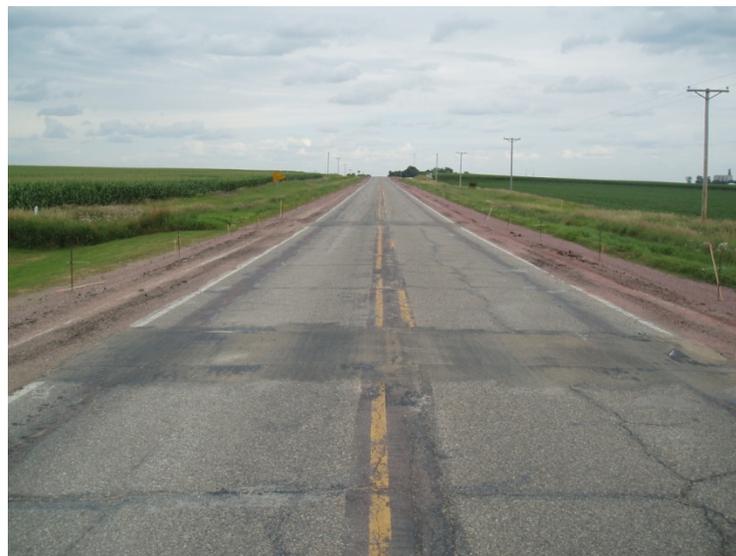
Figure 9. Osceola County original pavement

A large number of longitudinal subdrains were added to this project but accounted for less than one week of construction prior to the paving. In addition, a number of full-depth concrete patches were placed prior to the paving. Some contractor issues caused this activity to take multiple weeks, when only one week was required to complete the task. The project required 1,379 square yards of full-depth concrete patches and 153 surfaces patches of asphalt to repair transverse joint locations in the existing pavement. The general condition of the surface was good due to the maintenance practices of the local Iowa DOT authorities, as shown in Figure 9.

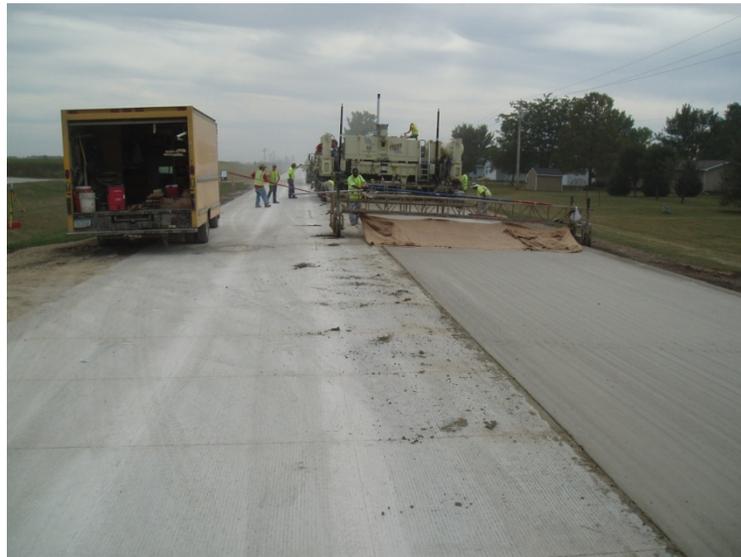
Figure 10. Mainline paving

burlap drag, and a Gomaco cure/texture machine, shown in Figure 10. Hand-floating and mopping of the surface was accomplished between the slipform paver and the work-bridge.

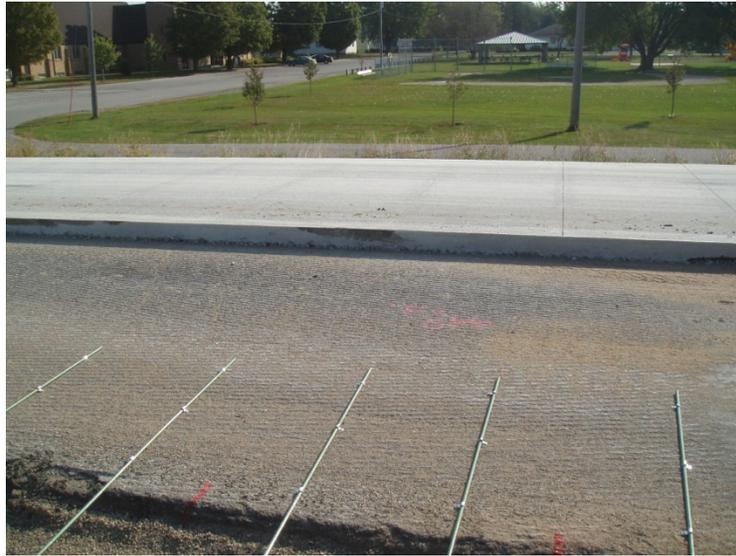
Figure 12. Worth County bar layout

Workers also installed deformed, epoxy-coated number 4 rebars on 30-inch centers across the old and new widening joints. These bars were 72 inches in length and were nailed to the surface with no less than three nails for each bar. It was important to know that the orientation of the bar nails must be such to resist movement of the roll of concrete in front of the slipform paver. The layout of the bars for the Worth County work is shown in Figure 12.

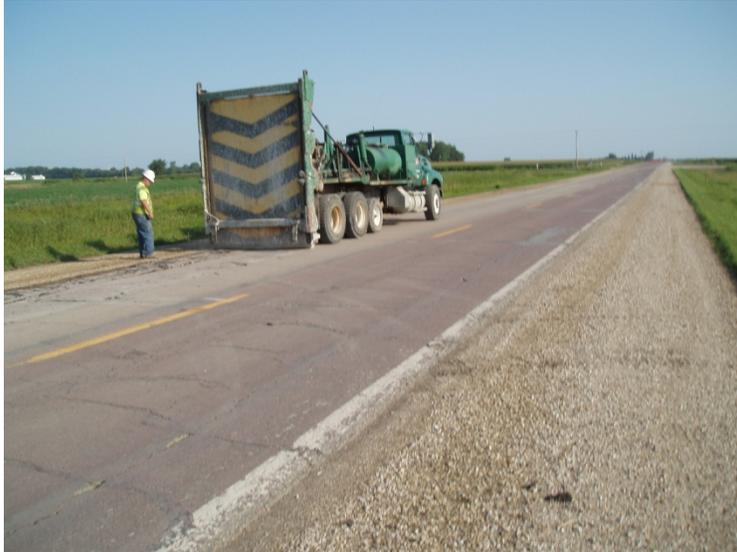
Figure 13. Worth County before milling

In general, the pavement surface was well maintained and in good condition, as shown in Figure 13. The existing surface friction course was exhibiting signs of localized delamination, and the Iowa DOT decided to remove it by milling. The final surface after milling is shown in Figure 14.

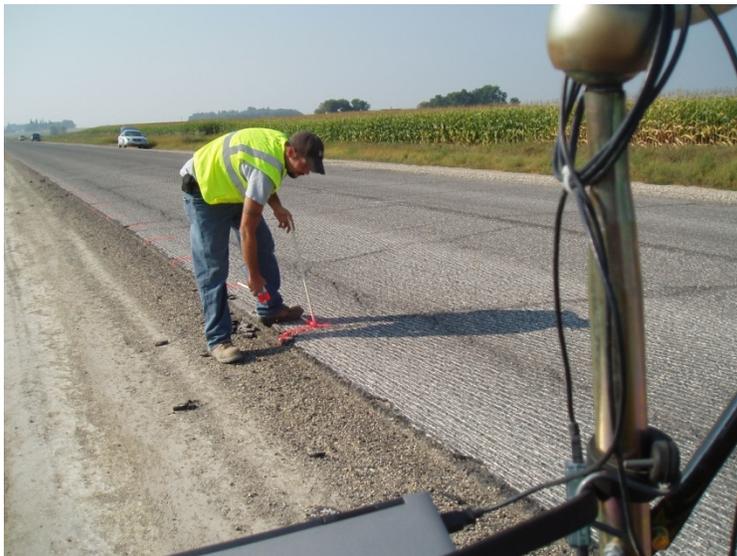
Figure 14. Worth County existing condition after milling

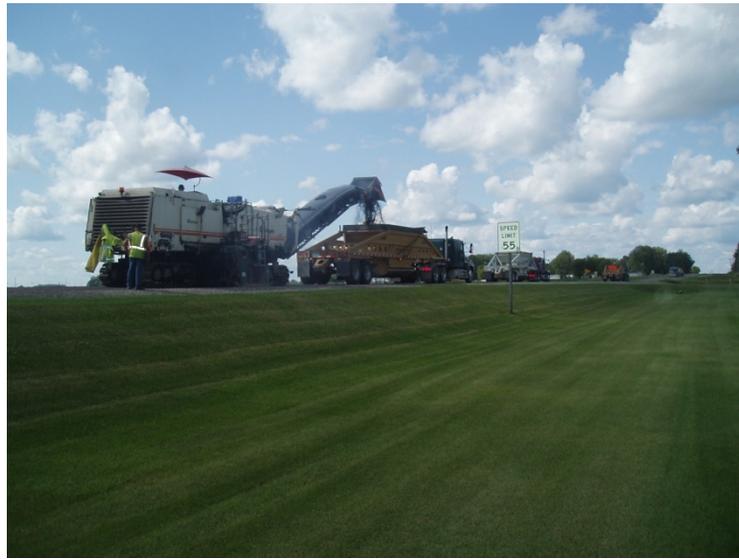
Figure 15. A 12-foot-wide milling machine

The Iowa DOT chose to mill the existing HMA surface to achieve a 2% cross-slope in each lane and reduce the amount of PCC overlay overrun due to wheel ruts. The Iowa DOT also wanted to remove much of a bituminous surface sealcoat that showed large areas of surface loss. There was a concern about the bonding capability of this layer. Milling was accomplished by using a 12-foot-wide milling machine, shown in Figure 15. Grade was established by setting the mill to scratch the surface at the centerline and mill to the 2% cross-slope across the driving lane in each direction. In super-elevated curves, the mill was set to follow the existing rate of the cross-slope.

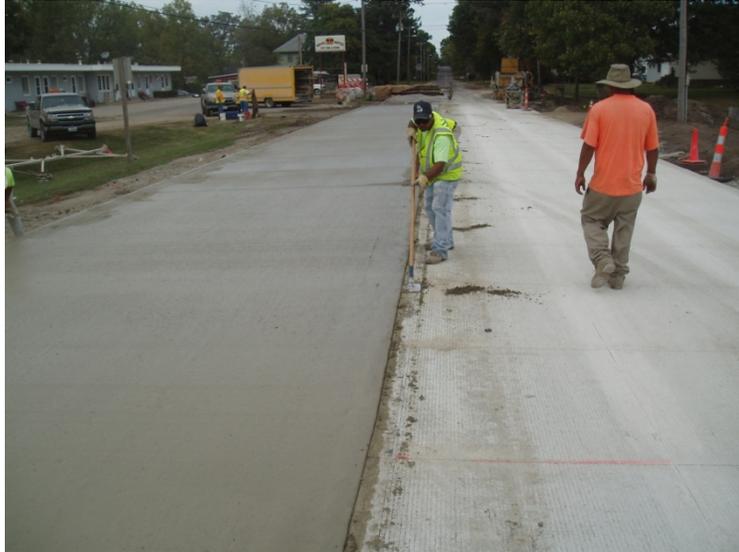
Figure 16. Hand tooling of the center line

The centerline joint was hand tooled for both lanes of paving, shown in Figure 16. Three early entry saws were used to cut the transverse joints. The first saw cut every fifth joint to a depth of T/3, and the other two saws cut the intermediate joints to a depth of T/4. The paving of the 16-foot-width did not exceed three-quarters of a mile per day on this project. No premature cracking was noted on this project.

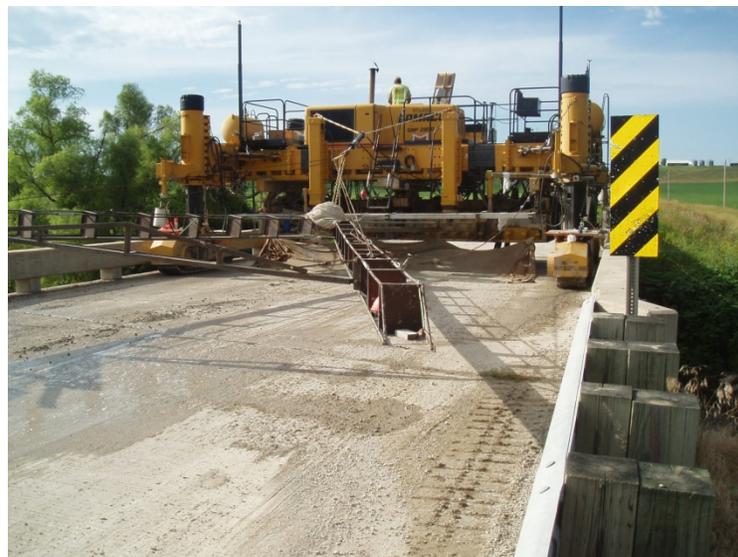
Figure 17. Gomaco 2800 Commander slipform paver

The paving train consisted of a Gomaco 2800 Commander slipform paver with V float, hand finishers, burlap drag bridge, and Gomaco cure/texture cart, as shown in Figure 17. In this case, the contractor also chose to use the Gomaco GSI profiler, shown in Figure 18, to measure the profile at various points across the slab and continuously along the pavement for the length of the project. This was used as a research project for Gomaco and to help the contractor evaluate the operation of the stringless technology and the slipform paver, which was a new machine for the contractor.

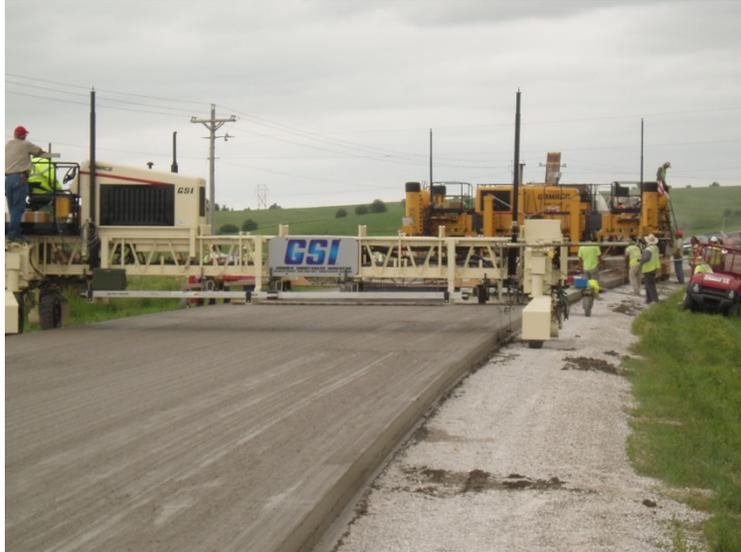
Figure 18. Gomaco GSI profiler

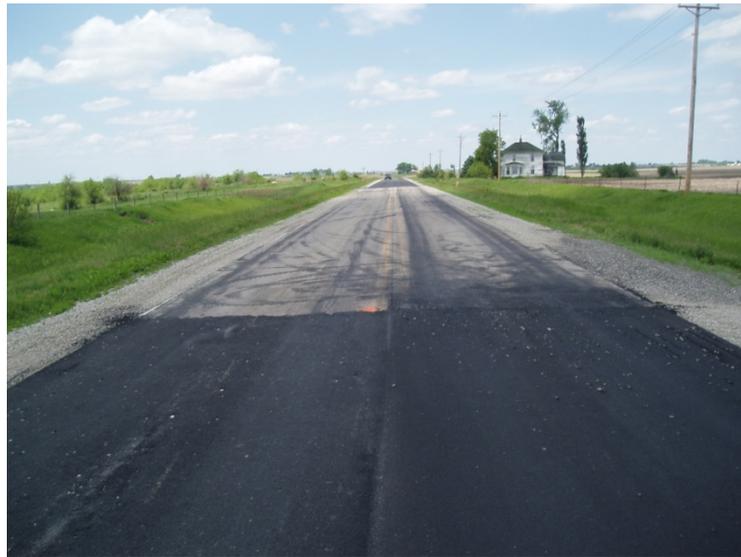
Figure 20. The gap in the HMA bond breaker where the geotextile material was placed

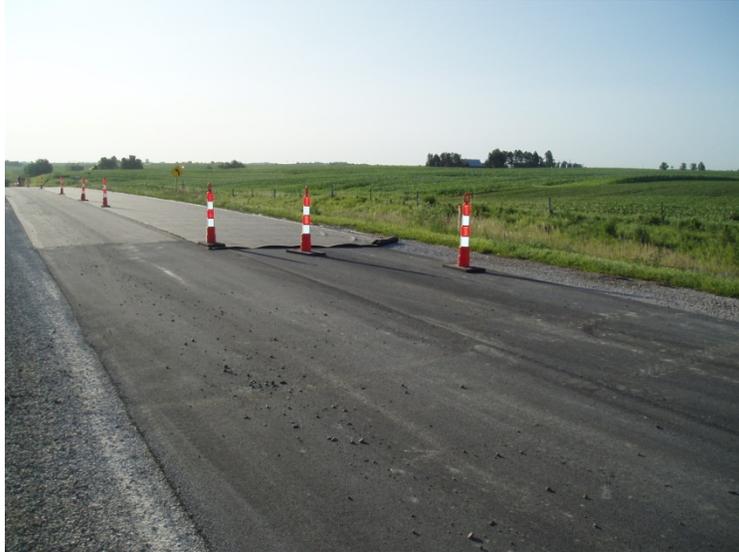
Figure 21. Fabric roll placement

Installation instructions were the same for both materials. A copy of the installation instructions can be found in Appendix A. The materials were to be overlapped no more than 6 inches at centerline, and the excess width was to be laid flat on the road shoulder to act as a wick drain for any moisture between the pavement layers after construction, shown in Figure 20. The test areas were gapped during the placement of the 1-inch nominal HMA bond breaker. Fabric roll placement began 3 feet before the HMA gap to allow for overlap of the two materials and ended 3 feet on the HMA at the terminus of the test area, as shown in Figure 21.

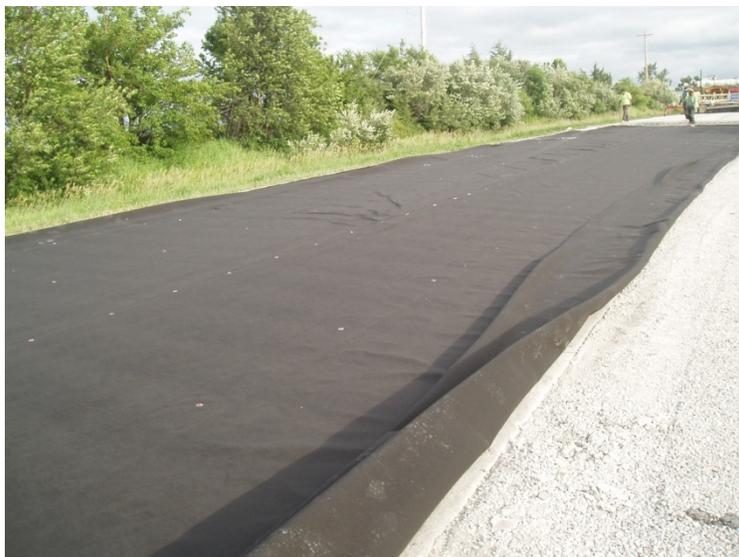
Figure 22. Nailing pattern for the geotextile materials to the existing pavement

The materials were attached to the existing pavement with nails, shown in Figure 22, from Hilti ramset-type guns. They were nailed in an approximate 5.25-foot transversely by 5-foot longitudinal grid pattern with one row of nails 3 inches from each pavement edge, one at the centerline, and one at each midpanel location. The material was difficult to keep straight under this type of construction and developed small bubbles in the surface. These bubbles were folded forward, and an additional nail was added to place them in a horizontal position prior to concrete placement. The intent was to have no bubbles under the material and no more than three layers of fabric between the concrete layers. It was permissible to cut such a bubble and make a two-layer overlap but this technique was not employed on this project.

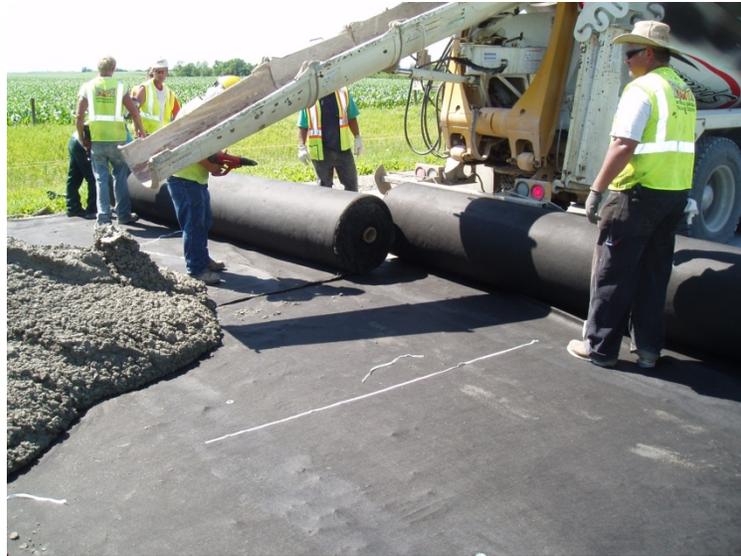
Figure 23. Unrolling and nailing the material to the existing pavement

At the first location, no prior instructions were given to the contractor as to how to place the material. The contractor chose to use hand labor to unroll two rolls of material at the same time. He accomplished this in the small area between the concrete delivery trucks and the slipform paver. The use of ready-mix concrete delivery trucks made this possible. The operation can be seen in Figure 23. It required that the material also be nailed to the existing surface in the workspace between the rolls and the concrete placement area. This required approximately four people to unroll the fabric, three people nailing the material to the existing surface, and close coordination with the person directing the concrete placement.

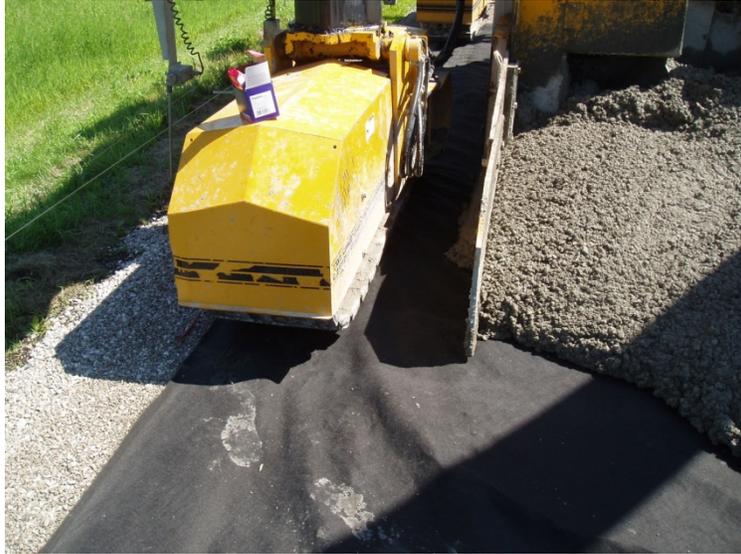
Figure 24. Streetpads

Site 4 was the next placement area. In this case, the contractor placed the entire length of fabric in both lanes prior to any concrete placement. The same number of crew were utilized for placement. Concrete delivery trucks were directed to back into the slipform paver by using the middle of the roadway surface. This required some turning of the trucks due to the horizontal curve location. No particular problems were noted in this fabric or concrete placement. The use of “street pads” on the slipform paver and the control of the concrete “head” in front of the paver removed any problem with the slipform trying to pull the fabric toward the paving operation, as shown in Figure 24.

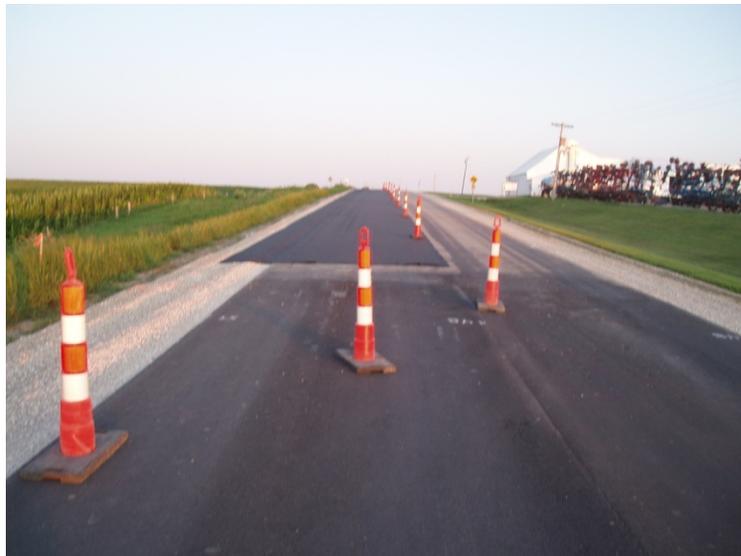
Figure 25. Non fabric-covered lane

The downgrade nature of Site 2 resulted in a different approach to the material placement. In this case, the first roll was placed prior to any concrete placement. Delivery trucks backing up the grade used the non-fabric-covered lane until they got closer to the paving operation and then deposited concrete over the second lane roll, as shown in Figure 25. This allowed the trucks to not maneuver on the fabric.

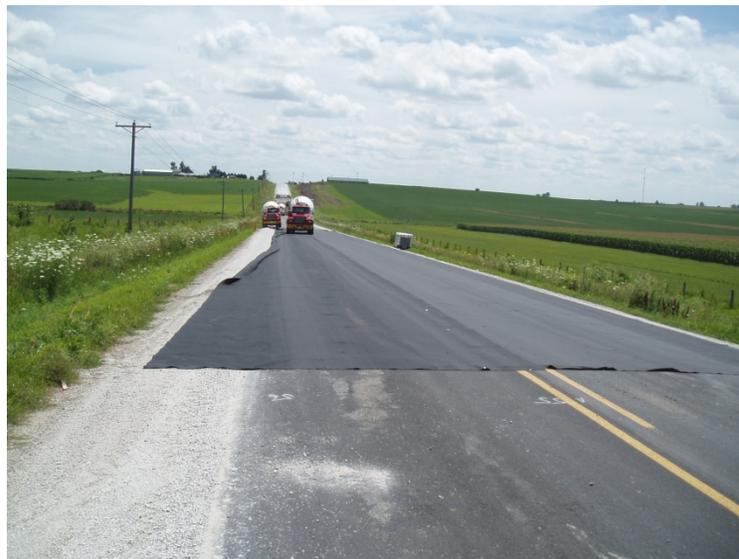
Figure 26. Fabric and concrete placement

fabric bubbles were treated with extra nails to secure them to the surface prior to concrete placement.

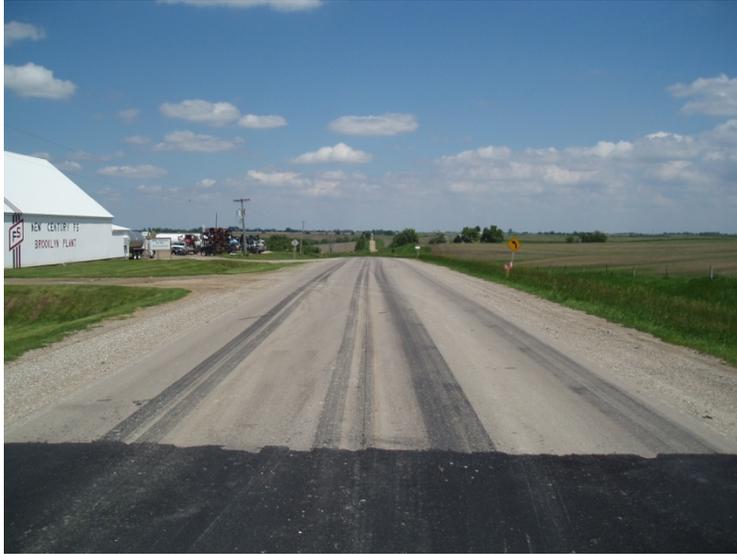
Figure 27. Poweshiek existing pavement

The existing pavement on this project was in good condition. The surface was uneven at the joints from years of vertical movement during spring thaws and subgrade clays that did not drain well. There was some evidence of random joint faulting, but in general travel was not impacted by the amount or severity of faulting. A view of the existing pavement prior to the placement of the bond breaker layer is shown in Figure 27.

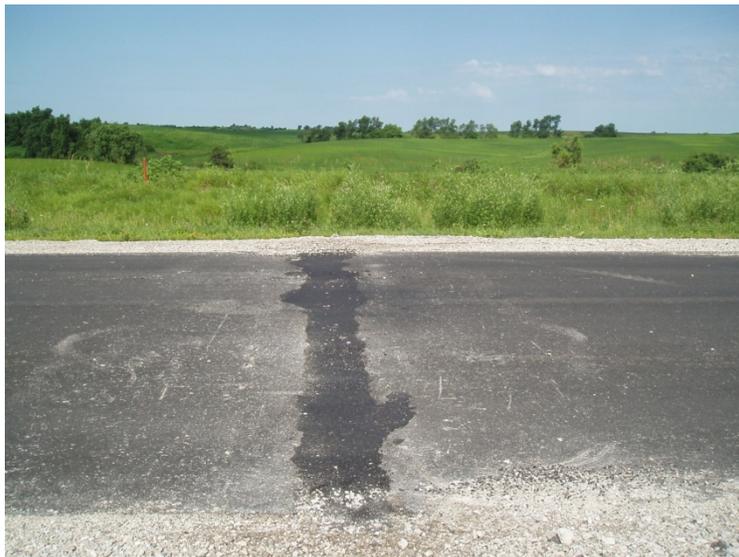
Figure 28. Rehabilitation technique for damaged transverse joints

This project contained 37 existing transverse joints that were exhibiting vertical movement and damage from expansion of the pavement in a longitudinal direction. The contracting authority had experienced this type of problem on other county projects and had developed a working rehabilitation technique. The technique consists of using a rock saw to cut along the joint at a width of 6 inches. The void was filled with hot mix asphaltic concrete. This work was done before the overlay operation and allowed the concrete delivery trucks to compact the asphalt during paving operations, as shown in Figure 28.

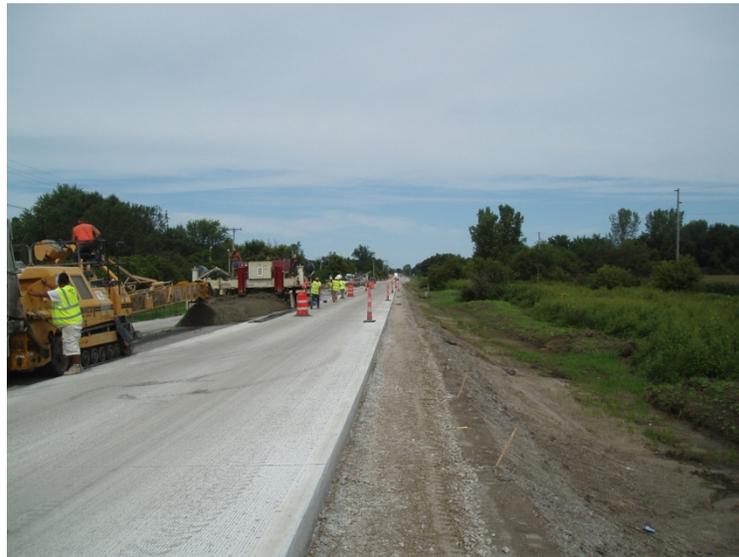
Figure 29. The project paving train

train was usually less than 500 feet between the slipform and the cure/texture cart. Cool, cloudy weather limited the contractor's ability to shorten that distance.

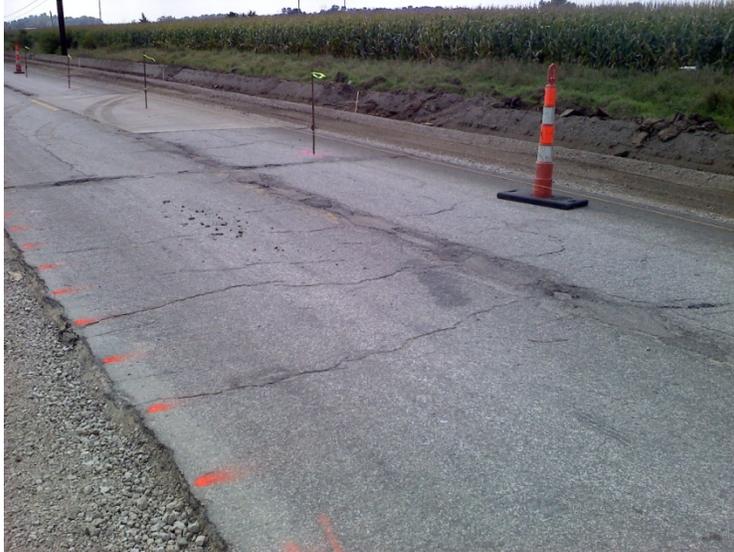
Figure 31. Johnson County existing condition

The existing pavement was in fair to good condition for its traffic load and the age of the underlying concrete pavement. As seen in Figure 31, there were many areas of delamination between the existing asphalt layers and the original concrete in the form of potholes near the centerline and across the slab in various areas. The plans called for 690 square yards of full-depth patching with concrete, and one patch by count.

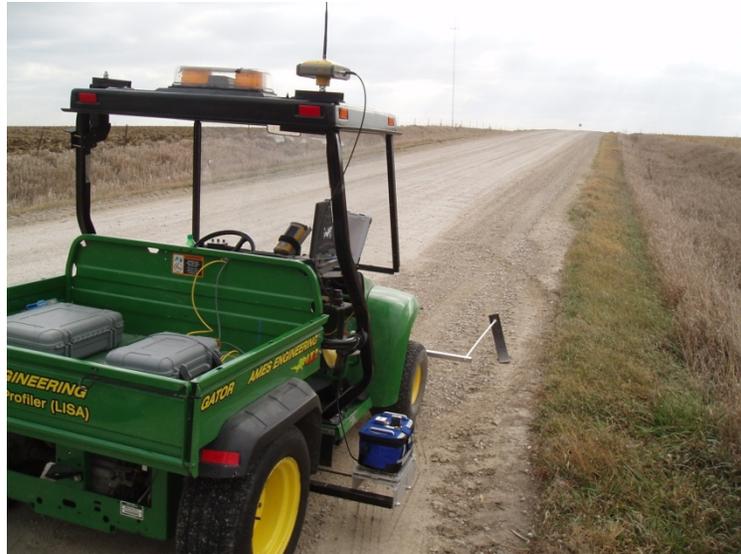
Figure 32. A John Deere Gator equipped with a GPS receiver

A John Deere Gator utility vehicle was used to map the existing surface of the roadway on the Poweshiek, Osceola, and Worth County projects. It was equipped with a GPS receiver mounted on the top of the cab, shown in Figure 32, directly over the laser profiler. Data were streamed from both units to a central computer for storage, as shown in Figure 33. Data were using the Iowa real time network (RTN) system and its ability to correct for location and elevation.

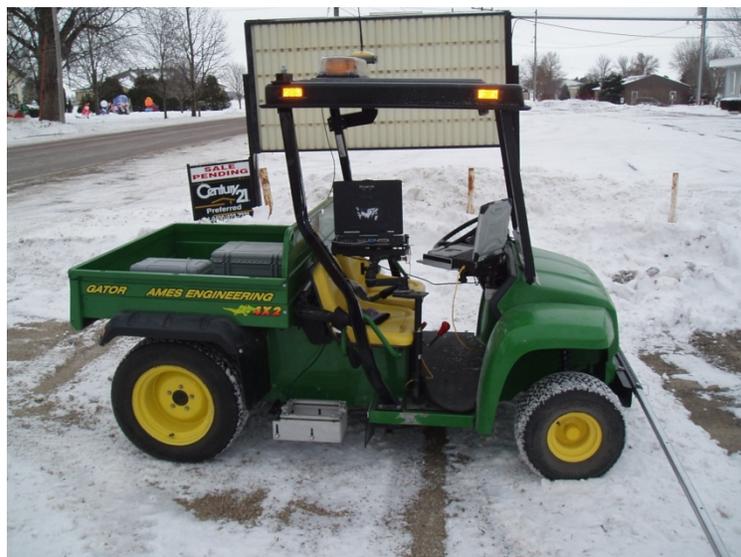
Figure 33. GPS receiver and laser profiler located on the top of the John Deere Gator

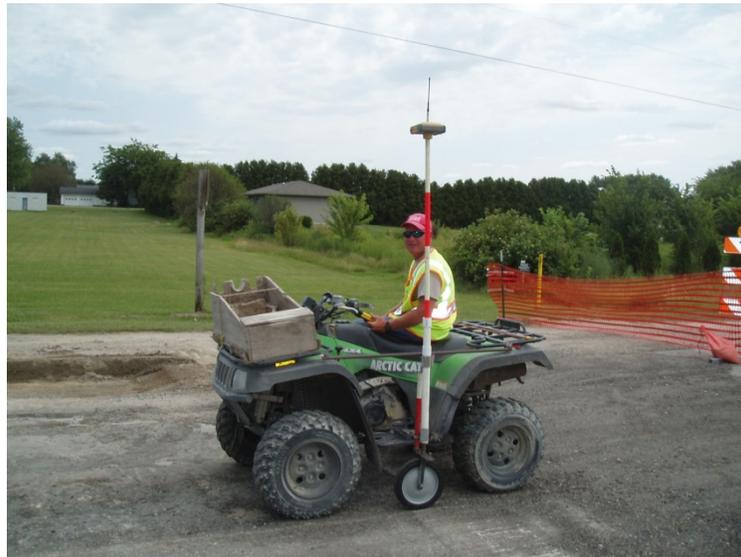
Figure 34. An ATV equipped with a GPS

subdividing the project into subsections, setting a base station, and communicating by phone through the base station to the RTN closest station.

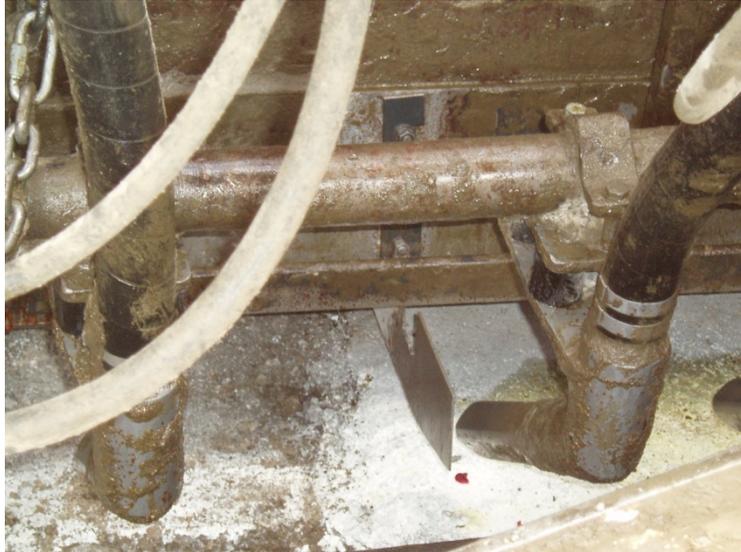
Figure 35. “Knife” mounted on the bottom of the slipform paver pan

The “knife” was redesigned by its inventor Bob Steffes and in conjunction with the contractor on the Johnson County Road W62 project. It was mounted on the bottom of the slipform paver pan and is shown in Figures 35, 36, and 37. The “knife” was connected to the front and back edges of the pan with clamps that held it rigidly in place during concrete operations. This also allowed the contractor to utilize the slipform paver on other projects during this construction and remove the “knife” within minutes for that purpose.

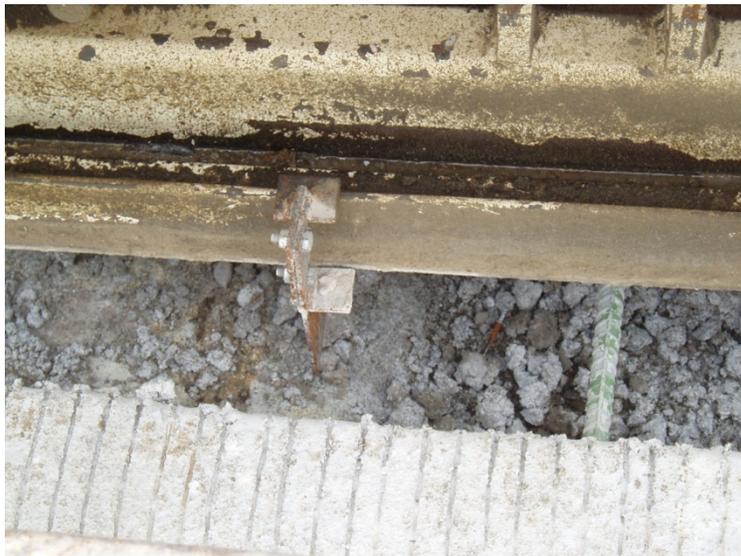
Figure 36. “Knife” held in place with clamps

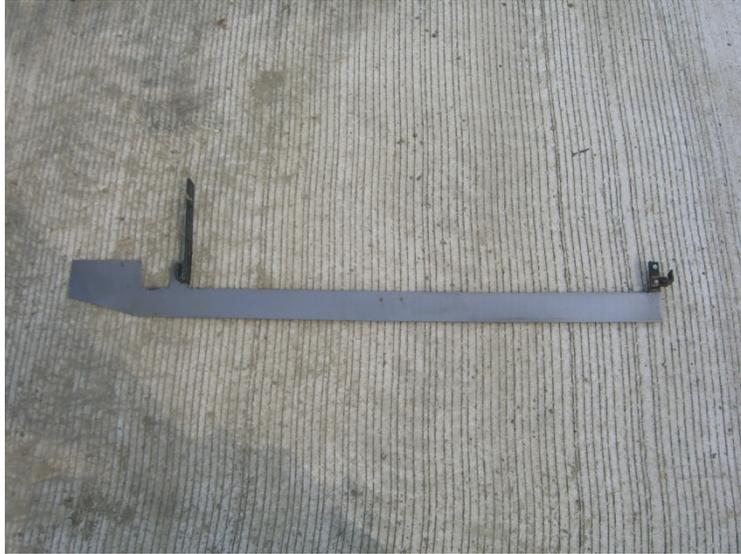
Figure 37. The “knife”

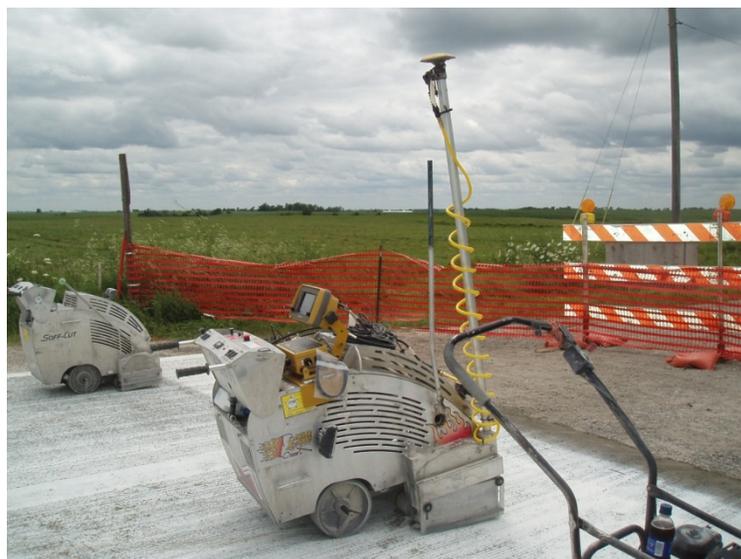
Figure 38. Saw equipped with a GPS unit

In a second location, a saw was equipped with the GPS unit and allowed to locate a line to saw from a GPS file. This site was used to demonstrate the ability of the saw to follow the GPS file points. The exact location of the original centerline could not be established as a reference for coring on this site. We were able to demonstrate the use of GPS to control the saw location by the efforts of equipment company representatives. Problems with the original GPS file caused the research team to resort to using manual methods to develop a line for the saw to follow. The line on the surface was then mapped by GPS and used as an input file for the saw, shown in Figure 38. A GPS receiver and screen were mounted on the top of a conventional early entry saw, shown in Figure 39, which was normally used by the contractor. The saw operator was given a 15 minute training session and told to keep a target type “+” on the screen lined up with a vertical line. He was able to saw the established line with no additional assistance and produced an acceptable centerline. The research team was able to estimate the cost of such a system that included a \$20-25K saw and a \$40K +/- GPS receiver unit for a total of \$60K.

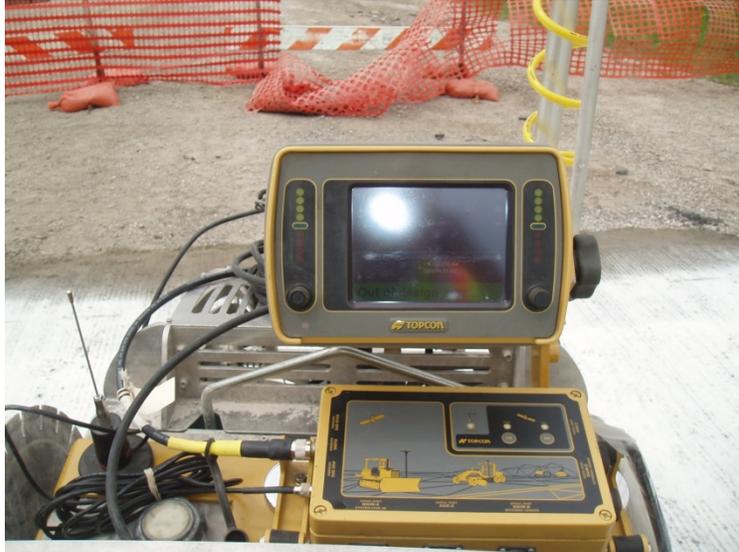
Figure 39. GPS receiver and screen

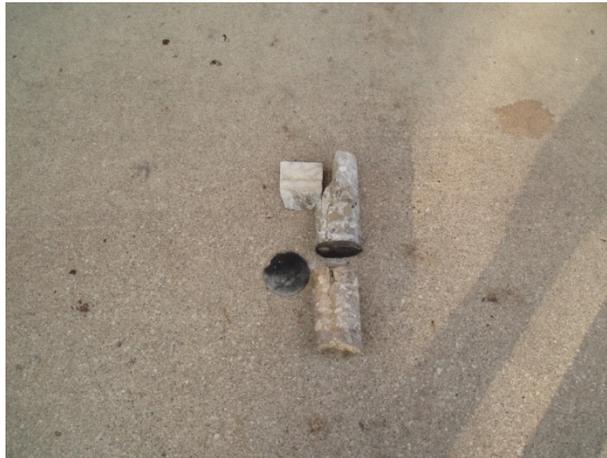
Figure 40. Concrete cores

Both of the products utilized on this project offered the same constructability and demonstrated no differences in handling or performance during paving operations. Cores were taken at centerline on Sites 1 and 3 to verify the immediate performance and assist in a joint experiment. The three cores that were taken can be seen in Appendix C. In each case, the materials performed as directed. The geotextiles adhered to the overlay concrete and not to the underlying concrete surface. No tack material was recommended or used between the existing concrete surface and the bond breaker, as would be the case with the use of the HMA.

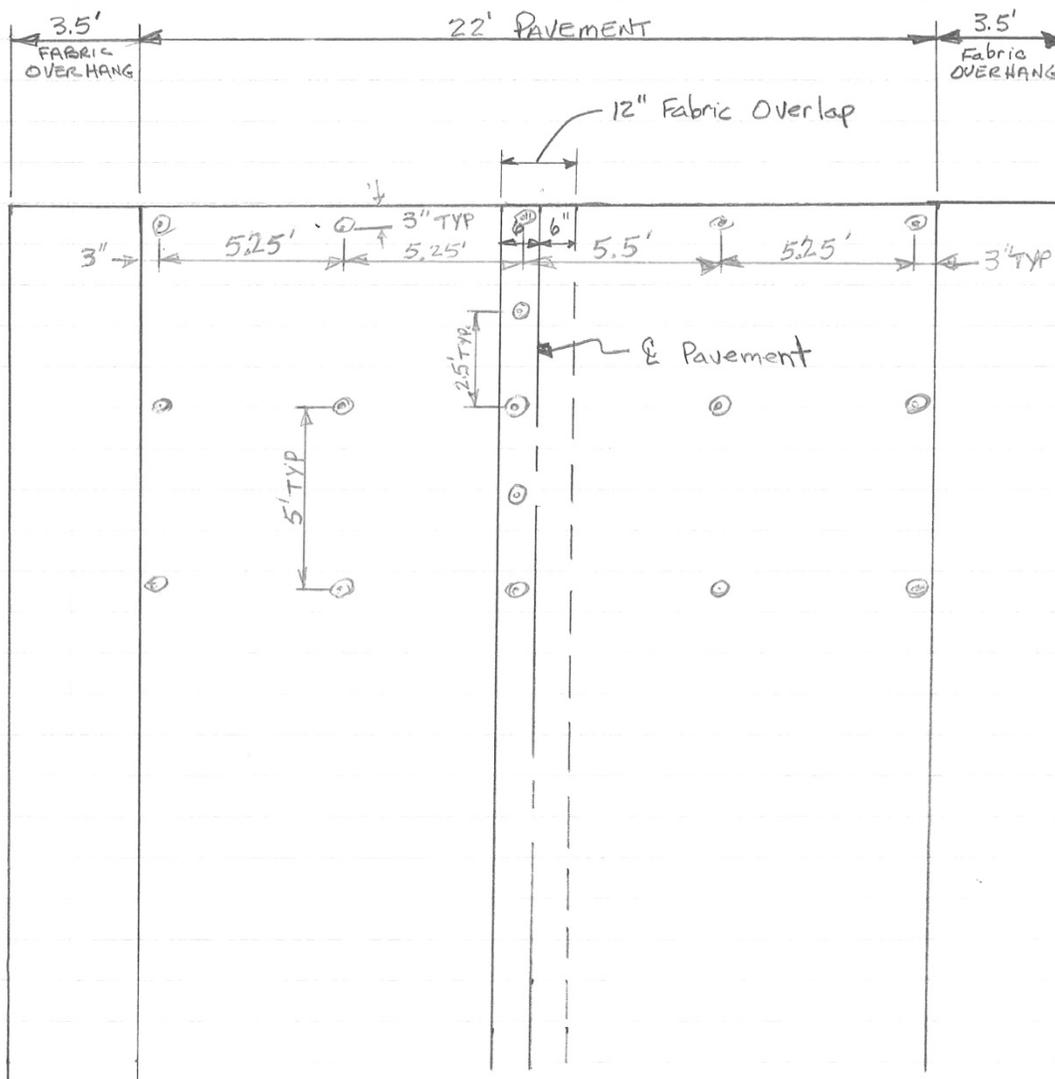
FABRIC INTERLAYER LAYOUT

FABRIC = 15' wide x 300' long
 LONGITUDINAL LAP — No More than 12" with the top layer
 in direction of paving

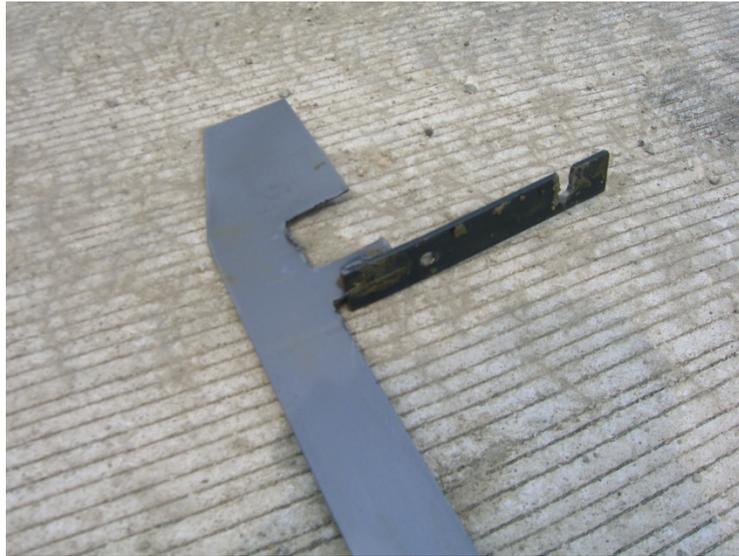
The removable joint-forming knife used for creating longitudinal joints

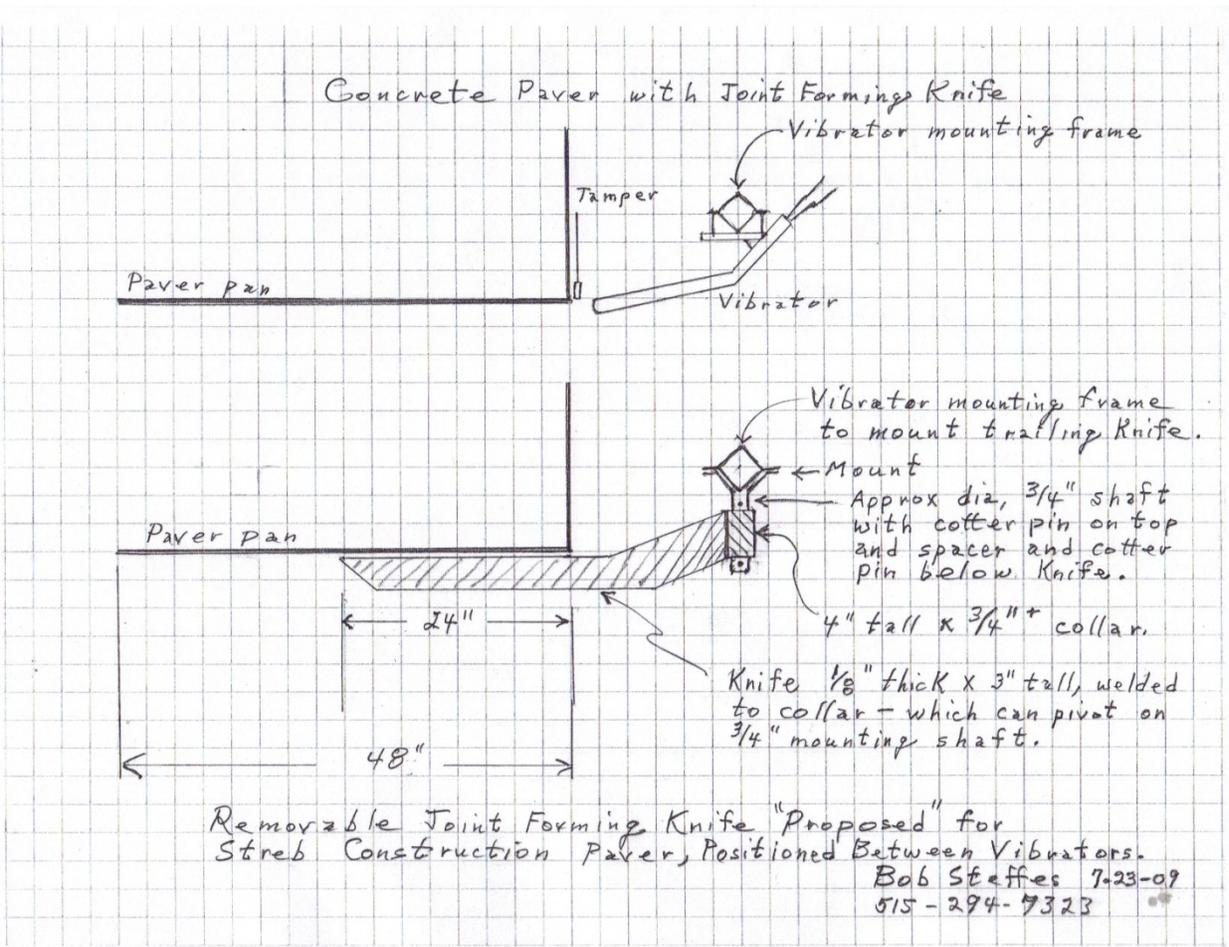
A schematic for the concrete paver with the joint-forming knife
