Improving Concrete Overlay Construction

Final Report
March 2010

Sponsored by
the Iowa Highway Research Board
(IHRB Project TR-600)
Federal Highway Administration
(DTFH61-06-H-00011, Work Plan 17)

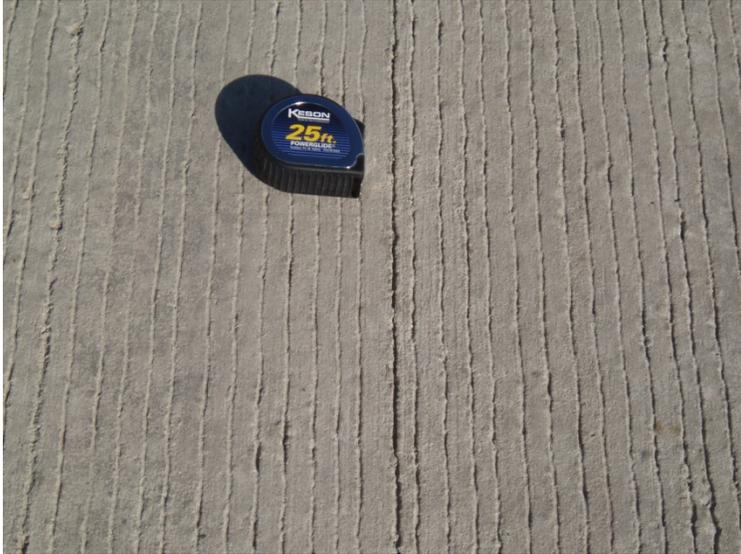
Pavement where a crack had formed along the longitudinal joint

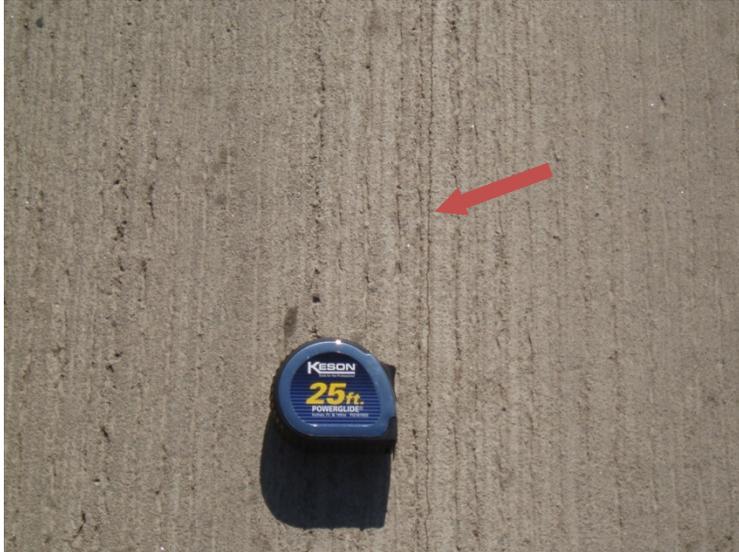
Pavement where a crack has formed along the longitudinal joint, but remains tight

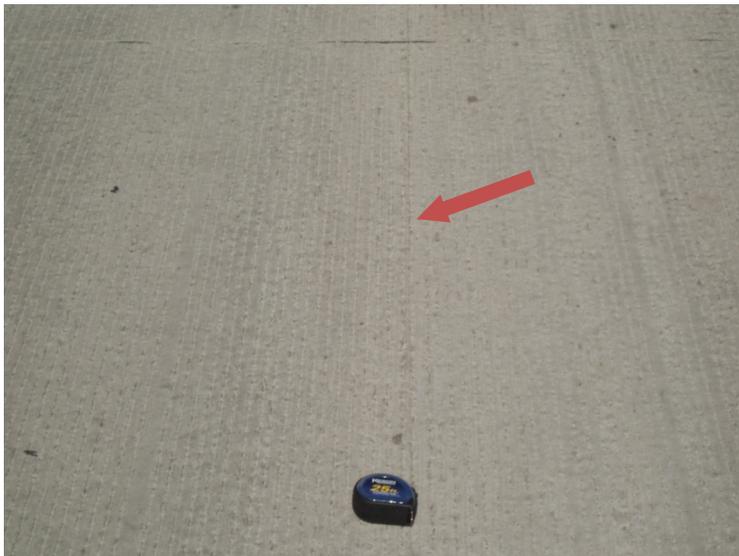
Pavement where a crack has formed along the longitudinal joint and is barely visible
