Summary Report
ISU-ERI-Ames-76035

ULTIMATE LOAD BEHAVIOR OF FULL-SCALE HIGHWAY TRUSS BRIDGES

Highway Division—Iowa Department of Transportation

ERI Project 1118S

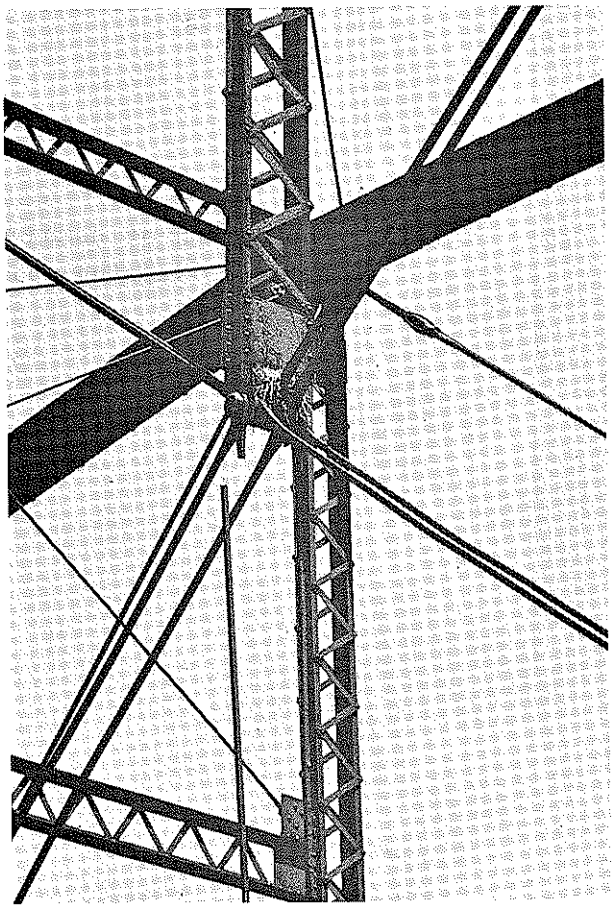
The truss tests proceeded as planned up to a total load of 80 kips. While proceeding to a load of 90 kips the observation was made that yielding was taking place in one of the hangers at L_5 on the downstream side. The yielding made it extremely difficult to hold and increase loads. During the load increment to 110 kips, there was considerable yielding at L_5. At a total load of 110 kips, a snapping sound was heard, and the load dropped several kips; however, no visible sign of failure was evident. Loading proceeded with the same difficulty to a load of 130 kips. At this load the flaking of the rust on the hangers at L_5 (upstream side) was very noticeable.

At a total load of 133 kips (106.4 kips at L_5 and 26.6 kips at L_4), one of the hangers at L_5 (upstream side) failed. The location of the failure and a close-up of the fracture are shown in Figs. 13 and 14. Subsequent reloading to 140 kips resulted in only increased truss distortion.

The initial failure of the truss took place at a load of 133 kips. This failure was the breaking of one of the hangers which made up member L_5M_5. The applied loading was 106 kips and 27 kips at L_5 and L_4, respectively. Additional load was applied in an attempt to cause additional members to fail. A large distortion of the lower chord of the truss near the load at L_5 occurred under this higher loading without any failure. The maximum load under this general loading was 140 kips; 112 kips at L_5 and 28 kips at L_4. The maximum vertical deflection at L_5 at this time was 15 in.

The capacity of the hangers at L_5 as calculated using data from coupon tests was 110 kips. This was just a few kips greater than the load that actually caused the fracture of one of these hangers. The actual stress at fracture was 47.4 kips/square in. This indicates that the "lap," near where the fracture occurred, was about 97 percent effective. An examination of the fracture (Fig. 14) indicates also that only a very small portion of the section was not fused. The current practice is to assume the "lap" only 40 percent effective, which is much lower than the actual capacity of the member.

Fig. 13. Photograph showing location of failure of member L_5M_5.

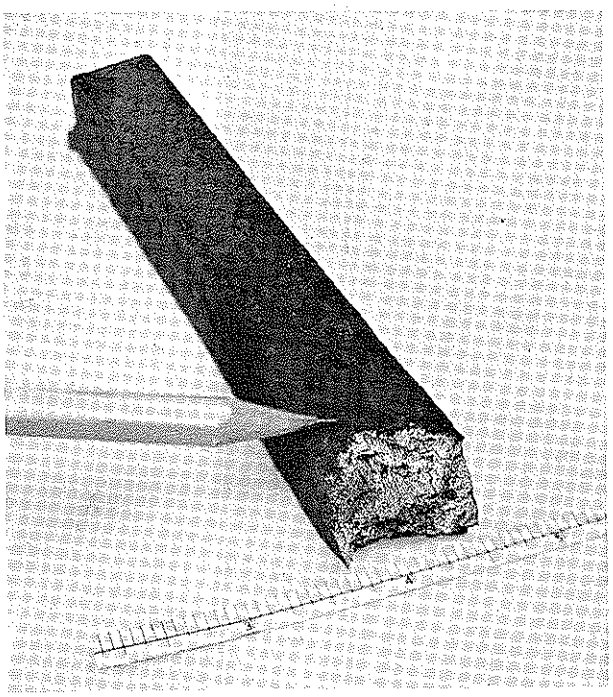
Fig. 14. Photograph of fracture.

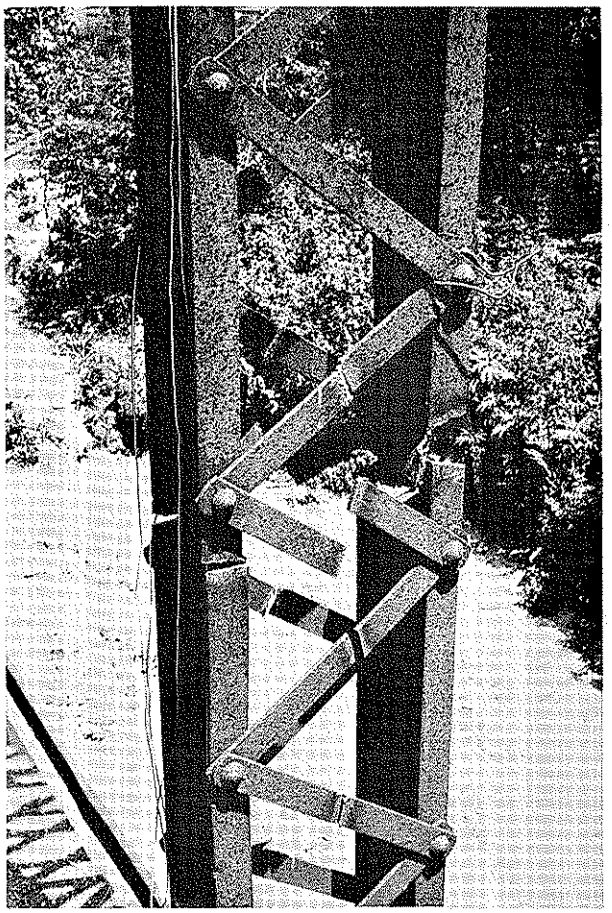
made to cut the other channel comprising member, L_2U_2, to obtain a failure of the truss. The load was again applied at L_4 with the load reaching 39 kips before the member collapsed upon itself (forming a complete but shorter member) at the cut location (Fig. 15). This resulted in a slight drop in load. The load was then increased to 72 kips with no further distress of the truss. The load was removed and all testing terminated because of potential danger of collapse during any additional member damage.

After adjustment of the loading system, all load was applied at L_4 with the maximum load being 78.5 kips. The test program then included damaging a member. After member L_2U_2 was cut completely through, a load of 39 kips produced a failure of the truss. This

Fig. 15. Photograph of damaged member after collapsing upon itself.

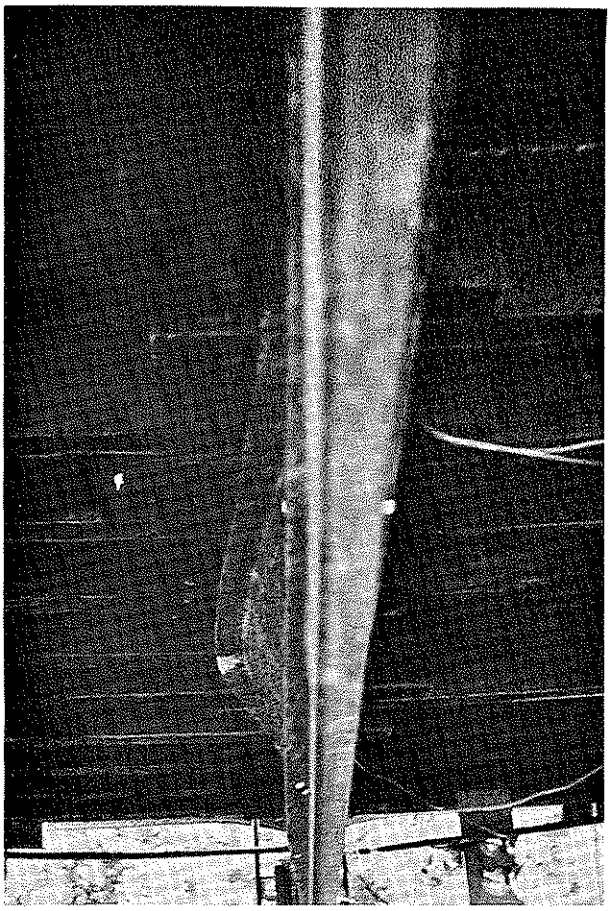
The first test was conducted on floorbeam 5. The load was first applied in increments of 10 kips, but as the loading progressed to higher levels the load increment was reduced to 5 kips until failure was reached. The test on floorbeam 5 proceeded as planned up to a load of 40 kips. At this load the floorbeam had started to buckle laterally between load points as well as to pull away from the timber stringers. As the load reached 45 kips the floorbeam continued to buckle laterally and pull away from the stringers. The load was then increased to 50 kips, at which point the lateral deflection due to buckling was approximately one inch beyond the initial crookedness of the floorbeam at its centerline as shown in Fig. 18. Termination of the test occurred at this point because the floorbeam was unable to sustain any further increase in load.

Fig. 18. Photograph of buckling of compression flange of floorbeam 5.
