BRIDGE DECK DELAMINATION STUDY

FINAL REPORT
RESEARCH PROJECT HR-179

DEPARTMENT OF TRANSPORTATION
IOWA

"BRIDGE DECK DELAMINATION STUDY"

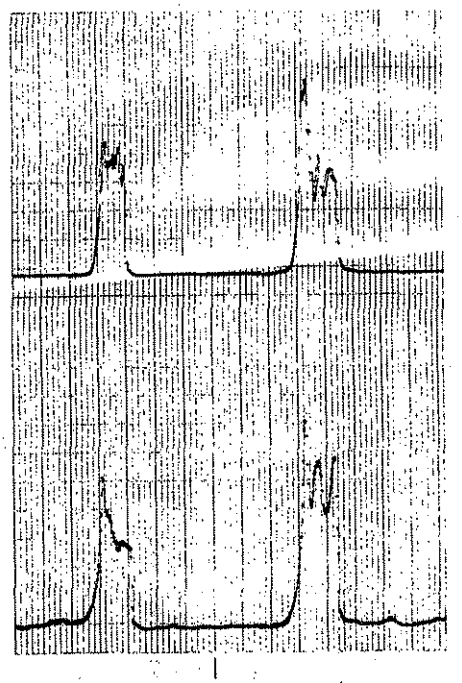
Figure 4
Strip Chart Showing Deflections Resulting From Delamination

7. Delaminations (deflection of 4 or more minor chart divisions above "BR") may be marked on bridge at time of survey by activating the paint spray.
