MLR 8510

Underseal Evaluation Project

Poweshiek County I-80 near milepost 189.5, Eastbound Roadway

UNDERSEAL EVALUATION PROJECT

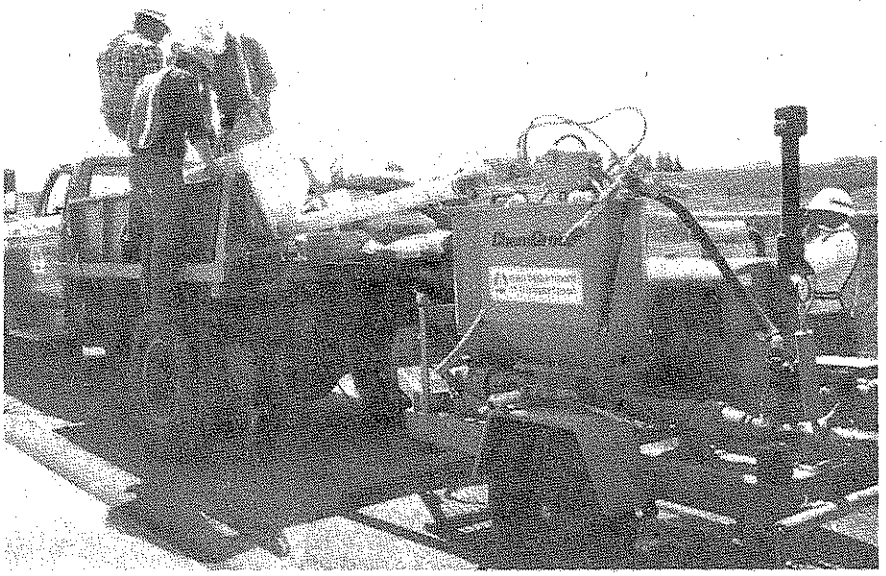
Drilling Monitoring Holes in Shoulder (Pressure Relief) over the Subdrain

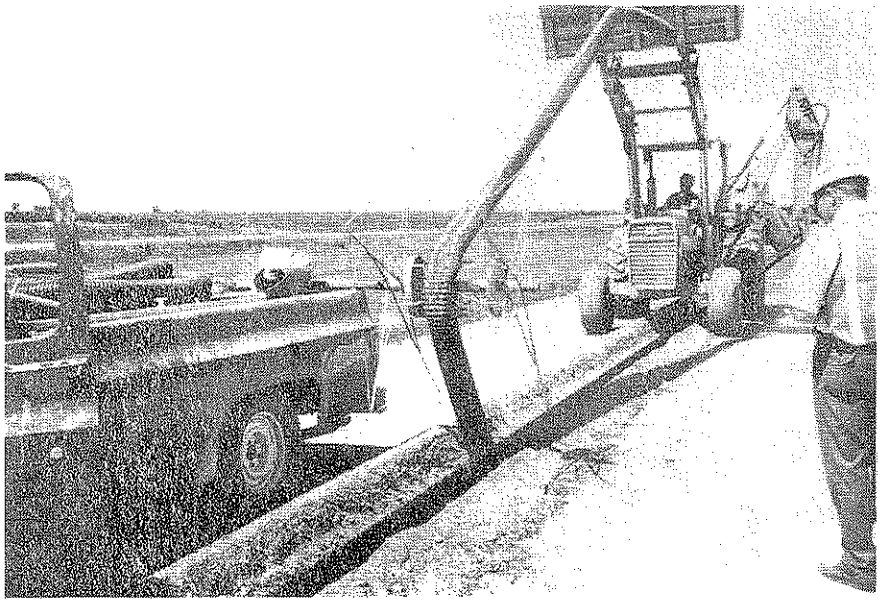
Removing Subdrain

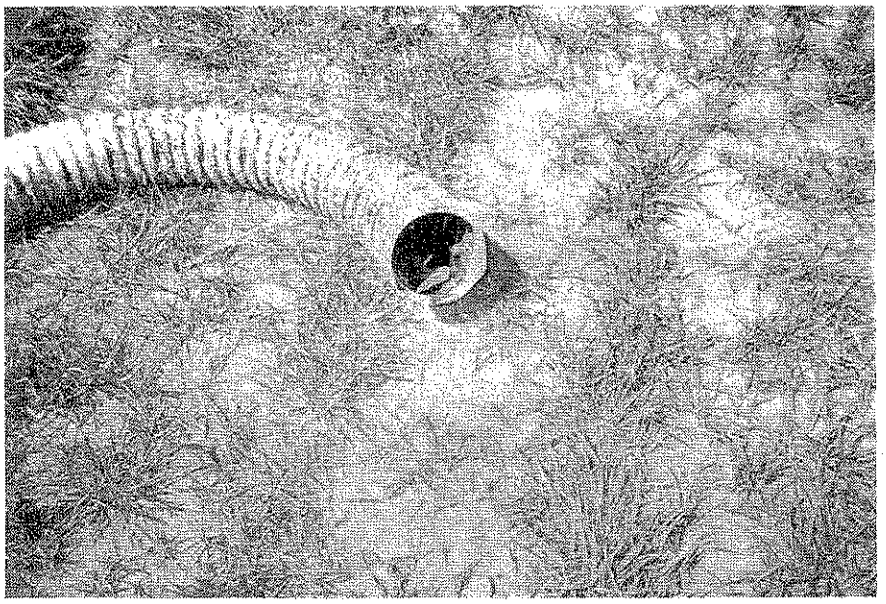
The undersealing grout infiltrated the subdrain system at three locations. The drainage system, however, appeared to be fully functional. It appeared that some damage to the drain tubing may have occurred during initial construction. An area located approximately 12' west of joint 3 contained a pipe splice failure which had resulted in a 4" separation. The drain pipe was also collapsed for about 4' adjacent to crack 12, possibly from excess "stretching" during installation. Water was flowing through the system at the time of drain removal and had apparently been flowing during the time of grout injection. The fact that this drain was continuing to function normally speaks very well for the porous backfill system.

Considerable grout was injected into the drainage trench. The grout caused backfill cementation at the base of the drain pipe between joints 2 and 3, and through an area extending 15' either side of joint 5. Grout had filled the subdrain trench to a depth of approximately 10" through the area where the

drain pipe collapsed at crack 12. Approximately 14' of pipe was encased by grout. At this location, hardened grout had entered the drain tubing and filled the corrugations in the flowline of the pipe. Some of the grout may have been removed from the tubing by flowing water while the grout was fluid. Joint 3, which contained 5 injection points, did not show any evidence of grout under the slab. The same situation was true with the approach panel of joint 11. Apparently the drainage system accepted nearly the total amount of grout placed at these locations with little harm. Heavy concentration of grout was present on the panel edge in these areas, but no grout appeared in the relief holes drilled over the subdrain. Through the entire trial section, the upper portion of the drainage trench was free of grout.

Fragment of Porous Backfill with Intruded Grout, which Encased the Subdrain Pipe.

Grout Intrusion Remaining in Subdrain Pipe

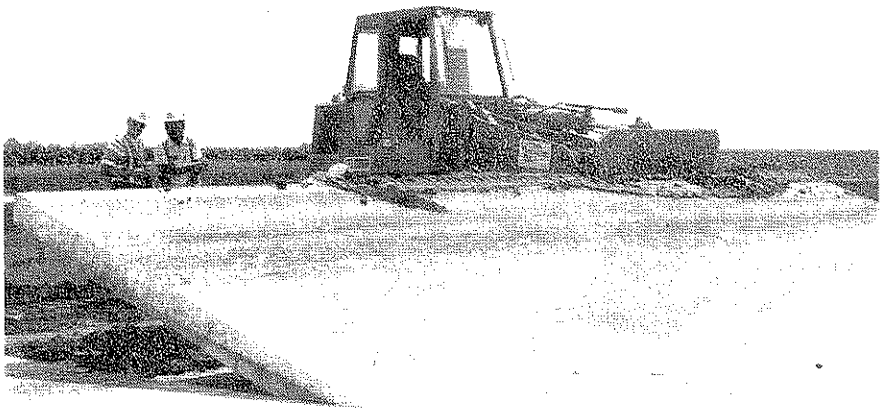
The leave panel of joint 13, extending for 18', had an approximate 2" thick, uniform layer of cemented subbase adhering to the slab. As at all other locations, the area adjacent to the shoulder did not contain grout.

Joint # 13. Pavement edge exposed during subdrain removal. The light area on the edge of the pavement is grout.

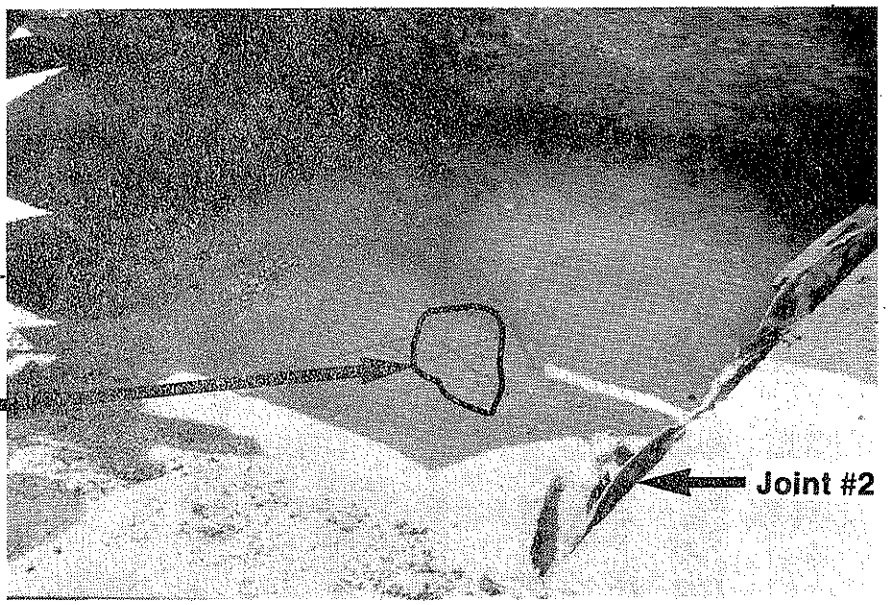
Joint #1 and Joint #2

The following remarks apply to all joints except joint 2. Existing load transfer devices were at best marginally operational. At all of these joints, concrete had deteriorated at the bottom of the pavement, exposing a portion of the dowels.

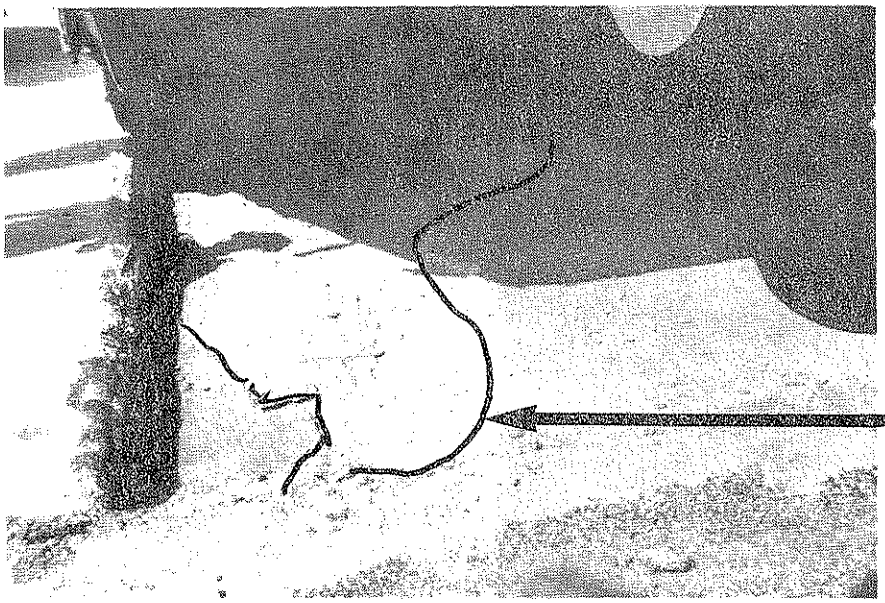
Two injection points were located 3' from the outside edges of the approach panel. Grout spread consisted of a 4" to 8" diameter cone centered on each injection point. This was the first test pattern tried and demonstrates the problems associated with a "thick" grout consistency.

One injection hole was located in the approach panel, 3' from the shoulder and 1.5' from the joint. This location contained the cone effect noted at joint 1. A definite unfilled void was present near this location.

Two injection holes were located in the leave panel adjacent to a 4" foam filled pressure relief joint. Cemented base material, 5" thick, adhered to the slab adjacent to the pressure relief joint. This material tapered to an approximate 3" thickness over a 12' long area adjacent to centerline and a 3' long area 30" from the shoulder. There was no cementation in a 30" band adjacent to the shoulder. No grout projected across the pressure relief joint.

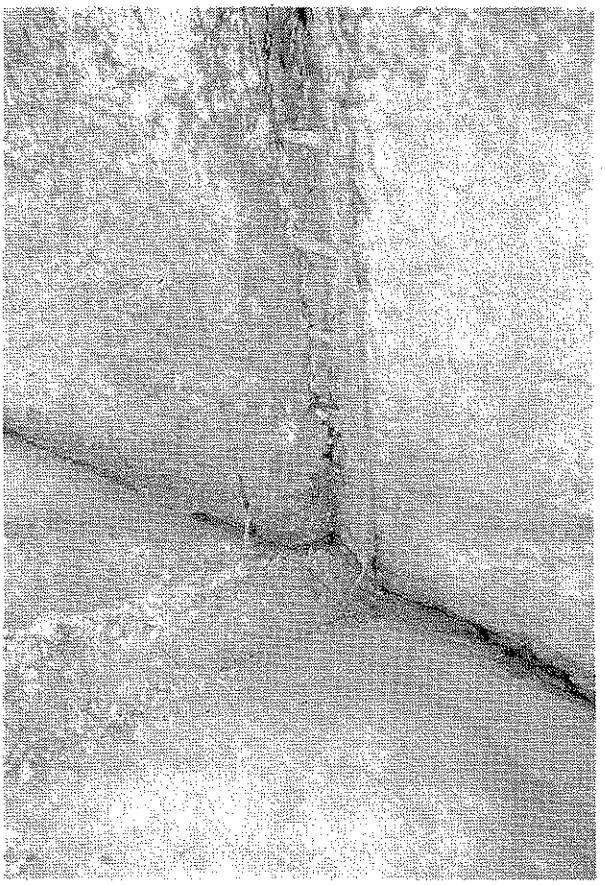
Approximately 4" of base was cemented to the leave panel, extending 5' from the joint. Grout did not migrate across the joint. There was definite evidence of "fines" removal from the interior portion of the approach panel. Considerable deterioration of the joint had occurred. Approximately 4" of dowel bar was exposed at the joint, with deterioration tapering towards the underside of the slab at an approximate 45 degree angle. The "void" left by the spalling was filled with fine rubble. Grout did not penetrate the rubble or fill the voids at the joint.

Joint #5 Leave Panel: Grout and subbase material is adhereing to underside of panel.

Joint.
Note Joint
Deterioration

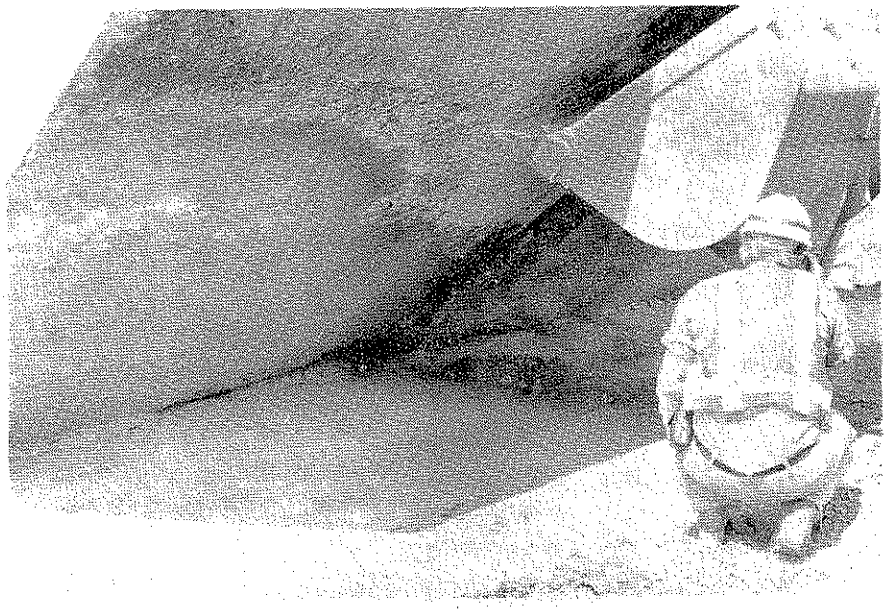
Joint #5 Note Joint Deterioration

Joint #5 Approach Panel
No grout distribution
under approach panel.

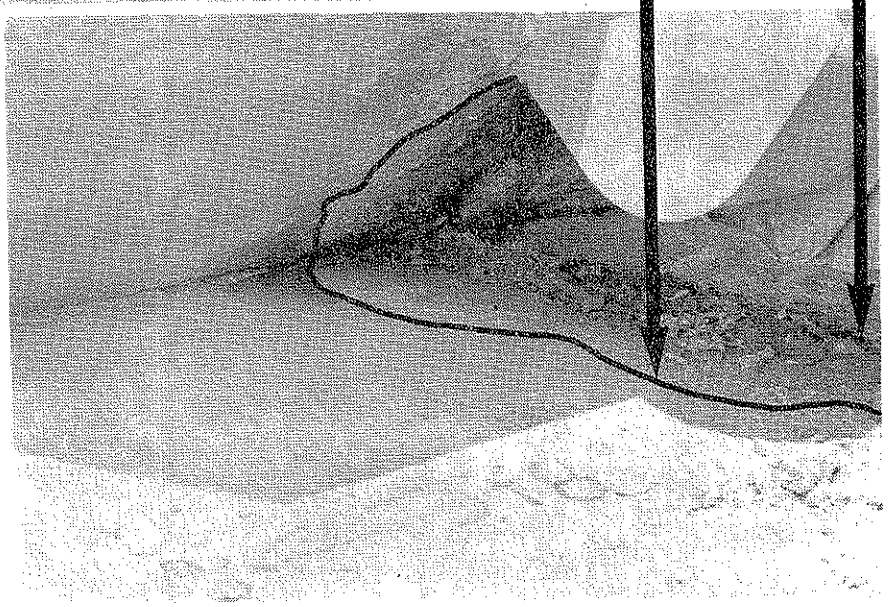
Flow characteristics were adjusted to new target values of 12 - 16 seconds at this point. Subbase was cemented to the slab, covering an area which extended for 3' under the approach panel to 7' under the leave panel. This joint also exhibited extreme deterioration, with bottom spalling extending 6" on

each side of the joint. The hole closest to centerline apparently did not penetrate the slab and all undersealing was accomplished from the hole located near the shoulder. As at all other locations, the outer 30" of the subbase appears to be choked with lime fines which the grout did not penetrate. There is evidence that grout penetrated cracks in the subgrade soil in this area.

Joint #8 Leave Panel: Note
Joint Deterioration. Grout and
subbase material adhereing
to underside of panel.

Joint - Note
Joint Deterioration

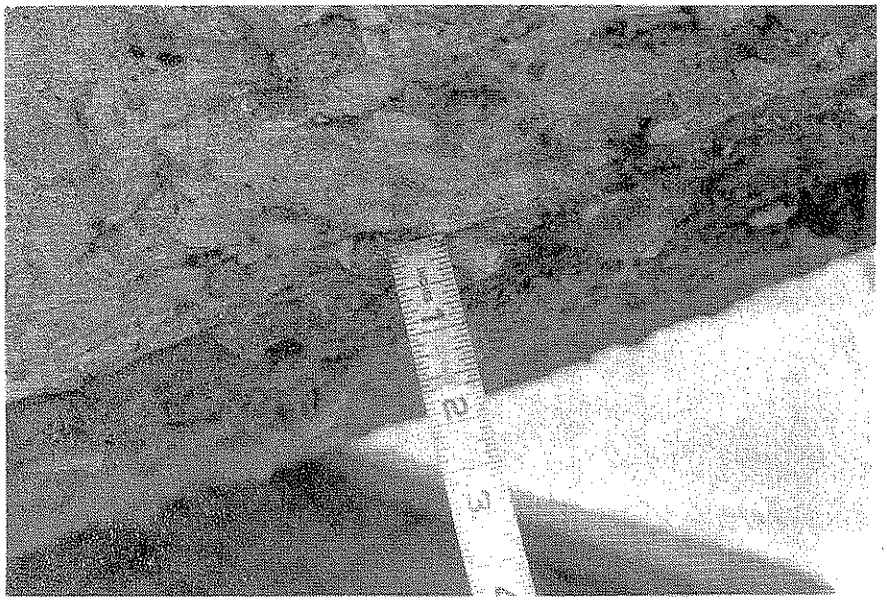
At centerline approximately 2" of subbase was cemented to the approach panel, extending for 9' from hole "0". This tapers to approximately a 5' width 24" from the shoulder. Grout was present around all of the load transfer dowels.

Joint #8 Approach Panel:
Grout and subbase material
adhereing to underside of
panel.

Joint #11
Indicates deterioration of concrete below dowel bars.

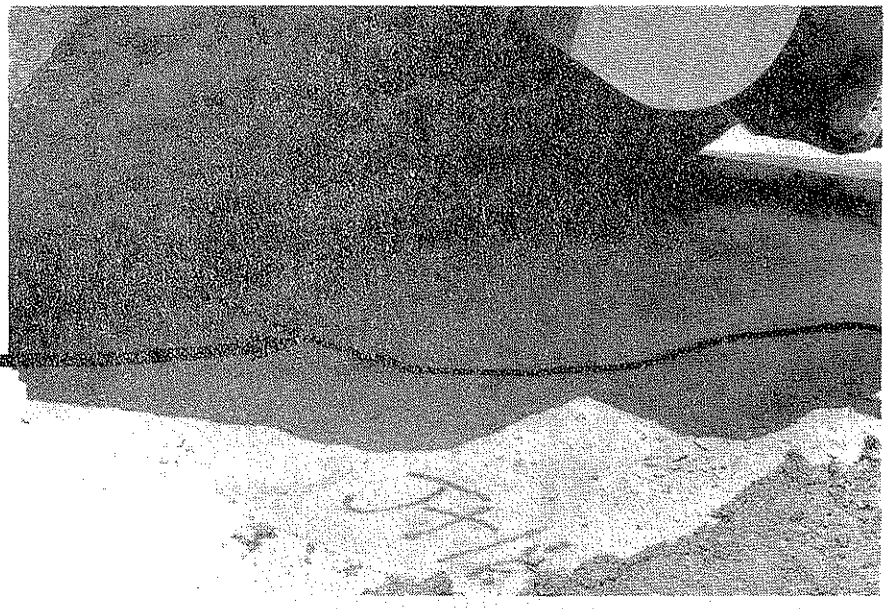
The leave panel had subbase cemented to an area near the center of the panel, beginning at about 5' from the joint. Approximately 1/2" of grout was deposited immediately under the joint.

Joint #11: ½" of grout and subbase material adhereing to underside of panel.

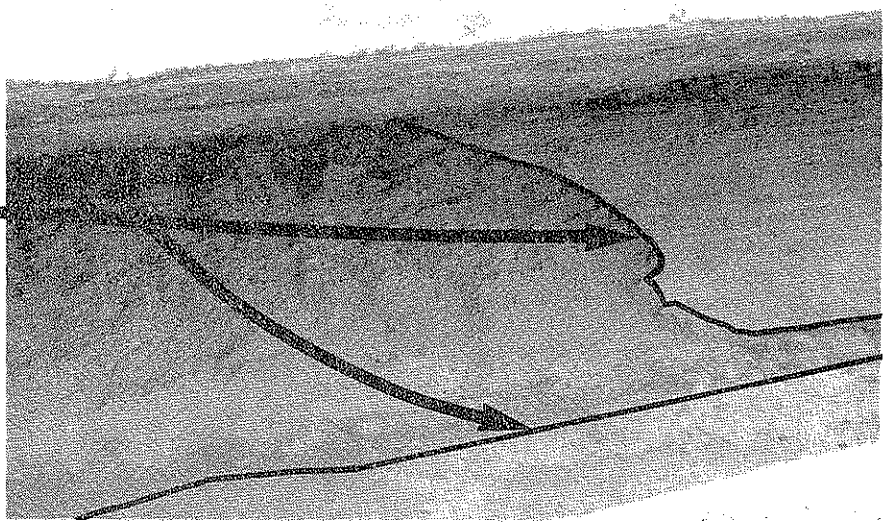
Crack #12 Leave Panel

The leave panel had a 3" thick layer of cemented subbase extending uniformly from the crack to approximately 6' from the crack. No cemented subbase was present throughout an 18" area adjacent to the shoulder. The three injection holes adjacent to the shoulder resulted in a 12" wide, 4" thick, "bar" of cemented subbase adhering to the slab.

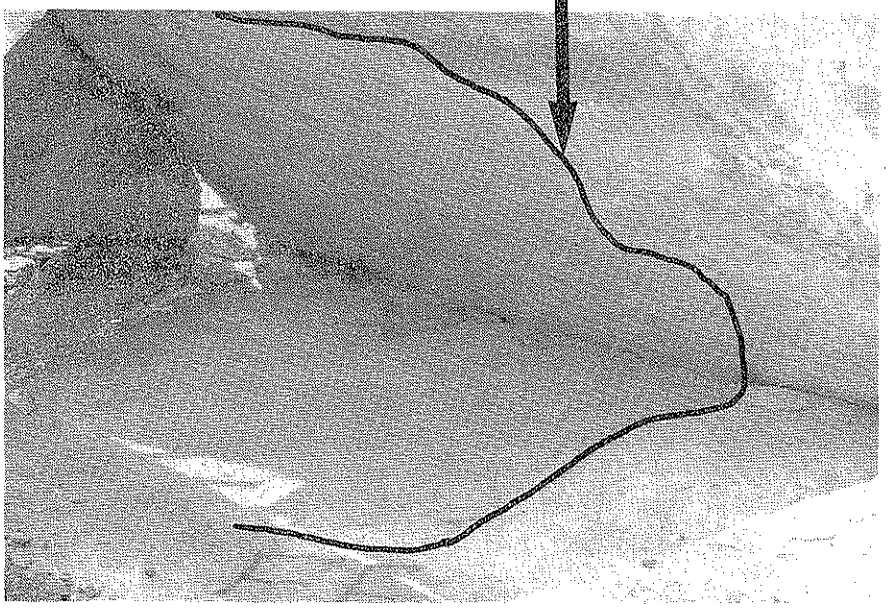
The approach panel of joint 13 had a thin grout covering on the subbase extending approximately 2' from the joint. Grout had intruded the joint and had filled the open areas around the dowel bars.

Joint #13 Approach Panel
Grout and subbase material adhereing to underside of panel.

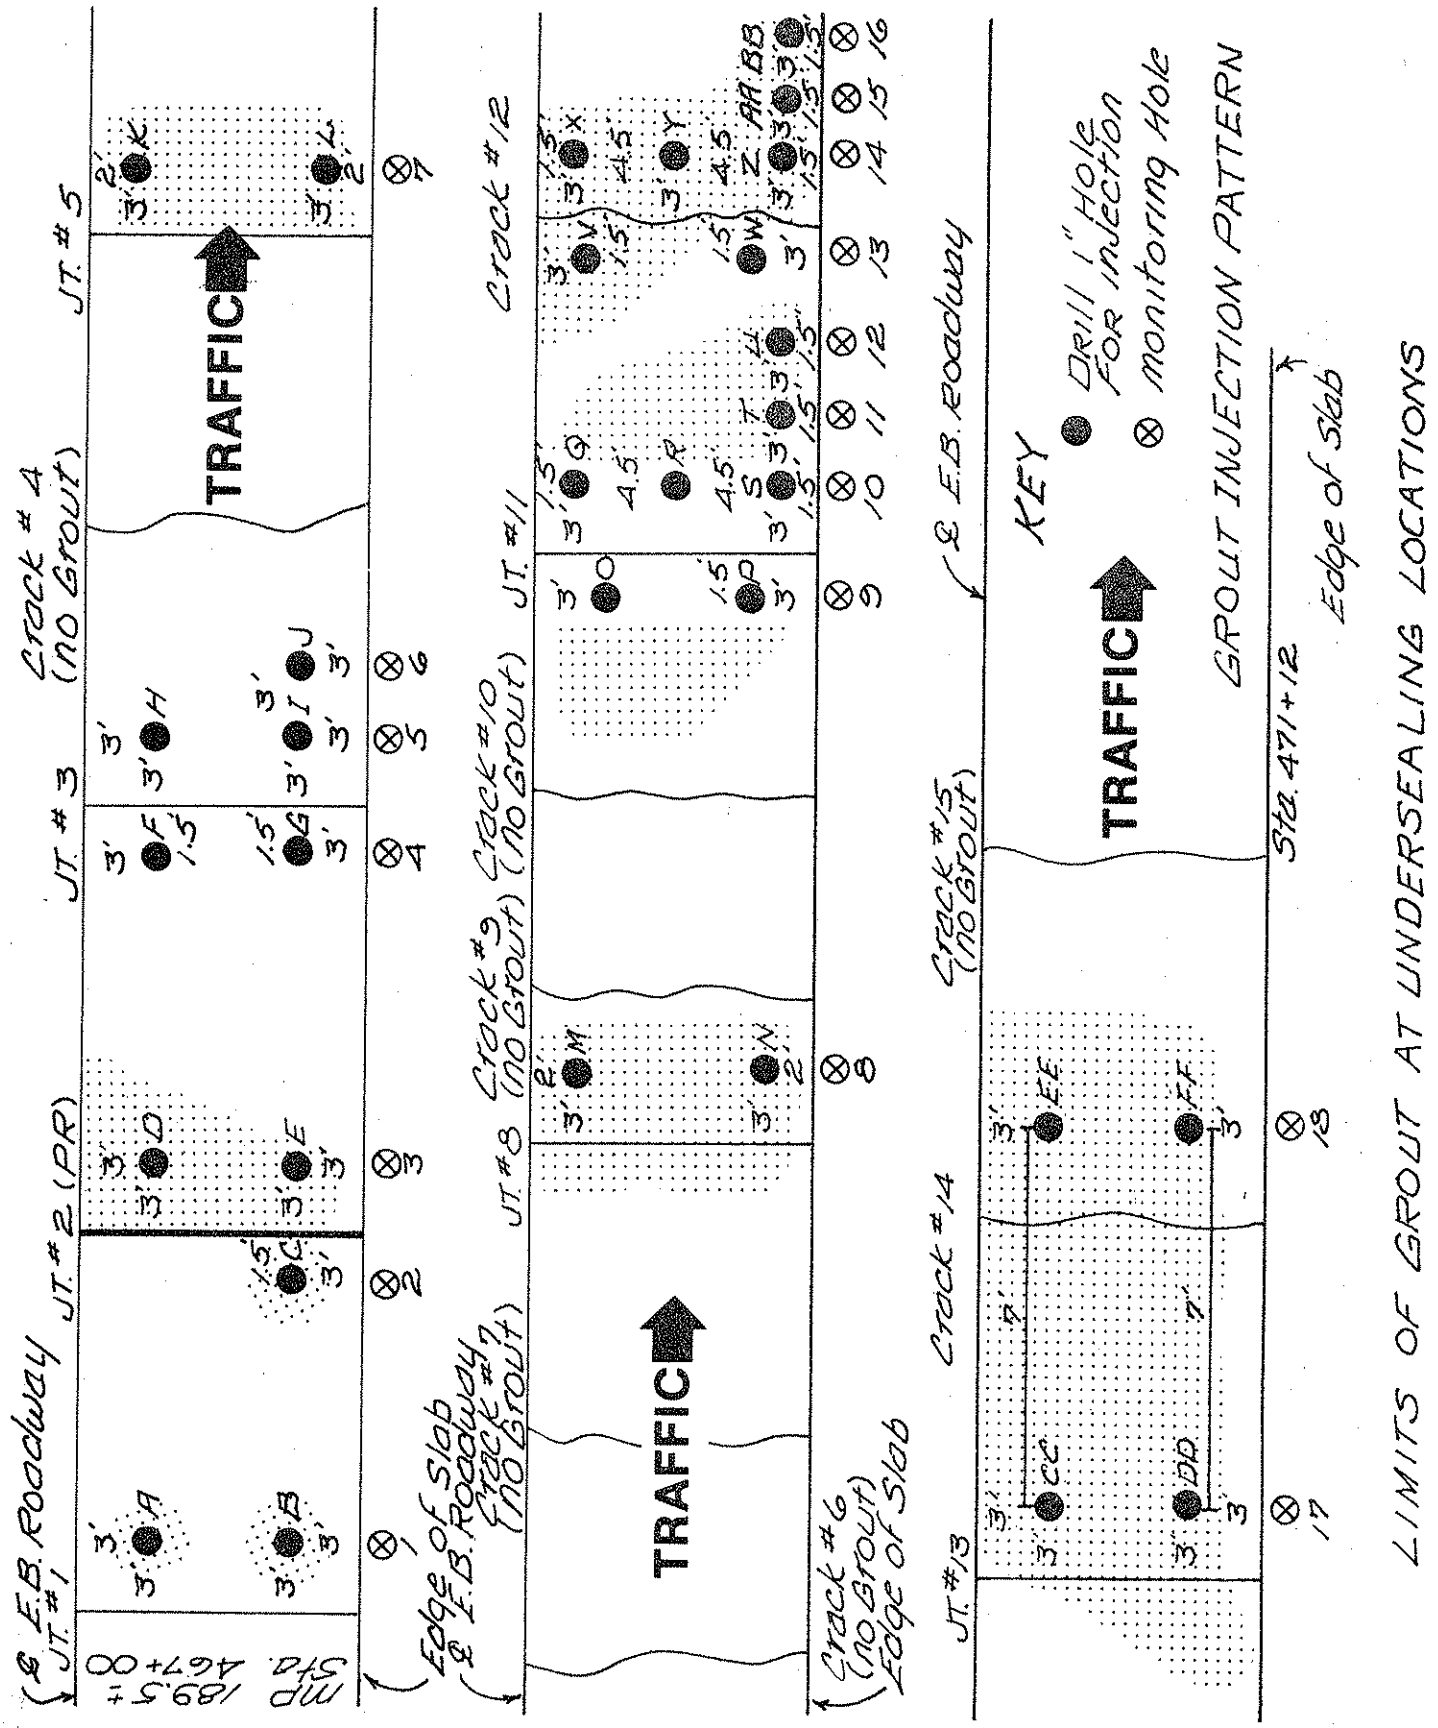
FIGURE 1

Seven joints and two mid-panel cracks were undersealed to evaluate the effectiveness of various injection hole patterns. Figure 1 shows the approximate grout spread at each location.

Void areas appeared at either side of the joint or crack. Voids under the approach panels were generally located very close to the joint or crack. The voids under the leave panels were more extensive, and extended greater distances from the joint or crack. These voids were most extensive along centerline and at mid portions of the panels adjacent to the joint or crack. The void zone began near the joint or crack and was more prominent approximately 3 ft. into the leave panel (see Figure 1, Appendix C.)

- The recommended hole pattern would consist of one hole in the approach panel. This hole would be placed 1.5' from the joint or crack and 4' to 8' from centerline. Two holes would be placed in the leave panel. These holes would be 3' from the joint or crack and 3' from the panel edges. The holes must extend at least 2" below the underside of the pavement. The holes would be 1" in diameter to minimize spalling at the bottom of the slab which could inhibit grout injection. When subdrains are present, monitoring holes (pressure relief hole) should be placed in the shoulder against the pavement edge. These holes should penetrate the porous backfill of the subdrain system.
