Performance Evaluation of Concrete Pavement Granular Subbase—Pavement Surface Condition Evaluation

Final Report
July 2008

Sponsored by
Iowa Highway Research Board
IHRB Project TR-554

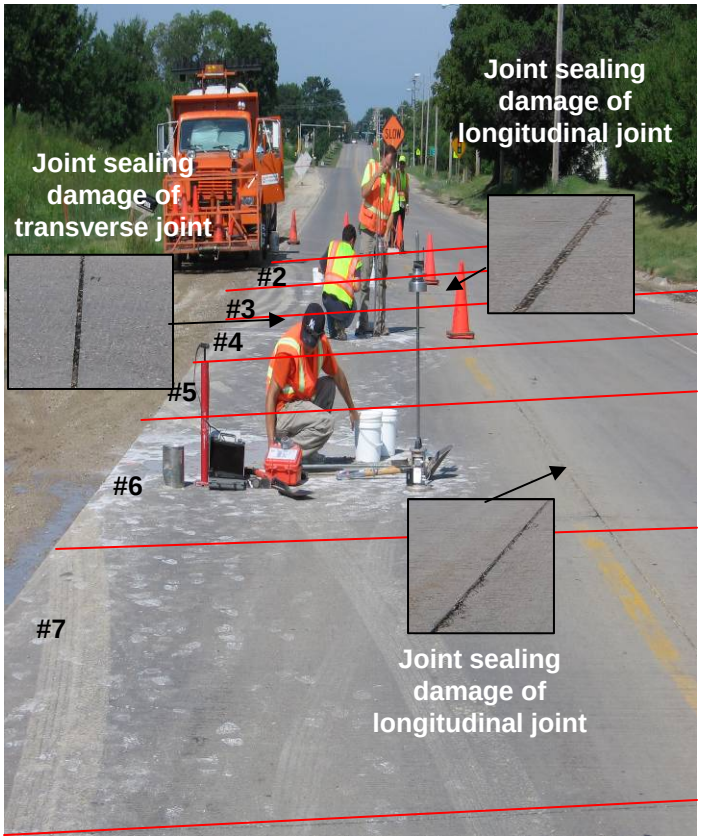
(a) Overall surface distress condition from slab #2 to #7

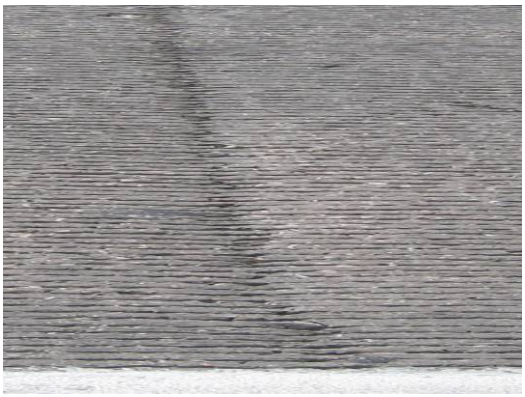
(a) Lane to shoulder separation at slab #2

(b) Transverse cracking at slab #5

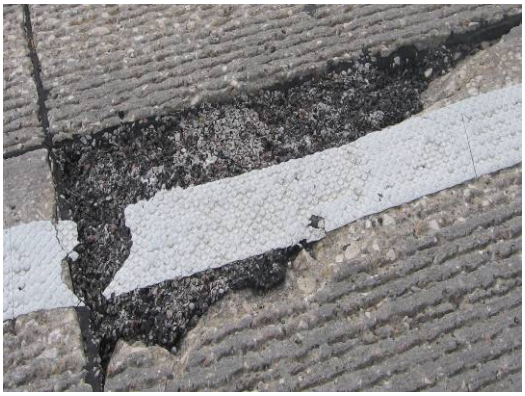
(c) Lane to shoulder drop-off at slab #6

(d) Patch at slab #13

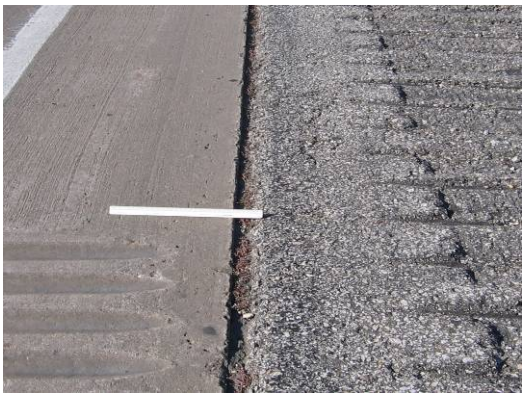
(c) Lane to shoulder separation at slab #17

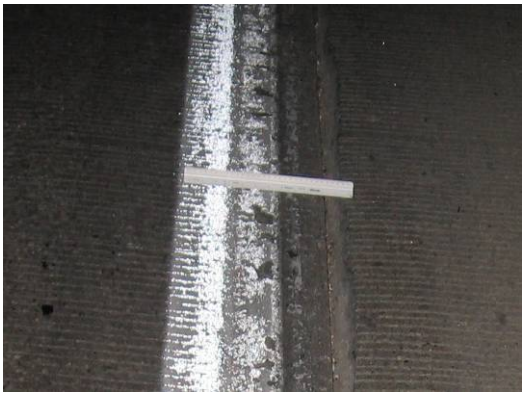
(c) Popout at slab #3

(d) Lane to shoulder separation at slab #9

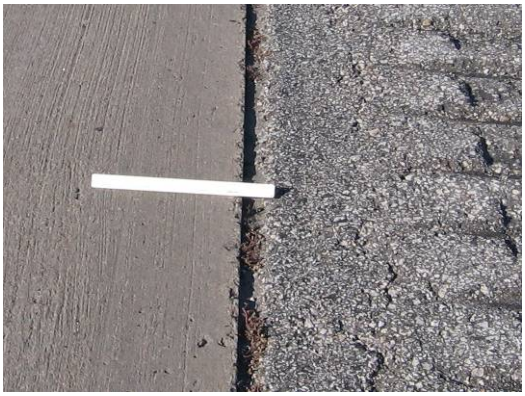
(d) Lane to shoulder separation at slab #18
