# Thermoset Composite Concrete Reinforcement

Iowa Department of Transportation  
and  
Iowa Highway Research Board

Project Number: HR-325

Part 2, final  
**report**  
Engineering Research Institute  
Iowa State University

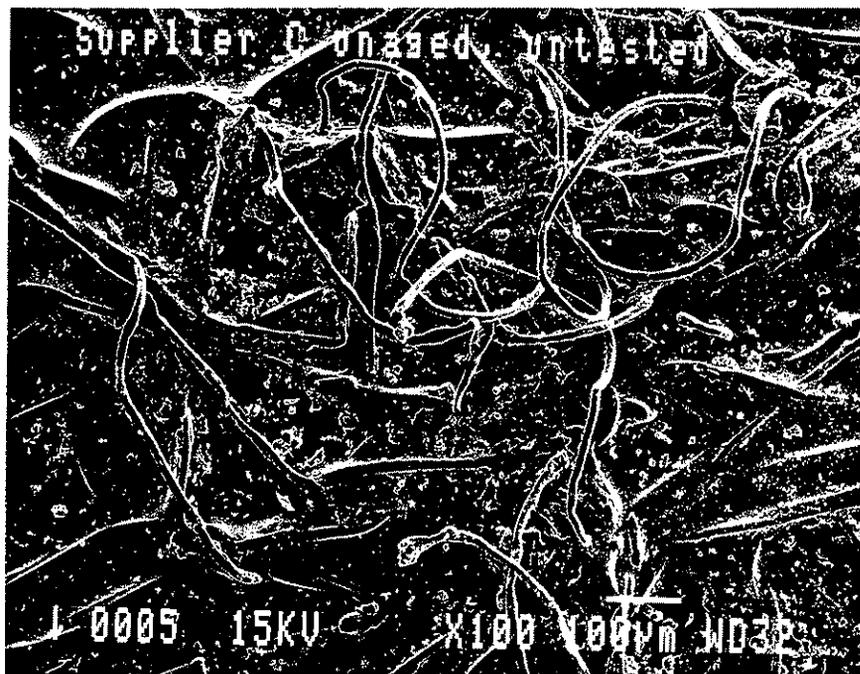
Figure 3.11. Surface microstructure of an unaged and untested C-FC-P rebar parallel to the long direction
