MEASUREMENT OF ICE SCRAPING FORCES ON SNOW-PLOW UNDERBODY BLADES

Iowa Department of Transportation Project HR 372

Final Report

IIHR Technical Report No. 385

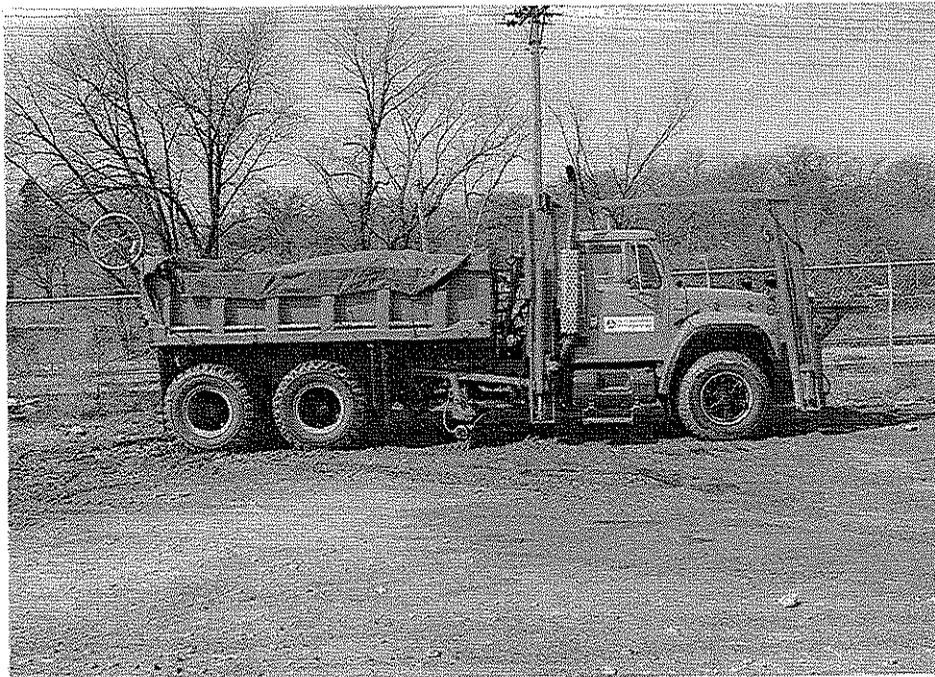
Figure 1 IDOT truck used in conducting the tests

A. Underbody Plow. Tests were performed on a 1983 International Fleetstar S-1900 25 ton gross vehicle weight (GVW) dump truck on loan from the Iowa Department of Transportation (IDOT). The truck was fitted with an underbody plow which is located between the front and rear axles (see Figure 1). The underbody plow can be controlled by four levers, which are located in the cab of the truck. The levers control the two main cylinders, which provide the right and left download force, the blade angle and the blade attack angle. The benefit of using an underbody plow is the large download force it can apply to the ice. This download force results when a portion of the truck's weight is

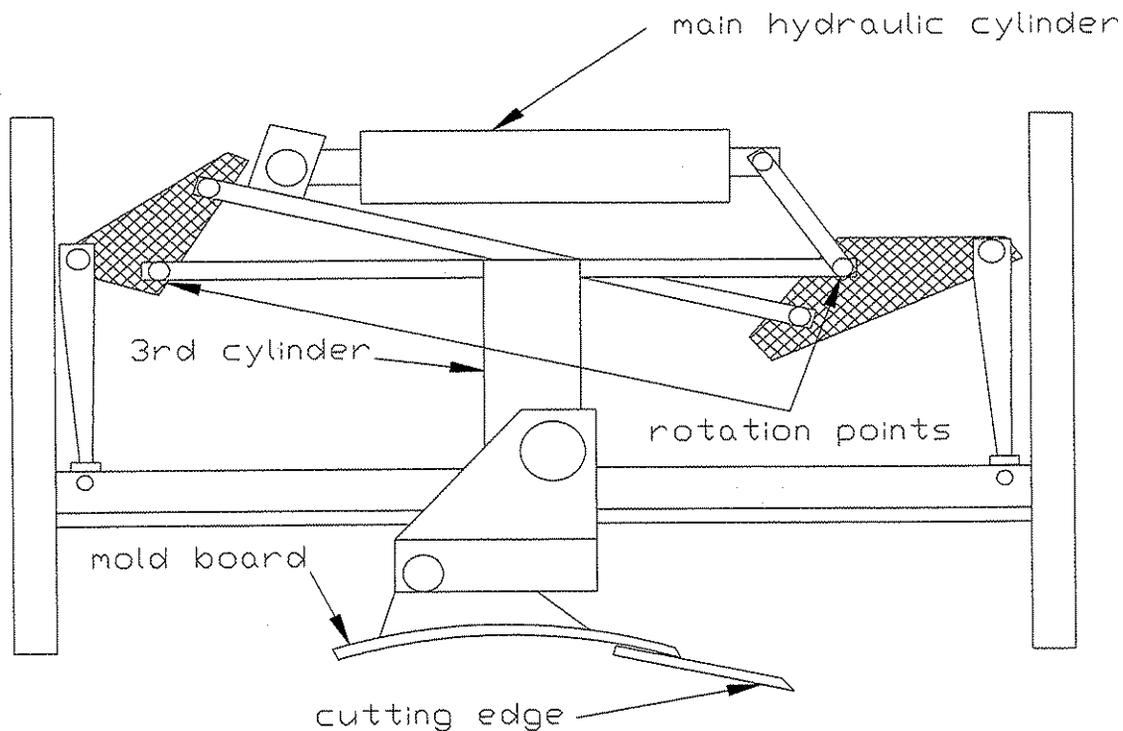
Figure 2 Side view of underbody plow

Due to irregularities that may exist on the roadway, the truck was equipped with a shock accumulator. When the truck encounters an irregularity on the roadway the cutting

edge will rotate back. This rotation diminishes any damage that might occur to either the roadway or the underbody. The hydraulic fluid that is forced out of the cylinder is collected in the shock accumulator. The truck operator may also adjust the attack angle of the snow blade. The attack angle is defined as the angle the cutting edge makes with the perpendicular to the direction of travel as shown in Figure 4. Adjusting the attack angle lets the truck operator direct the scraped ice and snow to either the left or right side of the truck.

2. Cutting Edges. The cutting edge or snow blade was bolted to the mold board. The mold board is shown in Figure 2. The research conducted was carried out using four different cutting edges. The first was a carbide insert cutting edge manufactured by Pacal Blades. This cutting edge consisted of two sections with each section being $3/4 \times 6 \times 48$ inches ($1.9 \times 15.2 \times 121.9$ cm). The geometry of this cutting edge is shown in Figure 5. This type of cutting edge was also tested in project HR 334. This cutting edge was used to provide a control between the tests conducted in the present research and those conducted in HR 334. However, there were some differences between the two

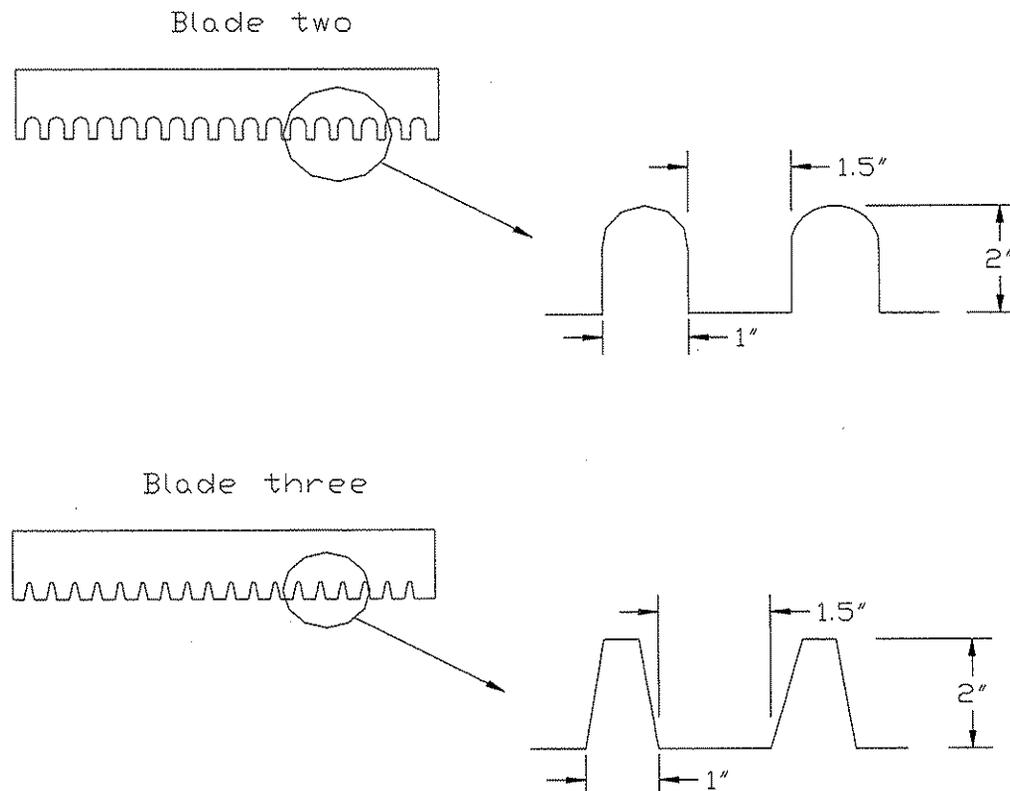
Figure 6 Geometry of blade two and three

consisted of two sections, but each section was $3/4 \times 8 \times 48$ inches ($1.9 \times 20.2 \times 121.9$ cm). Cutting edge two and three consisted of shapes with a tooth to gap ratio of 1.5/1.0. Cutting edge two was based on an elliptical pattern while cutting edge three was based on a triangular pattern. Cutting edge four consisted of a dual blade configuration that had a tooth to gap ratio of 1.0/1.5. This dual cutting edge configuration consisted of two cutting edges bolted back to back to the mold board. The two cutting edges are horizontally and vertically offset from each other. The purpose of the horizontal offset was to reduce the amount of unscraped ice. The horizontal offset aligned the teeth of one cutting edge with the gaps of the other cutting edge. A vertical offset was required to ensure both cutting edges were in contact with the ice during tests. The offset was accomplished by altering the vertical and horizontal position of the bolt holes on each of the cutting edges. The vertical offset was 0.3 inches (.75 cm) while the horizontal offset was 1.25 inches (3.2 cm). The geometries of cutting edge two and three are shown in Figure 6 while cutting edge four is shown in Figure 7. Figure 8 shows a picture of cutting edge four to help clarify its design.

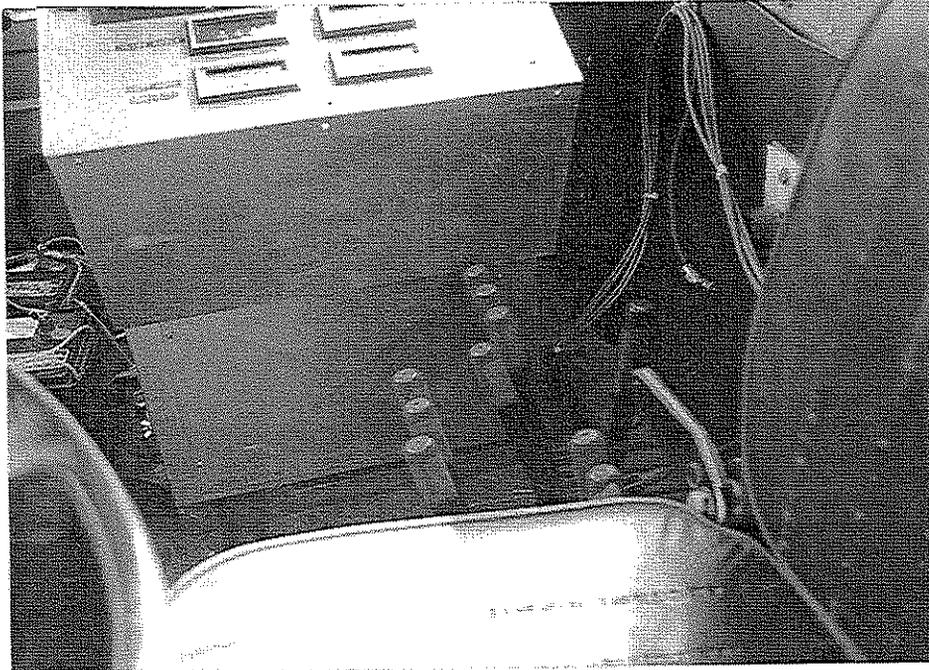
Figure 9 Computer system in support frame

The power for the computer and the sensors was provided by two car batteries located inside the cab. These batteries were required because power provided by the truck batteries produced undesired noise in the data. To allow the driver instantaneous feedback during the testing, four digital displays were installed in the computer frame. Figure 9 shows the computer setup while Figure 10 shows a close up of the digital displays. The values that were displayed were the current blade angle, the two download forces and the pressure in the 3rd cylinders.

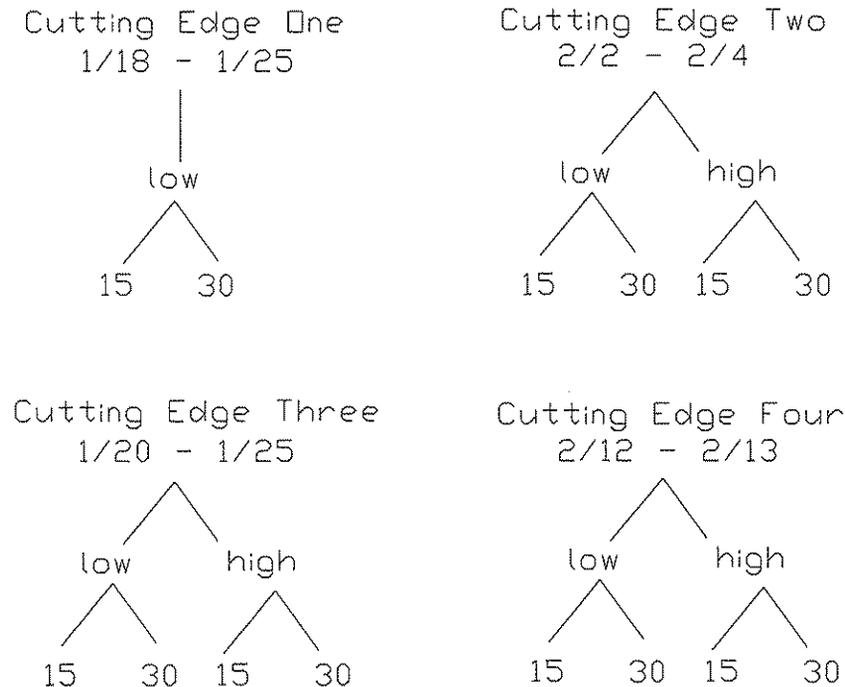
Figure 11 Testing matrix

E. Testing Matrix. The parameters studied in the tests were download force, blade angle and cutting edge configuration. Two ranges of download forces, low and high, were tested on each blade configuration previously discussed. The values of low and high download forces were 10,000 lbs and 23,000 lbs, respectively (Nixon and Frisbie 1993). The blade angle was tested at two different angles, 15° and 30°. The complete testing matrix (cutting edge, date of testing, low/high download force and blade angle) is shown in Figure 11. Cutting edge one was unable to reach a high download force because the cutting edge's height was only six inches while the other three cutting edges' height was eight inches. Since the underbody's vertical range of motion is limited to only seven inches, a blade would be unable to reach the high download force if its height was less than approximately seven inches.

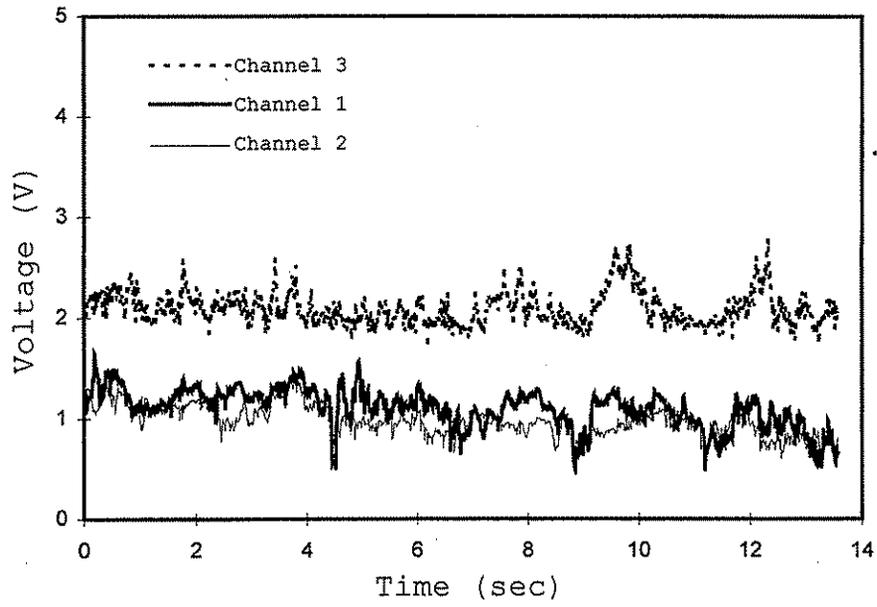
Figure 12 Data from channels one, two and three during test seven

Converting the voltage signals into the desired units was accomplished by using the calibration curves previously discussed. The two channels responsible for the vertical force were channel one and two. Thus, the vertical force was determined by summing channels one and two, then this total was converted into a force by using its calibration curve. The blade angle was determined by using the voltage signal from channel three and its corresponding calibration curve. To determine the horizontal force the following parameters were required: vertical force, blade angle and pressure in the 3rd cylinder.

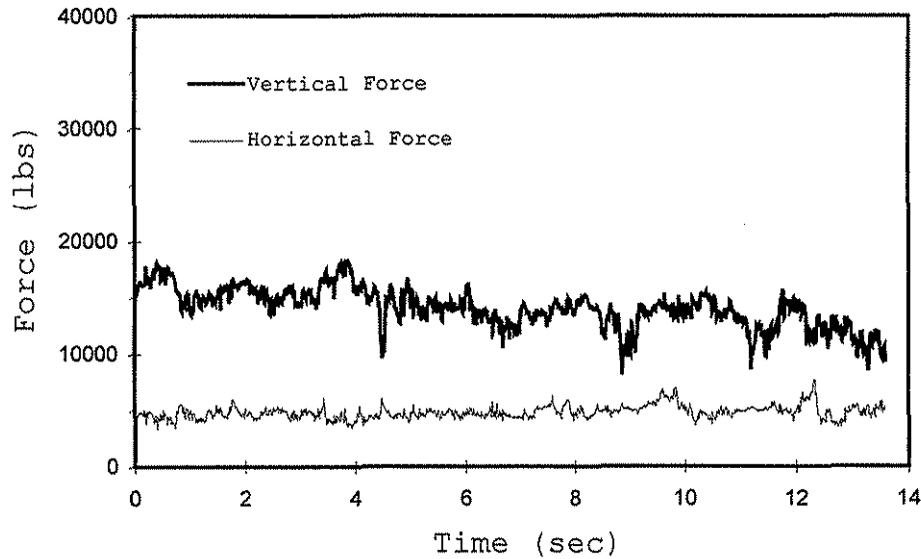
Figure 14 Vertical and horizontal forces experienced by the cutting edge during test seven

Figure 14 represents the vertical and horizontal force versus time for test seven. Figure 15 displays the blade angle for test seven.

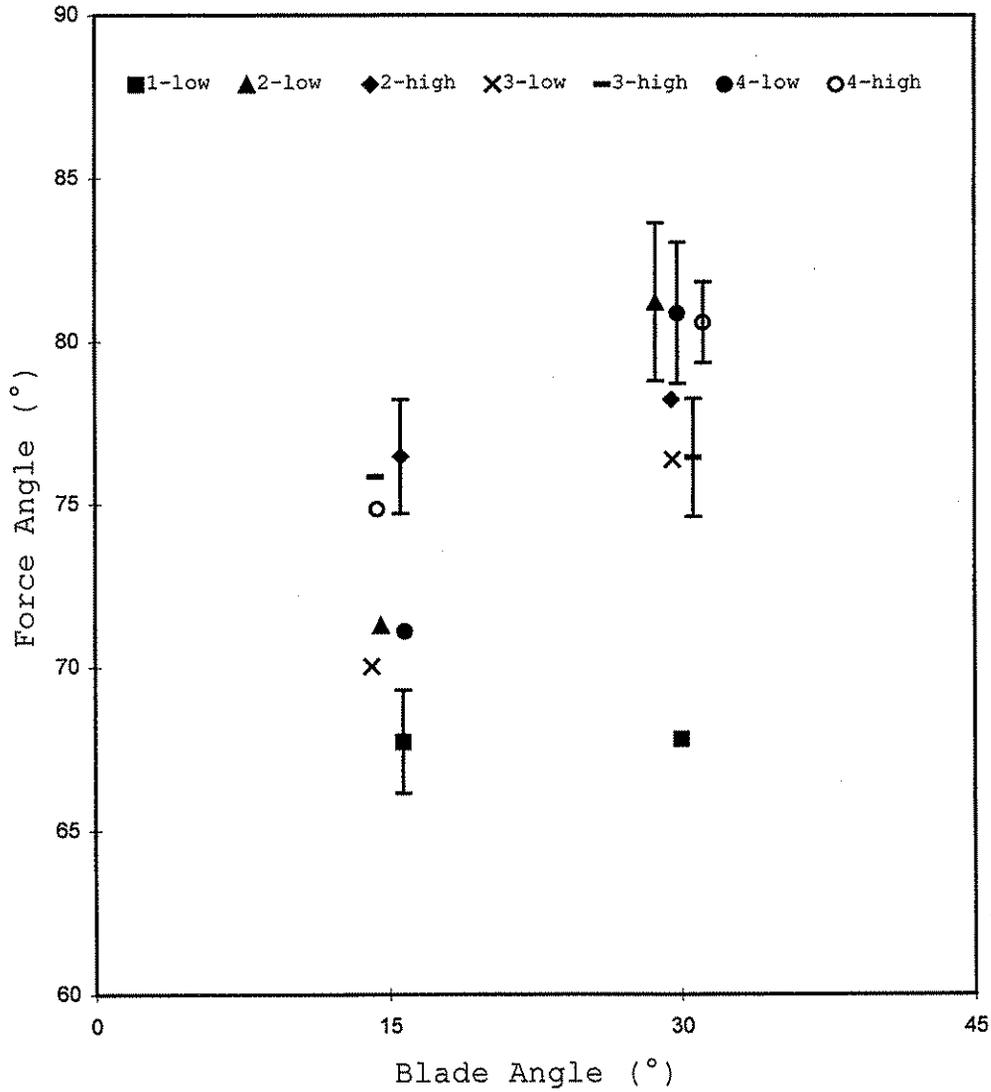
Figure 16 Force angle for all test configurations based on blade angle

when scraping ice occurs. The results for all test configurations are shown in Figure 16. The average for each testing configuration is graphed with its corresponding standard deviation (shown as a vertical bar – those points with no vertical bar had very small standard deviations). Each test was placed in either the 15° or 30° blade angle case, even though their mean values may have been slightly different. The standard deviation points out how excessive wear on a blade can effect the results. This is discussed in detail below. Figure 17 shows the force angle for all test configurations in ascending order of force angle. The test configurations in Figure 17 are described on the X-axis by blade number, blade angle and download pressure.

The results obtained for blade two were expected. For both download pressures the 15° blade angle had force angle less than the corresponding 30° blade angle. This behavior was expected because of the method used to determine the horizontal force, refer to Appendix B. This method determined the horizontal force by summing moments about a pin, which was located on the underbody. The moment arm for the vertical force significantly increased from a 15° blade angle to a 30° blade angle. The other forces included in the equation had only minor changes in their moment arms. Thus, for a 30° blade angle the larger moment arm decreased the magnitude of the horizontal force. This decrease in magnitude was a result of an significant increase in the moment produced by the vertical

force. If tests were able to be conducted at a blade angle of 0° , the force angle would be expected to be less than that obtained for a blade angle of 15° .

The standard deviation for the blade two data in Figure 16 shows a large variation in values for the low download pressure at a 30° blade angle. This may be explained by the difficulty a worn cutting edge has digging into the ice. The cutting edge was worn down quite quickly when compared to blade one. The excessive wear can be attributed to the serrated shape of the cutting edge. Blade two has only 58 inches of cutting edge in contact with the ice sheet, while blade one has 96 inches. The serrated shape of the cutting edge does increase the amount of stress the cutting edge can apply to the ice sheet. Larger stresses result in more ice being scraped from the roadway, but also increase the amount of wear on the blade. These large stresses eventually wear down the tip of the blade, resulting in an increase of cutting edge in contact with the ice. Figure 18 shows a cutting edge before and after excessive wear.

The results for force angle versus blade angle for blade four, shown in Figure 16, also followed previously discussed trends. Once again, a large standard deviation was shown for a 30° blade angle. This large scatter of data cannot be explained by wear effects (as was the case for blade 2). Blade four had 76 inches of cutting edge in contact with the ice sheet, which is 18 inches more than blades two and three. This increase prevented blade four from wearing down as quickly as blade two and three because of the decrease in stress at the tip of the cutting edge.

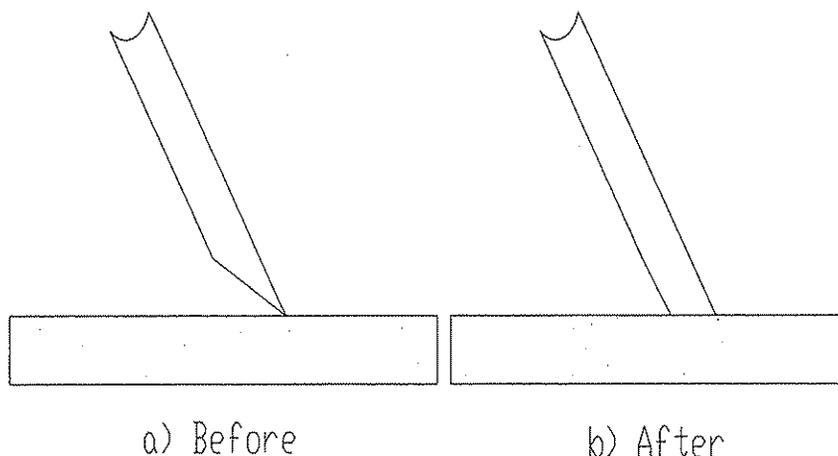
Figure 18 Wear effects on a blade at 30°

significant increase in force angle.

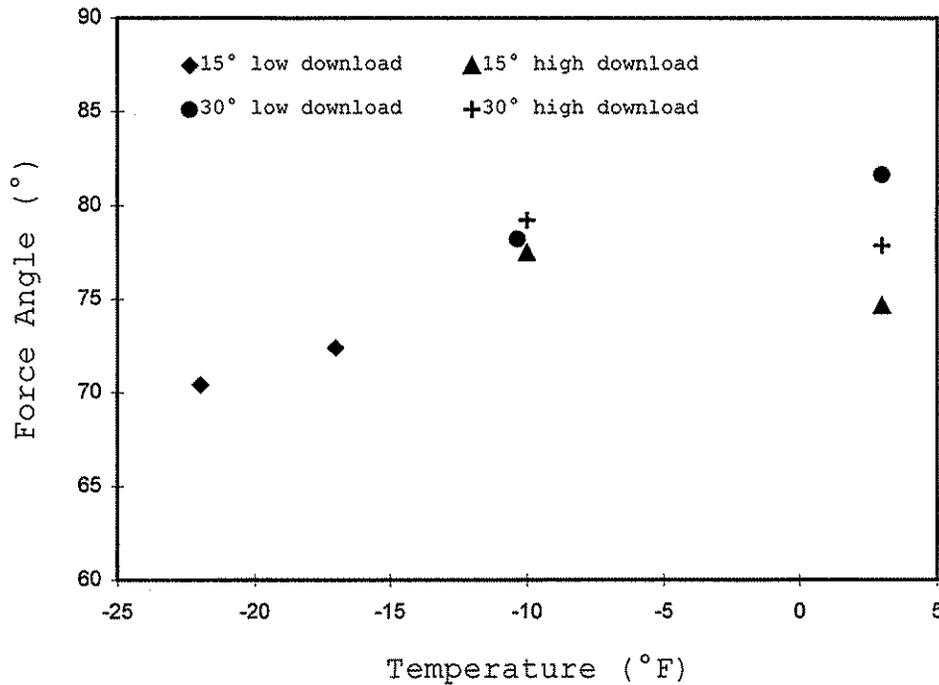
Figure 19 Air temperature effects on force angle for blade two

1. Air temperature effects on force angle. The air temperature was recorded prior to each test, using an electronic thermometer which recorded the temperature to the nearest 0.1°F (0.056°C). Plotting air temperature versus force angle shows the effects air temperature had on force angle. Conducting tests over a wide range of temperatures was not possible. Figure 19 shows a typical plot of force angle versus air temperature.

Even with the limited number of tests with varying air temperatures, there did not appear to be a relationship between air temperature and force angle. For example, Figure 19 shows two download cases that have an increase in force angle with an increase in temperature, while the remaining two download cases exhibit the opposite trend. It appears that air temperature has less effect on force angle than does download or blade angle.

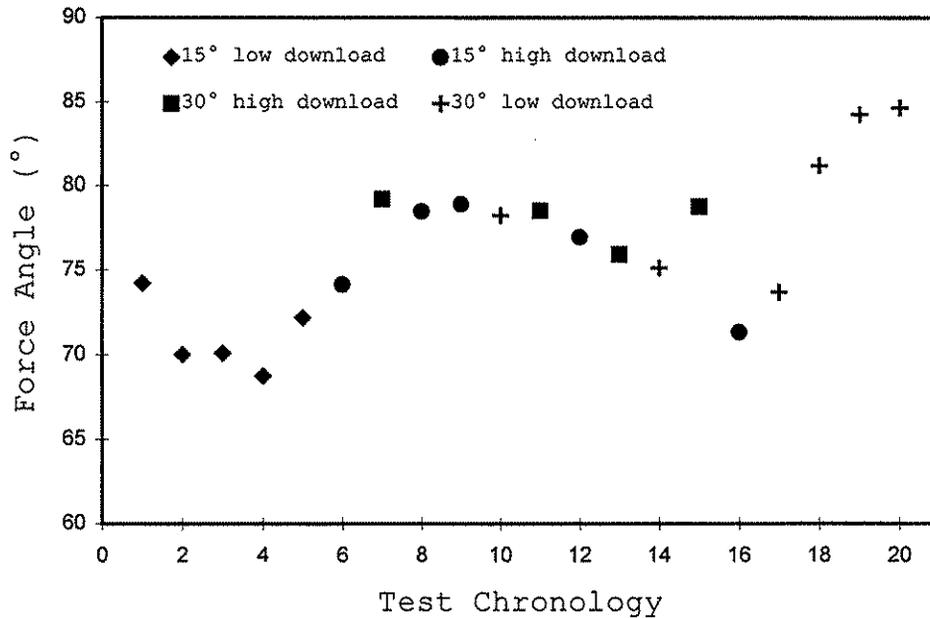
Figure 20 Effects of wear on the force angle for blade two

2. Wear effects on force angle. A variable that could not be controlled, but is very important in scraping ice, was the sharpness of the cutting edge. A sharp cutting edge has a smaller amount of surface area in contact with the ice as compared to a dull cutting edge. A sharp blade will produce a larger stress field between the cutting edge and the ice as compared to the dull cutting edge. A larger stress field will result in more ice being removed from the pavement. Blade two was the only blade that showed significant wear. The plot of the force angle in chronological order for blade two is shown in Figure 20.

The last four tests in Figure 20 did show a significant increase in force angle. This increase in force angle is a result of a decrease in the horizontal force. As more and more tests are conducted at the same blade angle, the edge of the blade eventually becomes completely flat. A flat edge (see Figure 18) produces a reduced stress in the ice. The observed smaller horizontal force is a result of the cutting edge just grazing the top of the ice sheet and not actually digging into the ice. A sharper edge leads the cutting edge to dig into the ice sheet and produce a larger horizontal force.

Figure 20 also shows how the blade angle changed from test to test for tests six through sixteen. Changing the blade angle from test to test prevents the blade tip from becoming blunt, as seen in Figure 18. Figure 21 shows how changing the blade angle helps keep a relatively sharp point on the cutting edge.

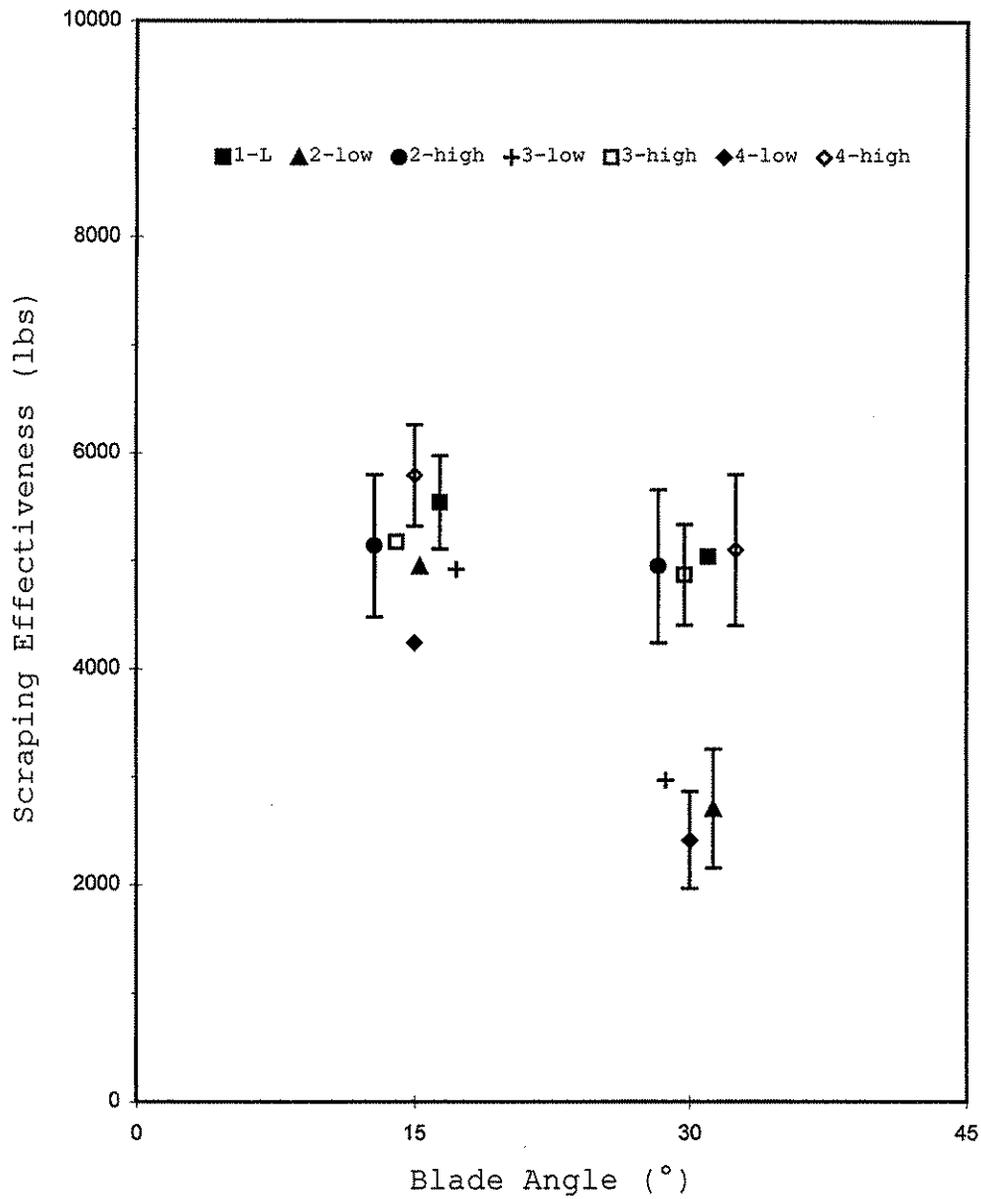
Figure 22 Scraping effectiveness for all blade configurations based on blade angle

It is expected that the scraping effectiveness would decrease with an increase in blade angle, assuming a constant download force. The results for blade 1 (see Figure 22) show a slight decrease in scraping effectiveness. This decrease in scraping is much less than that observed for the other three blades.

Figure 22 also shows the results for blade two though blade four. All three blades show a decrease in scraping effectiveness when comparing the 15° low download results to the 30° low download results. The figure also show a slight decrease in scraping effectiveness when comparing the 15° high download results to the 30° high download results. The slight decrease in scraping effectiveness for both high download cases may be the result of the difficulty of obtaining the same high download force for each test. The high download forces ranged between 18,000 lbs and 27,000 lbs while the low download forces ranged between 9,000 lbs and 14,000 lbs. The difference among the high download forces may distort any correlation that may exist between the 15° and 30° high download cases. If this difference could be minimized then a correlation similar to the one for the low download tests would probably be found.

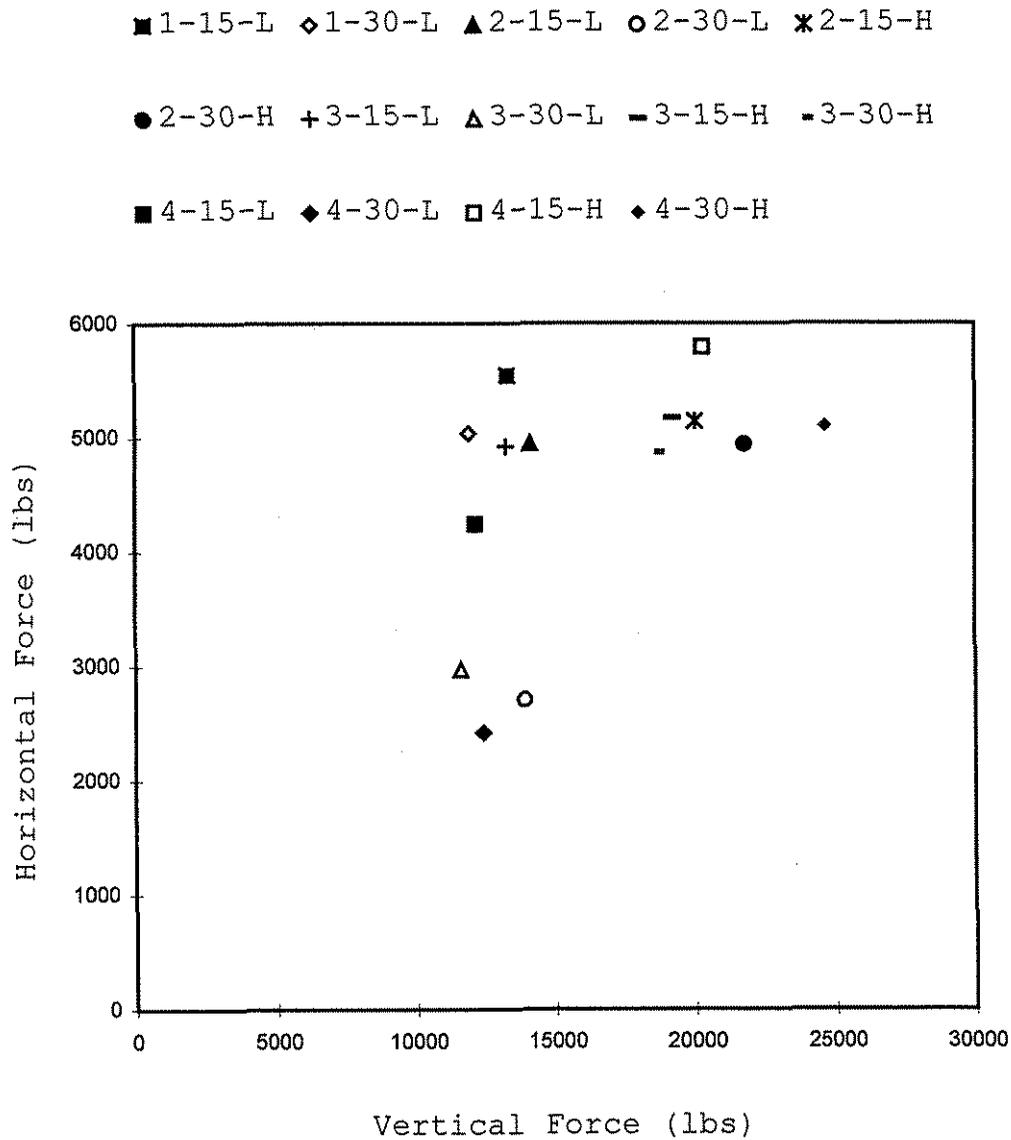
Figure 24 Average results for all testing configurations

below the others. Figure 24 shows a plot of horizontal force versus vertical force for all test configurations.

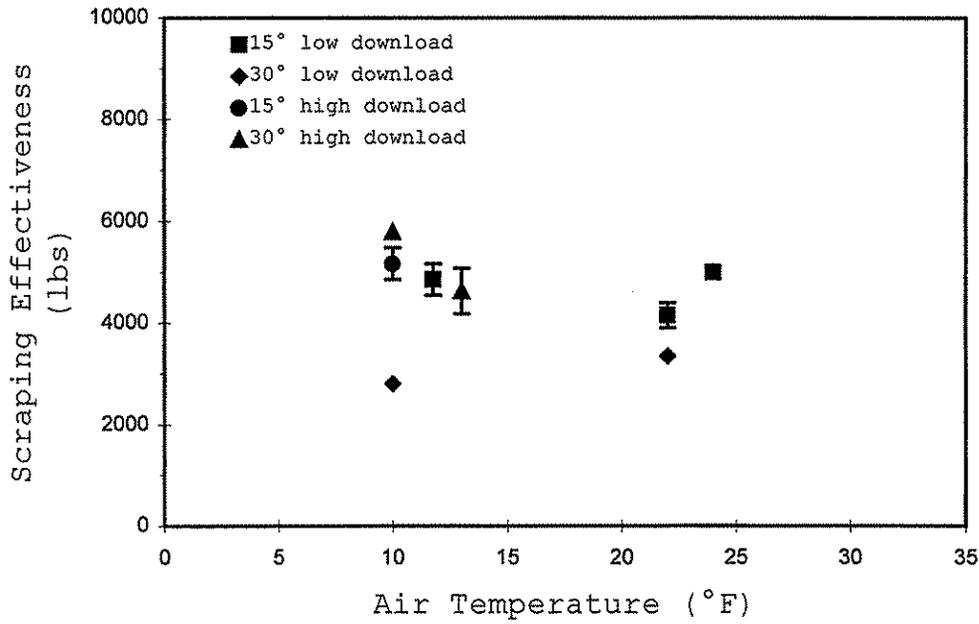
Figure 25 Air temperature effects on scraping effectiveness for blade three tests

1. Air temperature effects on effectiveness. To investigate the effects of air temperature on scraping effectiveness, these two parameters were plotted against each other. Figure 25 show the typical result of air temperature on the average scraping effectiveness for a given blade.

Again, as for the force angle, there does not appear to be a correlation between scraping effectiveness and air temperature.

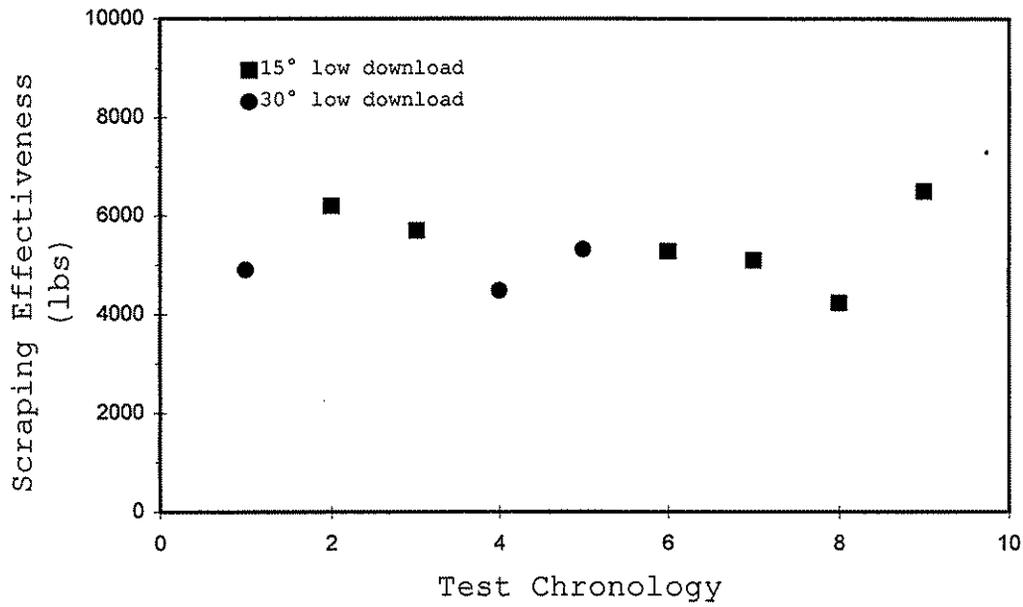
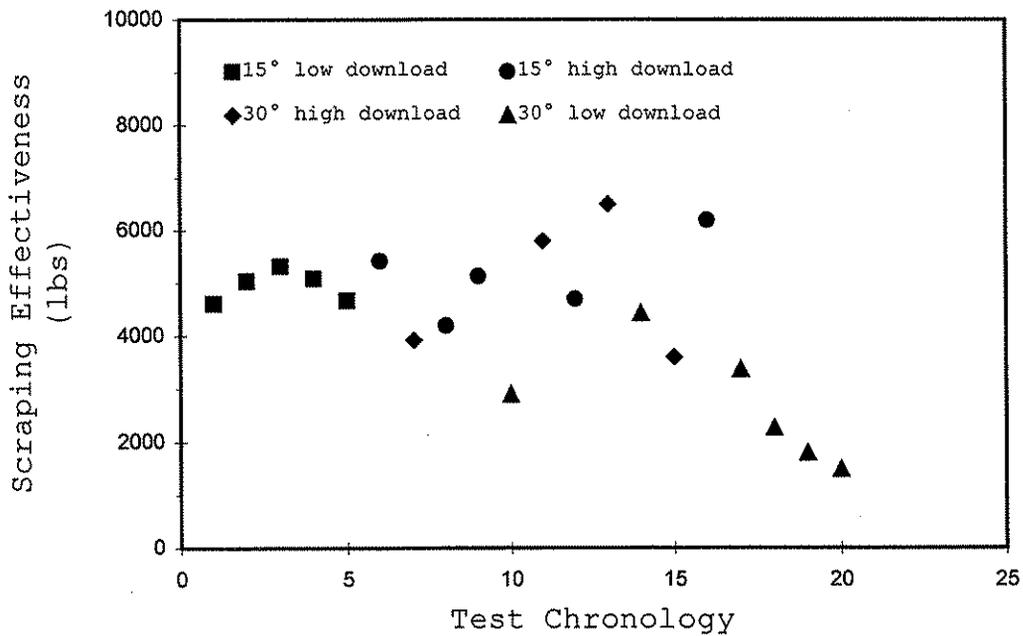
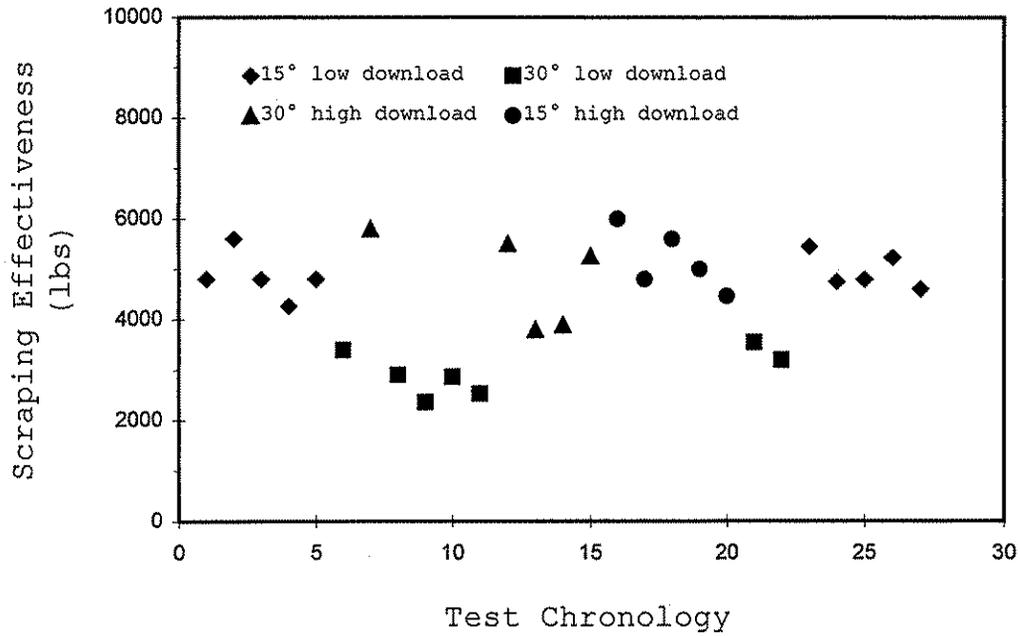
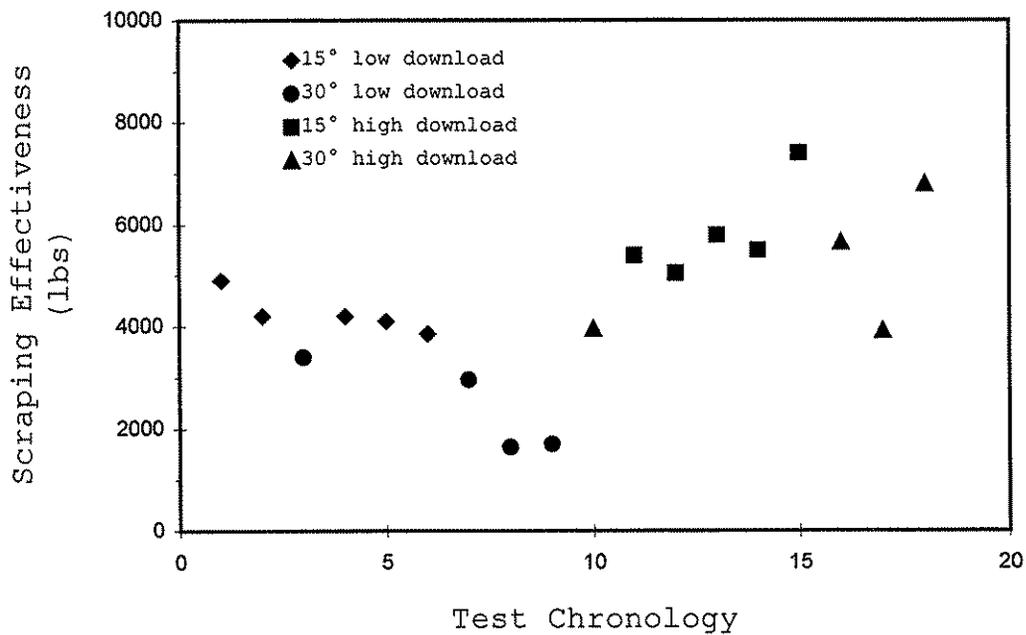
2. Wear effects on effectiveness. The scraping effectiveness was plotted versus the test chronology for each blade in Figure 26 through Figure 29. These figures attempt to show the effect of wear on the scraping effectiveness.

Two general statements can best summarize the results from Figure 26 through Figure 29. Firstly, Figure 27 shows some wear effects for the tests conducted at 30° blade angle with a low download pressure. The horizontal load for tests 17 through 20

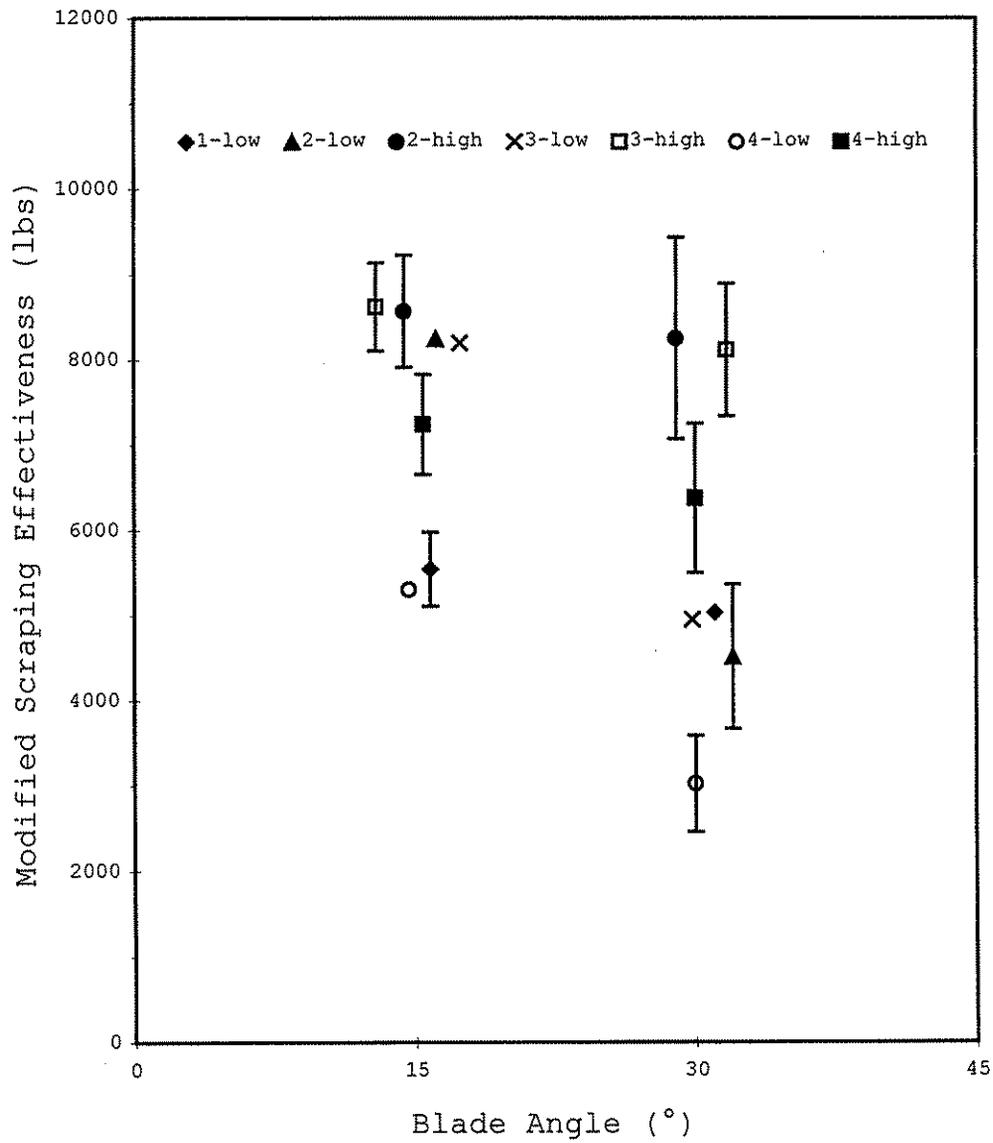
Figure 30 Modified scraping effectiveness for all blade configurations based on blade angle

Figure 30 shows the effect blade angle has on the modified scraping effectiveness for all four blades. This figure shows the same correlation, a decrease in modified scraping effectiveness with an increase in blade angle, that was previously discussed for the scraping effectiveness.

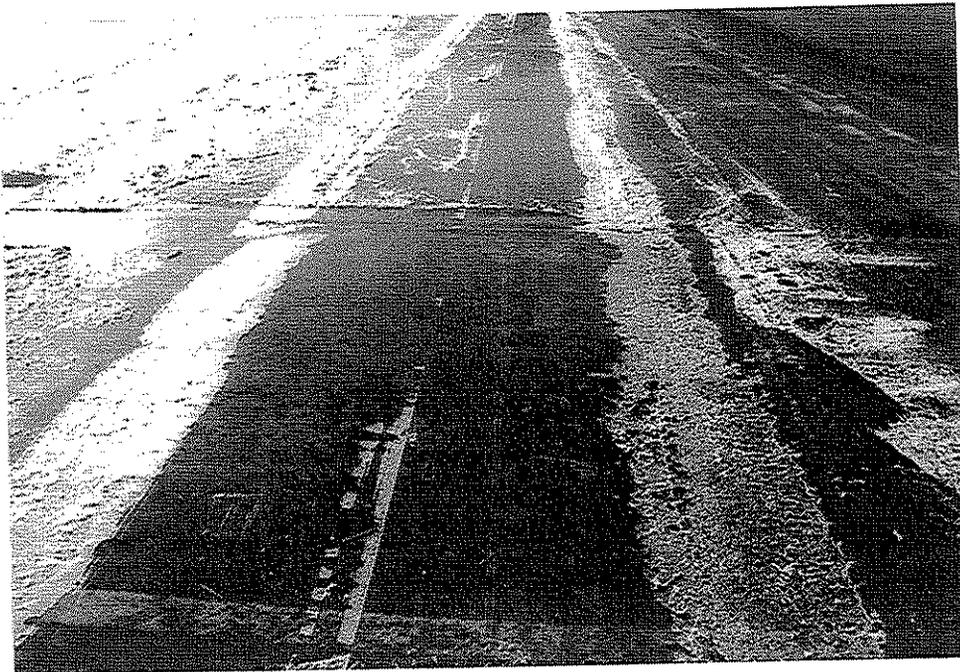
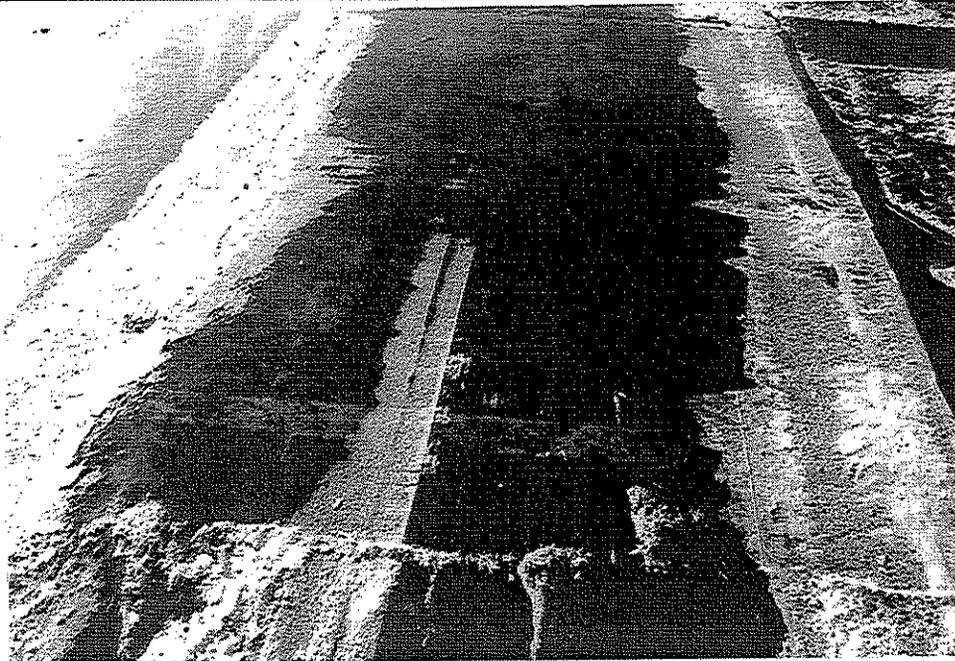
Figure 33 Ice sheet after testing with blade one

Figure 33 and Figure 34 show the visual results for blade one. These figures show that only the left and right side of the ice sheet get scraped by blade one. This result was typical of every test with blade one. The amount of ice scraped varied between 0.13 in. and 0.25 in. The two sections of the ice sheet that were scraped line up perfectly with

the location of the 3rd cylinders on the underbody. The middle of the blade must bow upwards (perhaps as a result of damage), because no ice was scraped in that region.

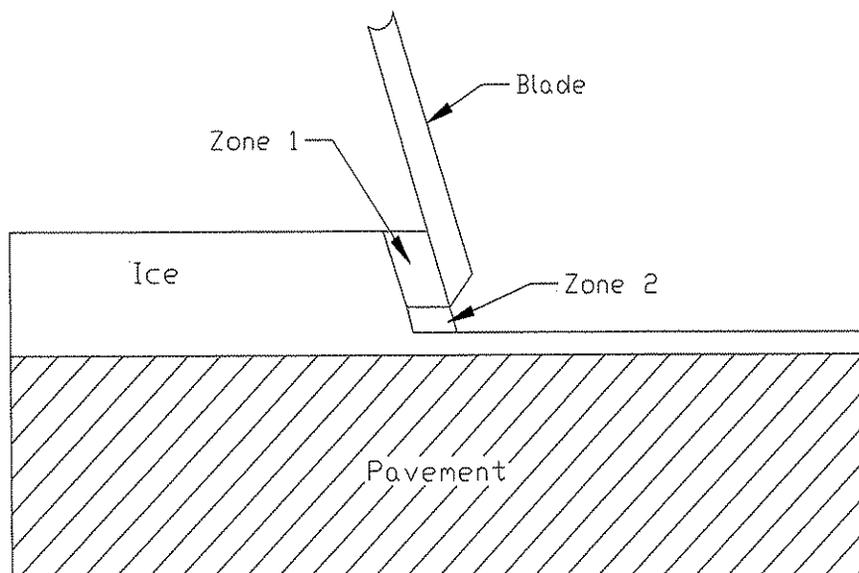
Figure 41 Two zones of ice failure produced by an underbody plow

B. Standard Blade. Prior research (Nixon and Frisbie 1993) found that, when ice is being scraped by an underbody plow, there are two failure zones. This finding was verified by the tests conducted in this project. The two zones of failure are shown in Figure 41.

The first zone represents ice that is fractured in front of the blade. This fracture is caused by the horizontal force applied to the ice. It causes ice fragments to be ejected into the air in front of blade, as can be seen in Figure 42.

The second zone represents ice compressed by the blade, then is ejected behind it. This zone is compressed by the vertical force being applied to the ice by the cutting edge. Figure 43 shows the underbody scraping ice and ice being ejected from zone two.

Ice typically fractured in zones one and two, shown in Figure 41, is fractured in a similar manner. The serrated shape introduces a new zone of ice fracture. Grooves left behind in the ice sheet were smaller than the serrated gap, thus parts of the ice sheet must be fracturing alongside the serrated teeth of the blade. Zone three will be designated as the zone where ice fractures alongside the serrated teeth of the blade. Zone two and zone three are shown in Figure 44. This is only a preliminary description and requires further development.

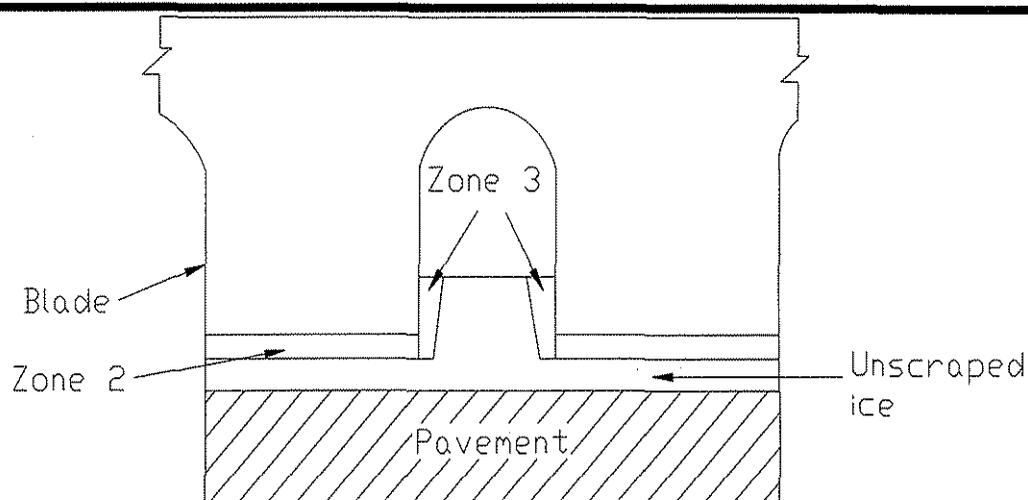
Figure 44 Front view of serrated blade showing zones two and three of fracture

C. Serrated Blade. Serrated blades experience a different type of fracturing due to the shape of the blade. The main difference between the two shapes is the serrated blades' inability to remove ice across the entire sheet of ice. Ice that lies in the path of the serrated gaps is not removed from the ice sheet.

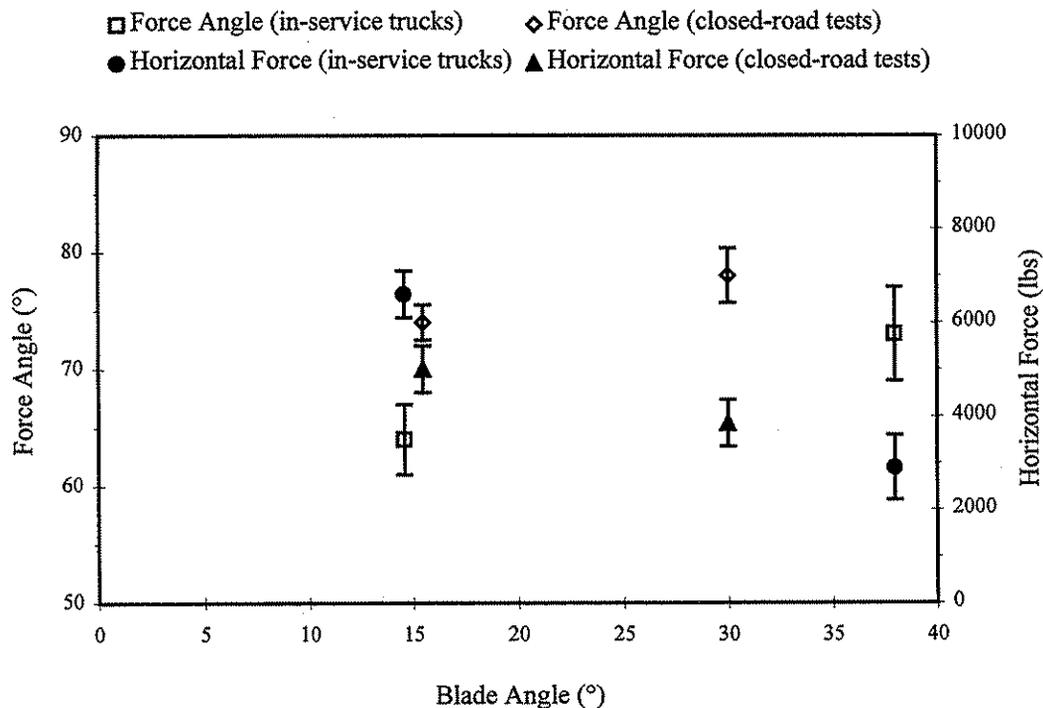
Figure 45 Results of blade angle effects

Figure 45 shows the results of the data (averages and standard deviations) after being split into two different blade angle groups (15° and 38°). To ensure a significant break between the two blade angle groups, all tests with an average blade angle between 23° and 33° were not included in the results as shown in Figure 45. 15° and 38° represent the average of the remaining tests. Also shown in Figure 45 are the results from the closed-road tests.

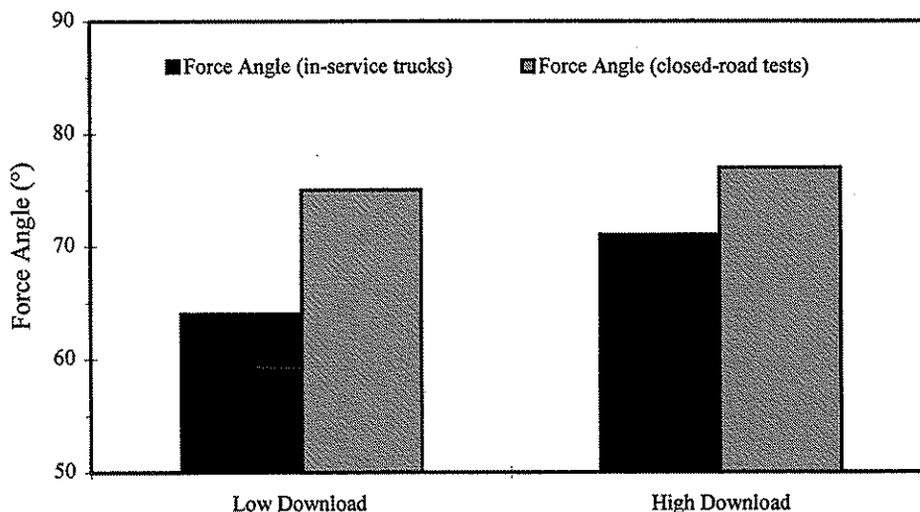
Figure 46 Download effects on force angle

Figure 46 shows the effects of download force on the force angle for the results collected by the in-service trucks and the previously discussed results. For the in-service trucks the low download case had an average vertical force of 9,000 lbs and the high download case had an average of 20,000 lbs, as compared with 10,000 lbs and 23,000 lbs for the closed-road tests. Figure 46 shows that the force angle clearly increases from the low to the high download case for the in-service trucks. Again this mirrors the trend observed in the results of the closed-road tests.
