MEASUREMENT OF ICE SCRAPING FORCES ON SNOW-PLOW UNDERBODY BLADES

Iowa Department of Transportation Project HR 372

Final Report

IIHR Technical Report No. 385

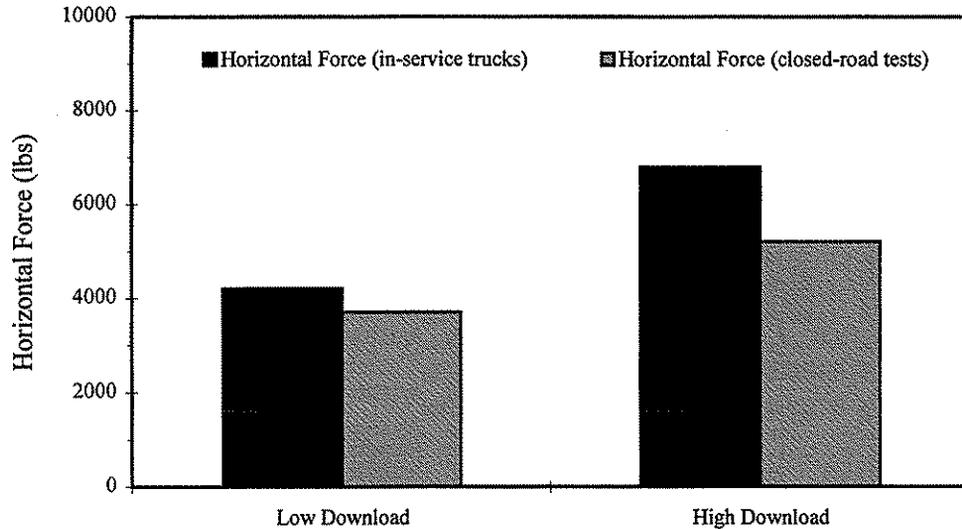
Figure 47 Download effects on horizontal force

Figure 47 shows the effects of download force on the horizontal force. Once again, the figure includes the results from both the in-service trucks and from the closed-road tests. Looking at the results obtained by the in-service trucks, it is apparent that the horizontal force increases when the download force is increased. Again, this correlation

also existed in the results of the closed-road tests.

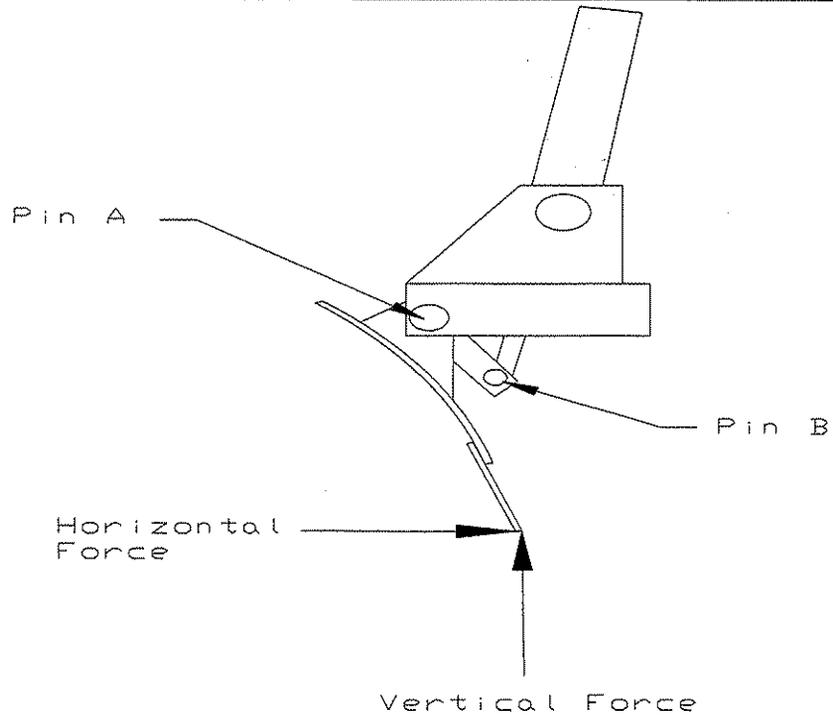
Figure 48 Descriptive placement of Pin A and Pin B relative to the horizontal and vertical force

The third moment arm is not as easily determined as the other two. The distance between pin A and pin B was determined by analyzing the geometry of the mold board; later it was rechecked by measuring the distance directly from the truck. The distance between pin A and pin B was determined to be 5.8 in. Pin B is rigidly attached to the mold board, thus any changes in the blade angle will also change the position of pin B

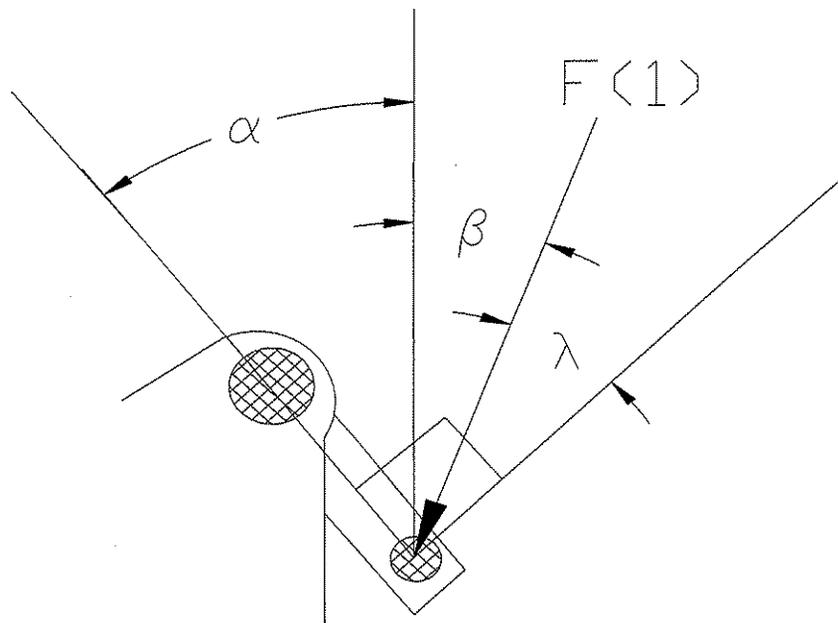
Figure 51 Angles required to determine moment produce by $F(1)$

$$\lambda = 90 - \alpha - \beta \quad (2)$$

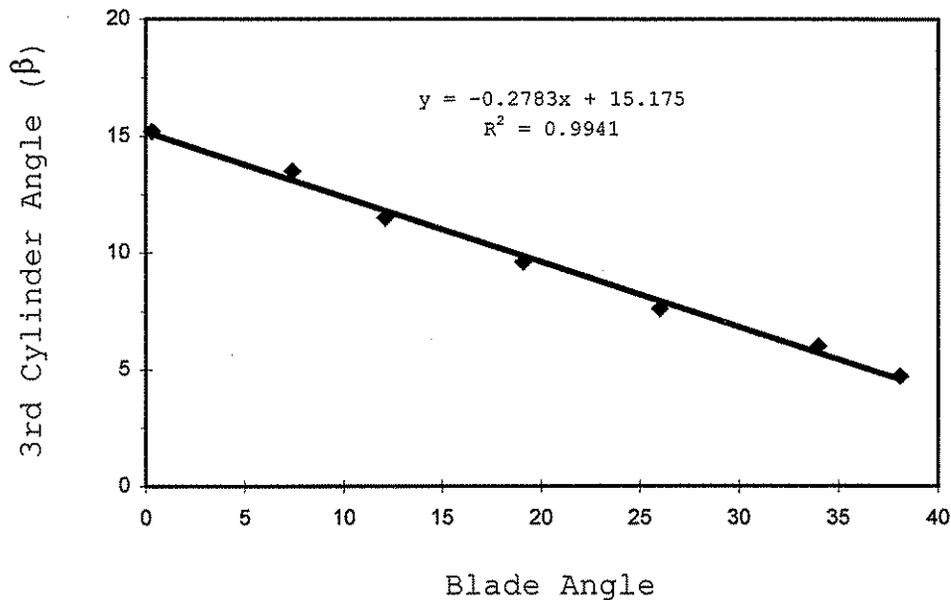
Figure 52 Angle β versus blade angle

$$\lambda = 59.5^\circ - 0.72 * \text{blade angle} \quad (4)$$

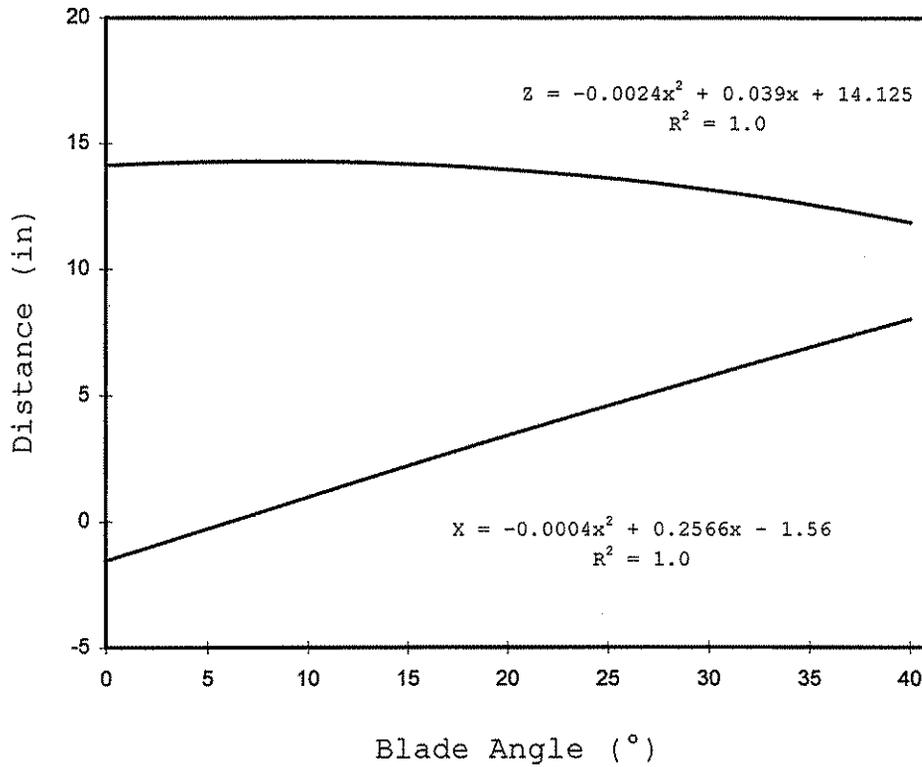
Figure 53 Plot of "X" and "Z" values for an eight inch blade

The number "2" in front of F(1) is required because there is two cylinders that are classified as a "3rd cylinder". This equation is only applicable to only snow blades that are six inches in height. Cutting edges that are eight inches in height need to use "X" and "Z" values specifically for an eight inch blade. Figure 50 shows the plot of "X" and "Z" for an eight inch blade.
