# **Early Entry Sawed Portland Cement Concrete Transverse Joint Ends**

Final Report  
For  
MLR-97-05

April 2003

**Iowa Department  
Of Transportation**

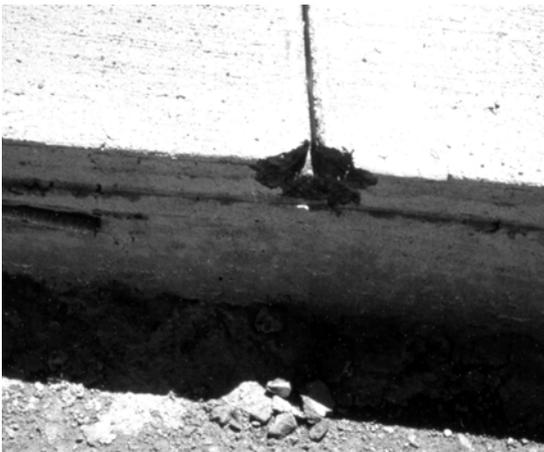
Figure 1  
Joint End Corner Spall

The conventional method of early sawing of PCC was cutting a 1 1/8 inch deep joint with the saw blade passing completely out through the edge of the slab. This practice, in “green” concrete, often resulted in an immediate large spall at the joint end or caused hairline cracks which result in corner breaks or spalls later (See Figure 1). A logical cause for this spalling was the saw blade being forced toward the unsupported slab edge. In addition, sawing completely out to the shoulder resulted in weakening of the joint ends leading to potential additional damage or corner spalls from roadway construction and maintenance equipment operating or scraping along the shoulder’s edge (See Figure 2).

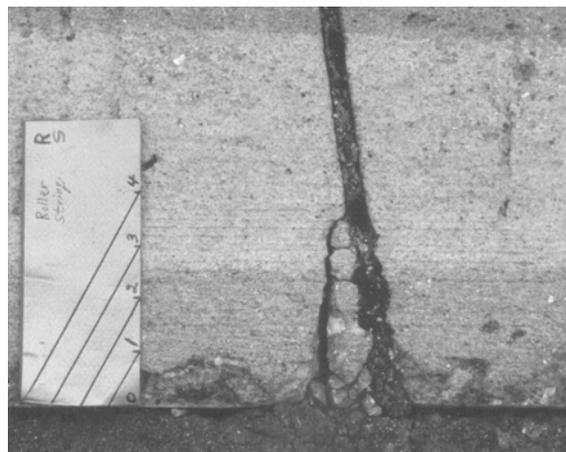
Figure 2  
Joint End Corner Spall

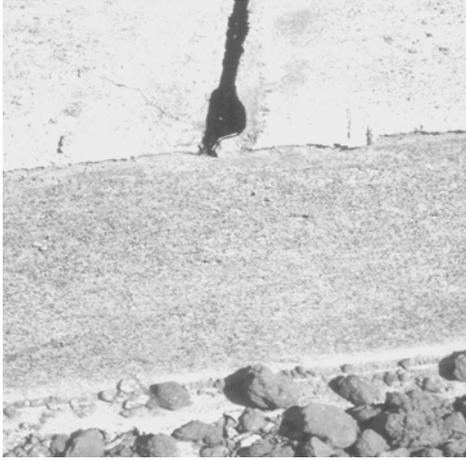
Figure 3  
"Short Cut" creates a sealant dam.

Reduction of the joint end spalling is the primary objective of this research (See Appendix A). In order to do this, a southbound lane test section of one day’s paving on highway US 65 bypass southeast of Des Moines has been evaluated using non-conventional methods. This procedure involved early sawing of the transverse contraction joints at the conventional depth of 1 1/8 inches up until approximately 1/2 to 3/4 inch before the leading edge of the blade reaches the end of the slab. Stopping the saw at that point created a “short joint”. In addition to preventing end spalls, this method will decrease costs of labor by leaving a concrete “dam” to contain hot pour sealant from flowing out over the end of the joint (See Figure 3). Currently, materials and labor are used to create a duct tape dam at the end of each joint. The tape dam has a high rate of adhesion failure due to the curing compound coating on the PCC (See Figure 4).

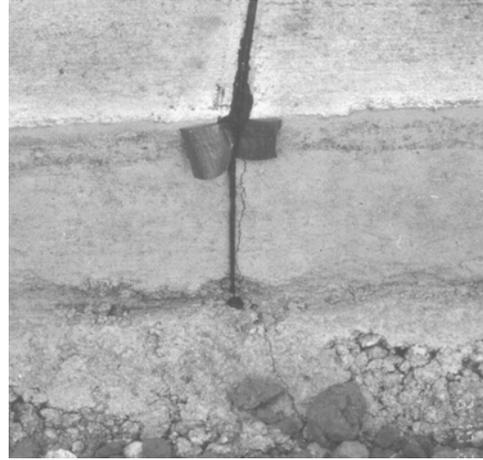
Figure 4  
Adhesion failure of duct tape  
and sealant leakage.

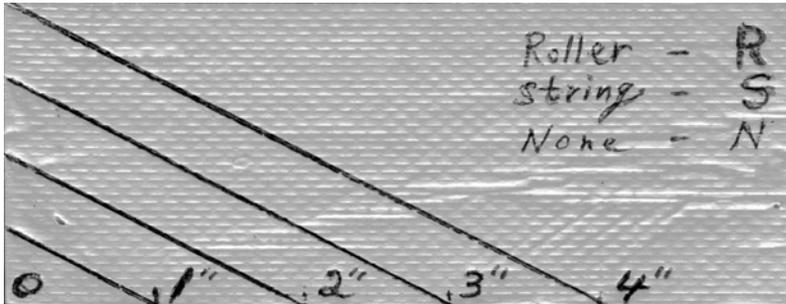
Figure 5  
Corner Spall Gauge  
(Not to scale)

Measurements to determine corner spall lengths were made (in inches) using a special gauge (See Figure 5). Contraction joint crack width was measured in inches using a crack comparator (See Figure 6).

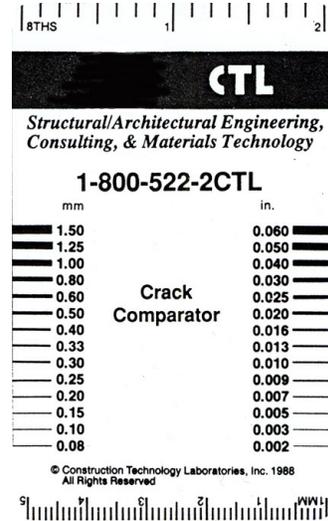
Figure 6  
Crack Comparator  
(Not to scale)

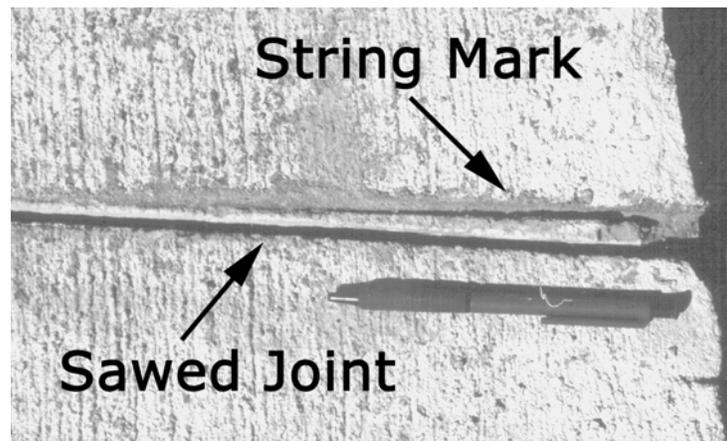
Figure 7  
String mark seen beside  
sawed joint.

- The saw did not always follow, exactly, the mark left by the contractors' joint marking string. The string marking action on the plastic concrete over the center of the dowel basket, often created a deep groove near the shoulder, simulating a shallow joint (See Figure 7). That groove created a secondary-like joint and provided a path for the hot liquid sealant to escape over the shoulder's edge. It can eliminate the benefit of the dam left by the "short joint".

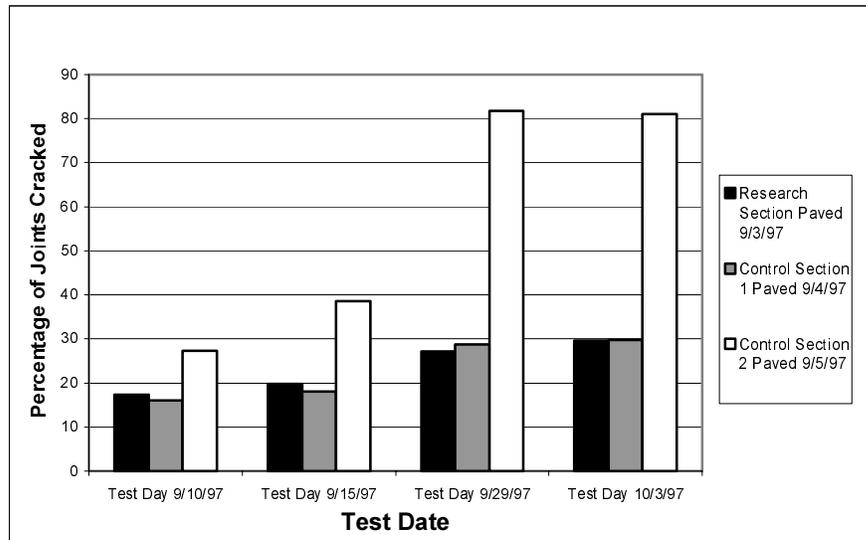
Graph 1  
Percentages of  
Contraction  
Joints Cracked

The development of shrinkage cracks below the sawed joints was observed along the shoulder’s edge and recorded progressively on 4 different dates before shouldering work covered the edge of the slab. The data is given in Appendix D. It is interesting to note the rate of concrete joint shrinkage crack development over time. The research section and control section #1 each acted in a similar way, but control section #2 had an unusually high rate of joint cracking. Over the 3 sections, the percent of joints cracked at approximately 1 week of age was 17.3, 16.0 and 27.3 respectively and at 4 weeks of age was 29.6, 29.8 and 81.8 respectively (See Graph 1).

Analysis of paving and weather data over that time period did not show any significant changes which would influence the high cracking rate for control section #2, as shown in the data on page 20 near the end of Appendix D. It is interesting to note that the number of contraction joint cracks in control section #2 were much higher (82%) than in control section #1 (30%). It is also interesting to note that the crack width for control section #2 was about half as wide (0.028 inches) as control section #1 (0.056 inches) and in the research section (0.050 inches). (See Graph 2) The cause for the difference in joint cracking rate was not determined.

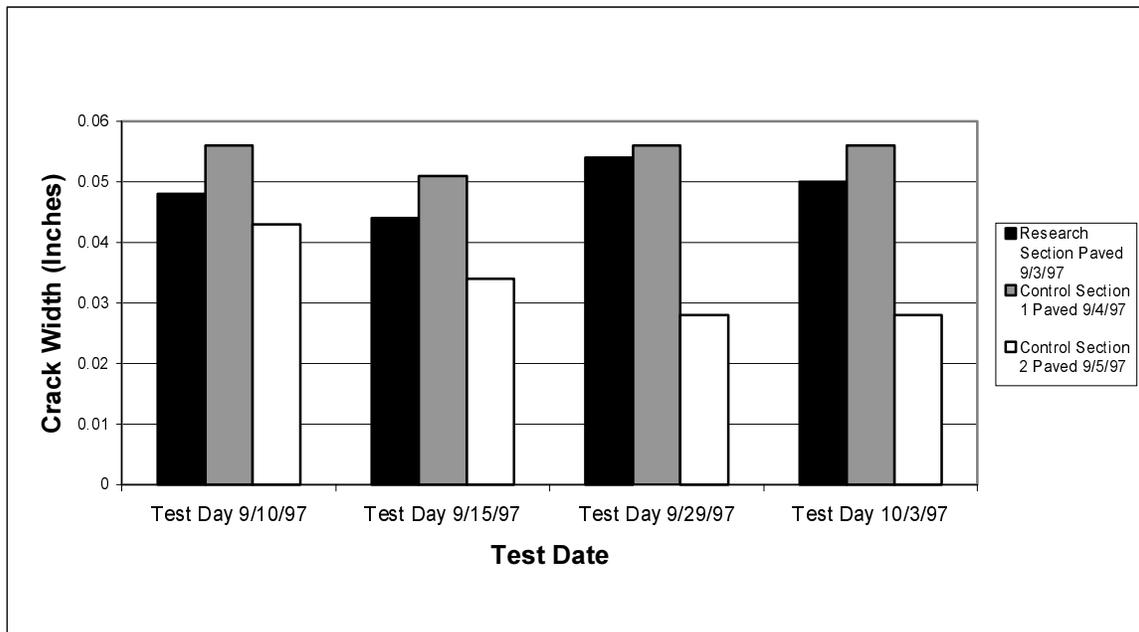
Graph 2  
Average Crack Width

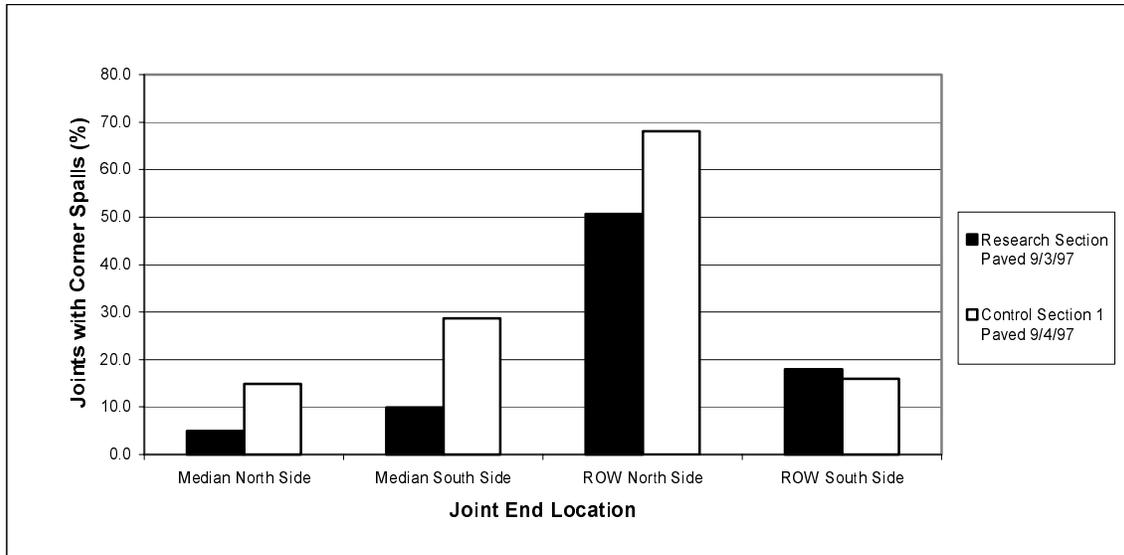
Graph 3  
Joint End Corner Spalls

The test section ROW end of the joint contains even more damage (See Graph 3). The test section shows damage on 17.9% of the joint ends on the south side and 50.6% on the north side. Similarly, control section 1 showed 16.0% of the joint ends damaged on the south side and 68.1% on the north side. Control section 2 showed 9.1% of joints damaged on the south side and 47.7% on the north side (See page 20 in Appendix B). Test section joints have spalls averaging 1.9 inches on the north side and 1.5 inches on the south side (See Graph 4). The control corner spalls average 2.5 inches on the north side of joint ends and 1.7 inches on the south side (See Appendix B).

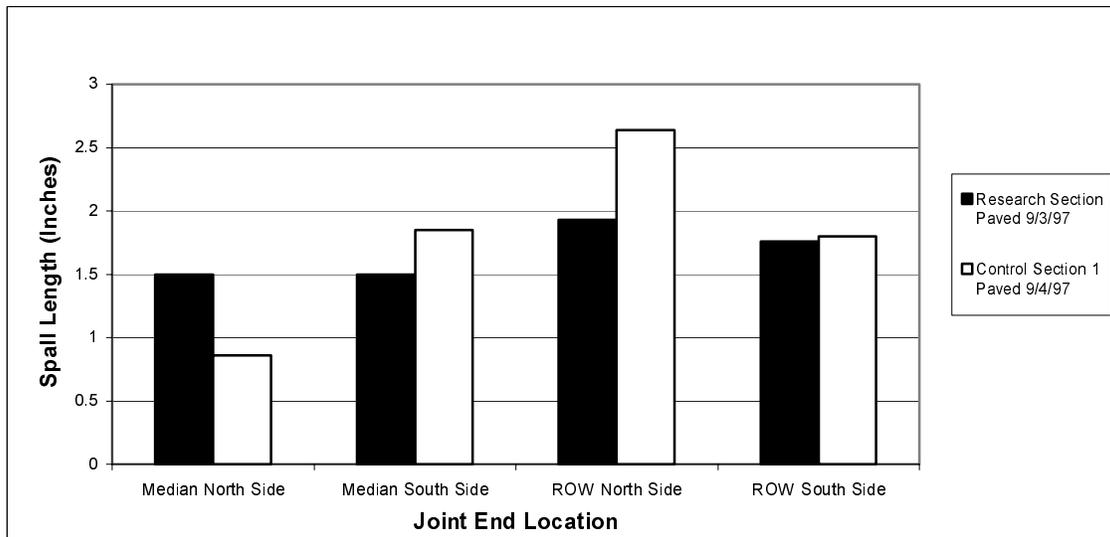
Graph 4  
Average Corner Spall Lengths

In the test section passing lane end of the joint, 10% of the south and 5% of the north joint ends have corner spalls. This is much less than the control section where 35% of south and 13% of north joint ends have corner spalls. Actual sizes of the spalls in the test section are also smaller with an average length of 1.5 inches on both, the north and the south sides. Control section corner spall sizes average 2 inches in length on the south side and 1.6 inches on the north side (See Appendix B).

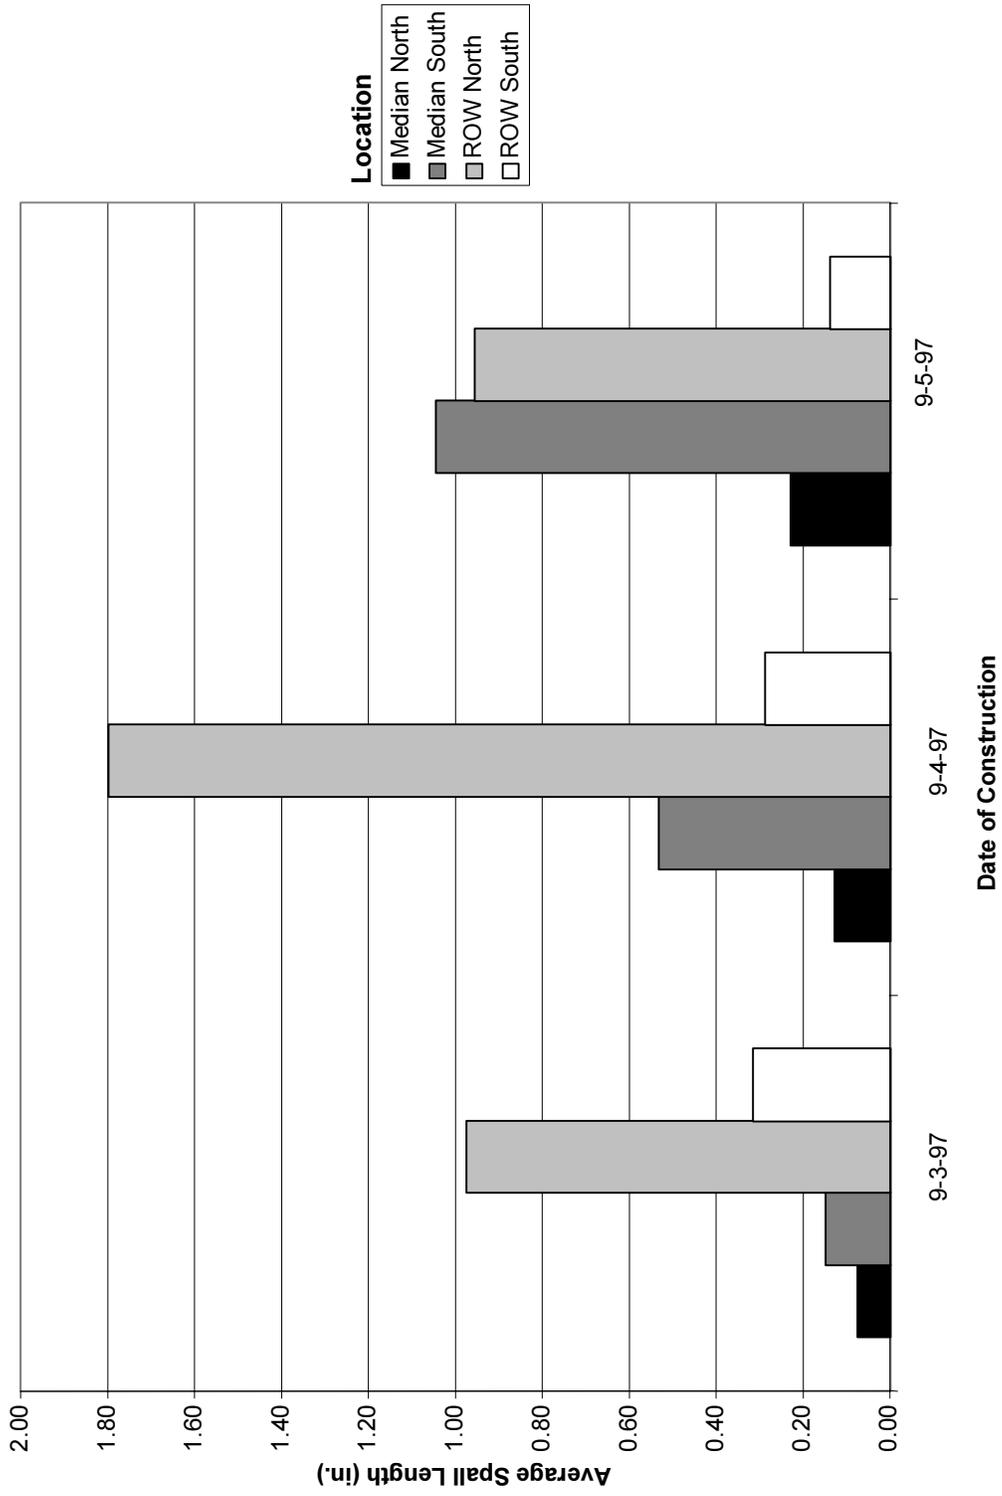
**Graph B-1: Average Joint End Spall Length For All Joints.**

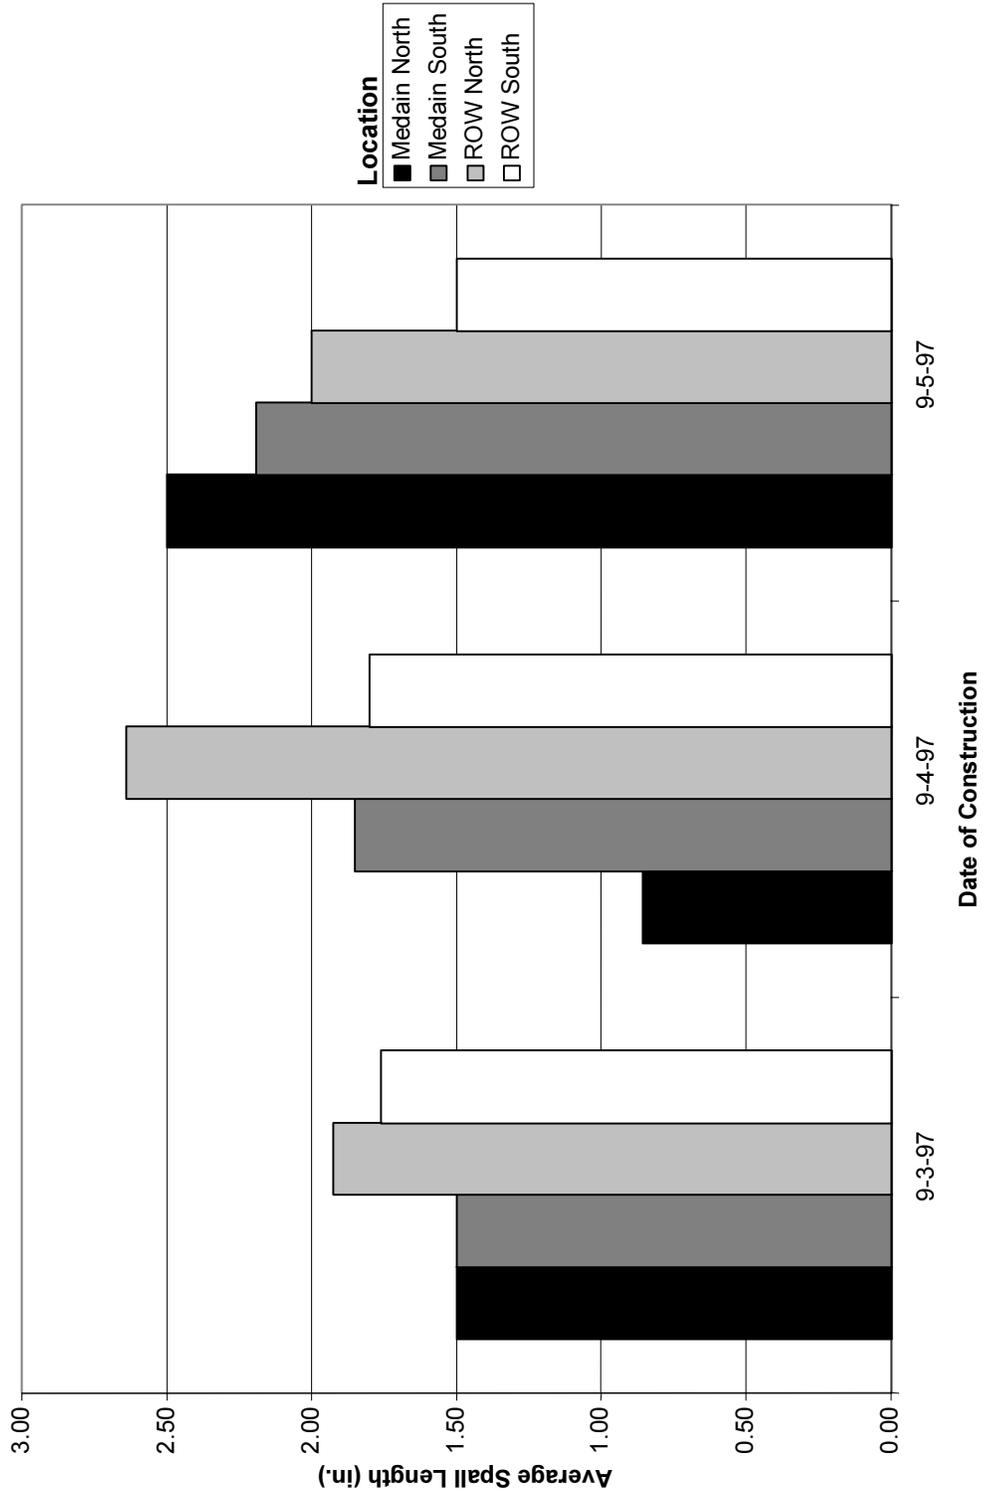
**Graph B-2: Average Joint End Spall Length For Spalled Joints.**

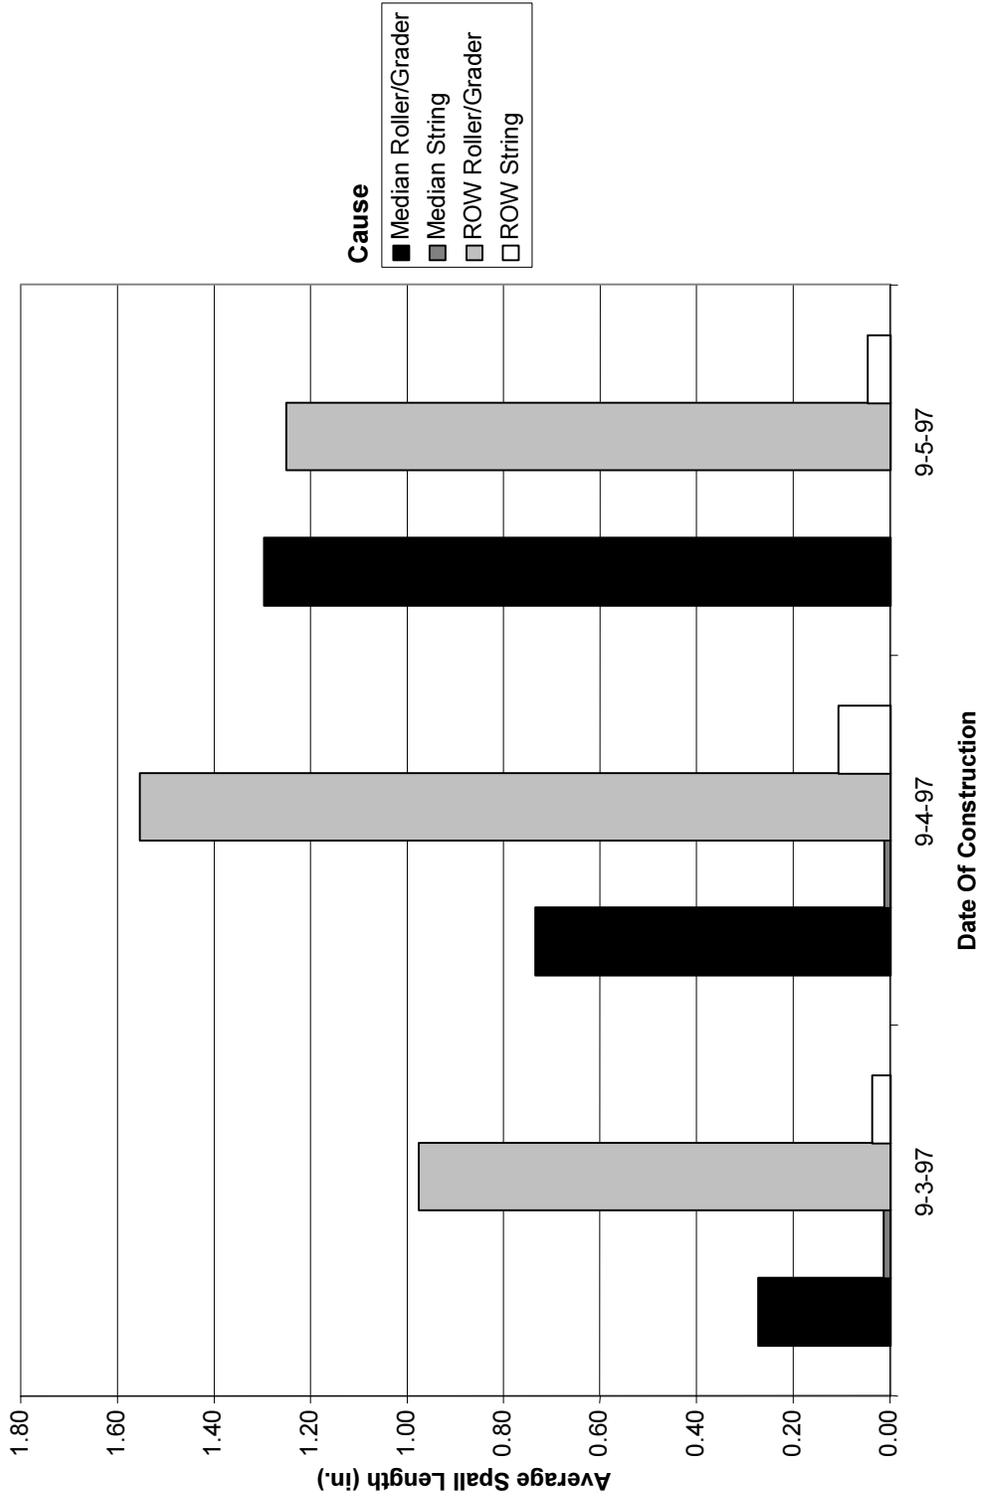
**Graph C-1: Average Joint End Spall Length For All Joints.**

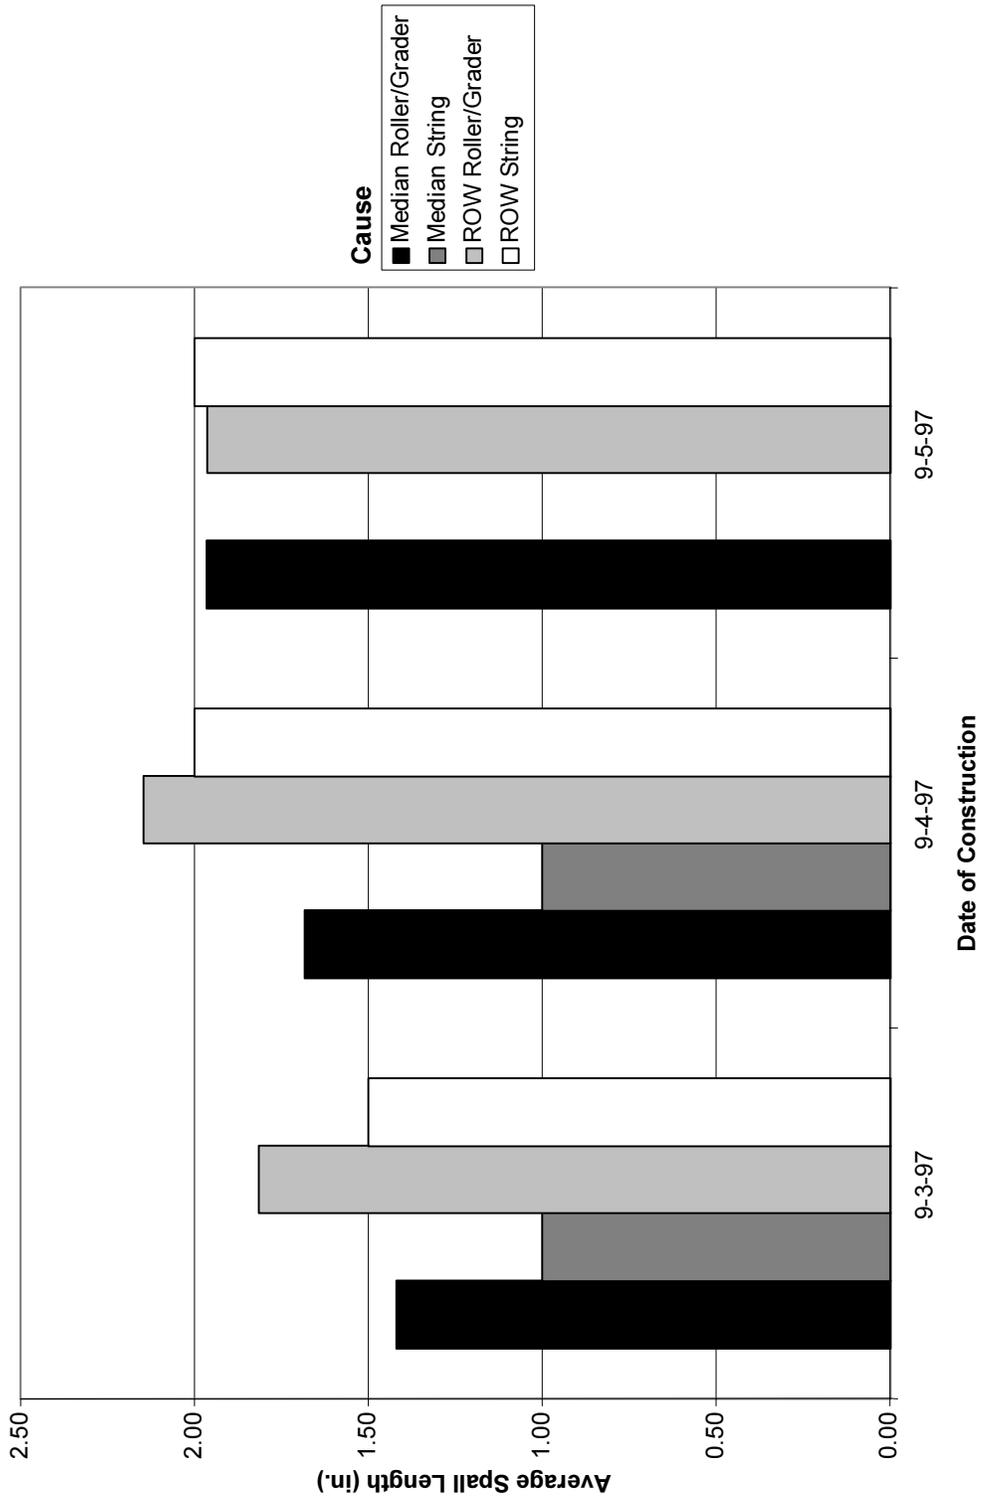
**Graph C-2:** Average Joint End Spall Length For Spalled Joints.

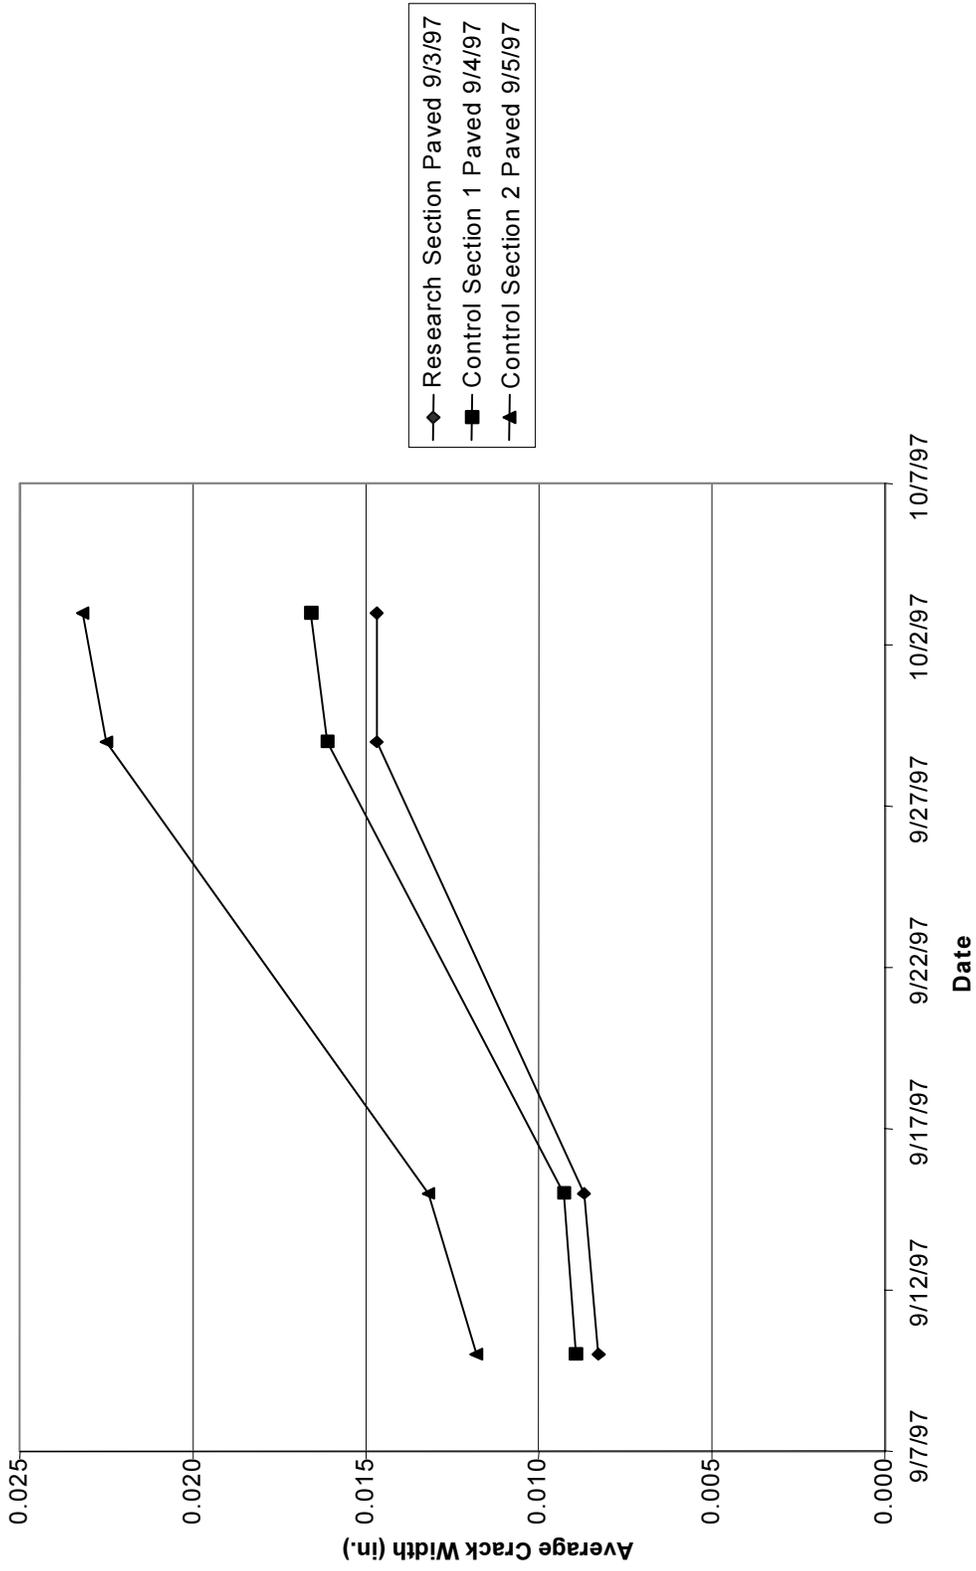
**Graph D-1:** Average Crack Width For All Joints.

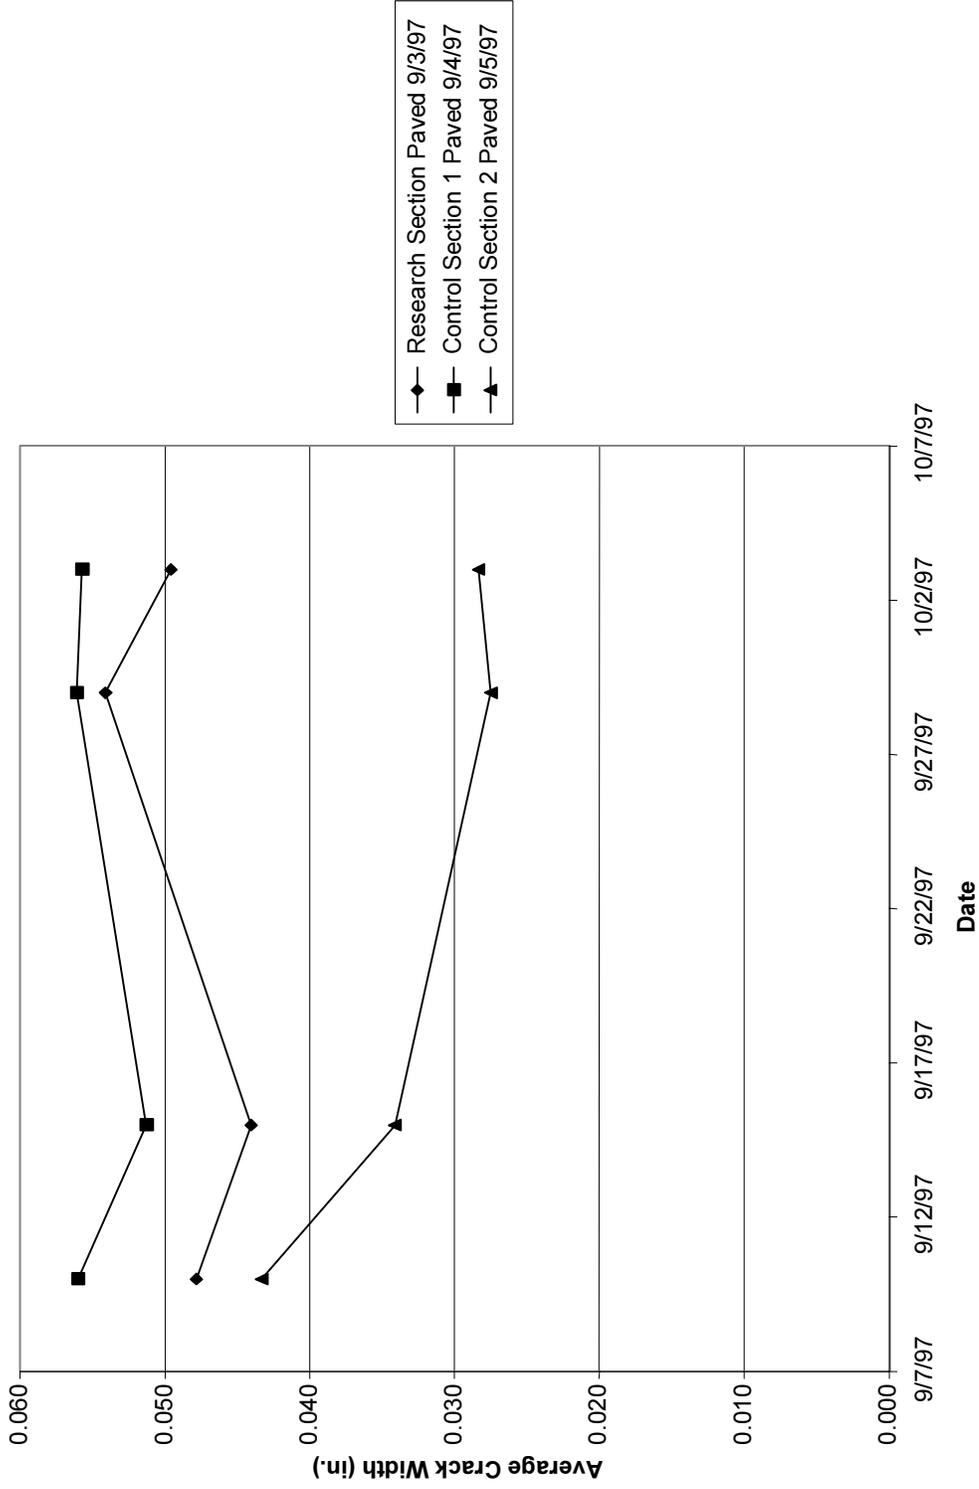
**Graph D-2:** Average Crack Width For Cracked Joint
